Inspection Report

Property Address:
123 Anytown Street
Anytown GA 30000

Champ Home Inspections, Inc.

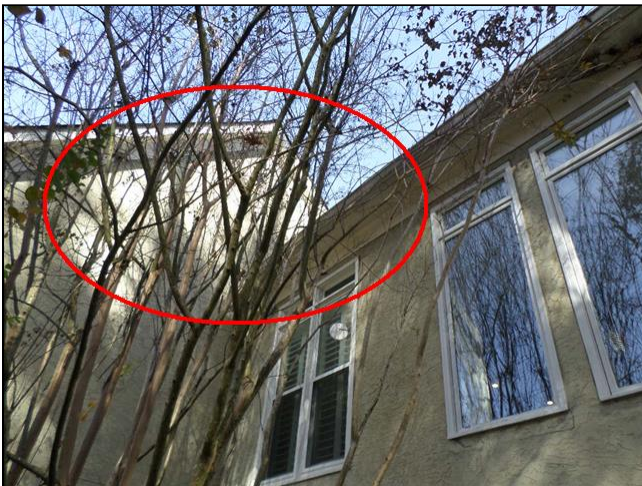
1.8 Recommend trimming over hanging branches noted on the front right and rear right sides of the house.

1.8 Item 1(Picture) over hanging branches

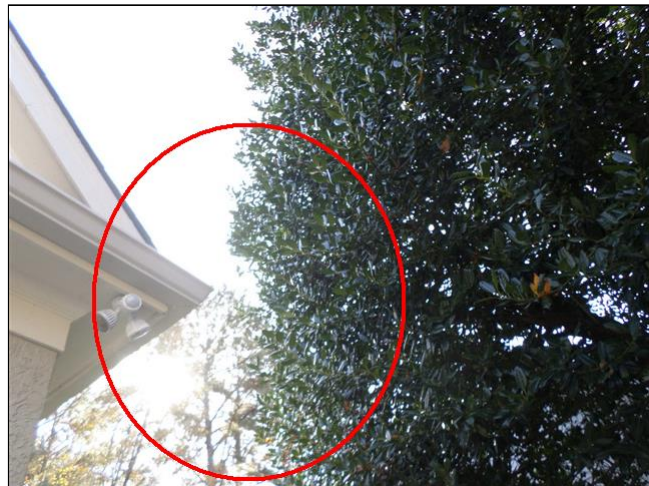
1.8 Item 2(Picture) over hanging branches

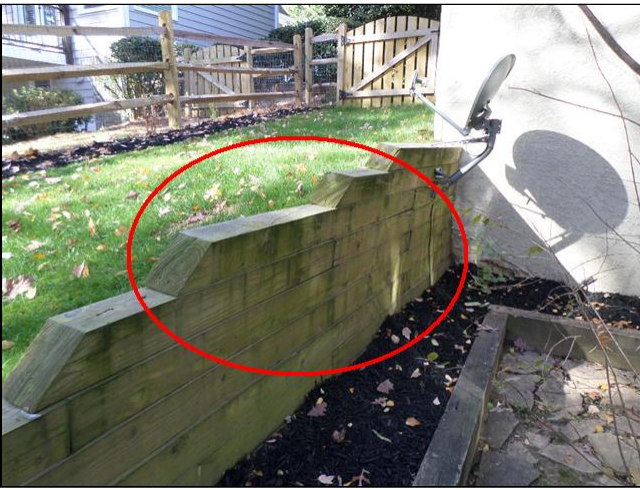
1.9 The rear right timber retaining wall was leaning. Recommend further evaluation from a licensed landscaper.

1.9 Item 1(Picture) leaning wall

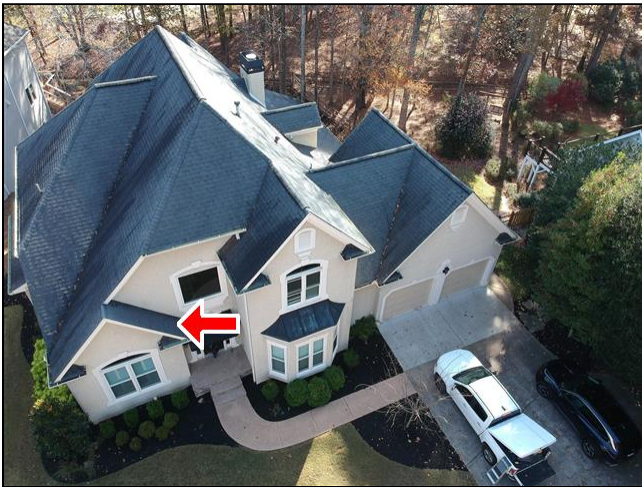
2.0 (2) One cupped shingle was noted on the front side of the roof above the living room. Recommend further evaluation from a licensed roofer to evaluate the entire roof and repair as necessary.

2.0 Item 1(Picture) cupped shingle

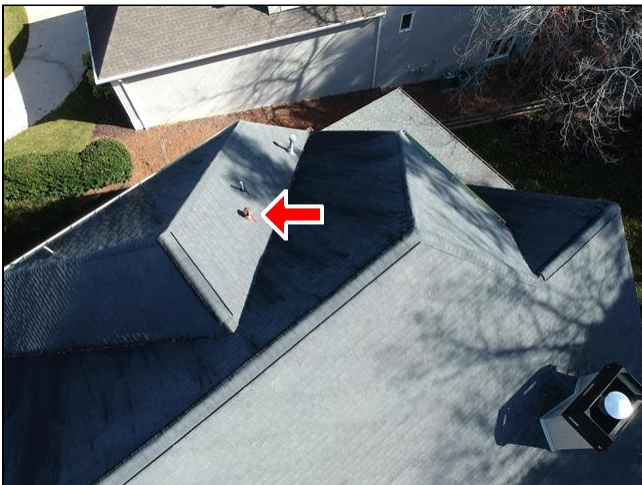
2.1 (2) Rust was noted on the furnace vent pipes and several bathroom exhaust fan vent pipes. Recommend re-painting or replacing if necessary.

2.1 Item 1(Picture) rust on vent

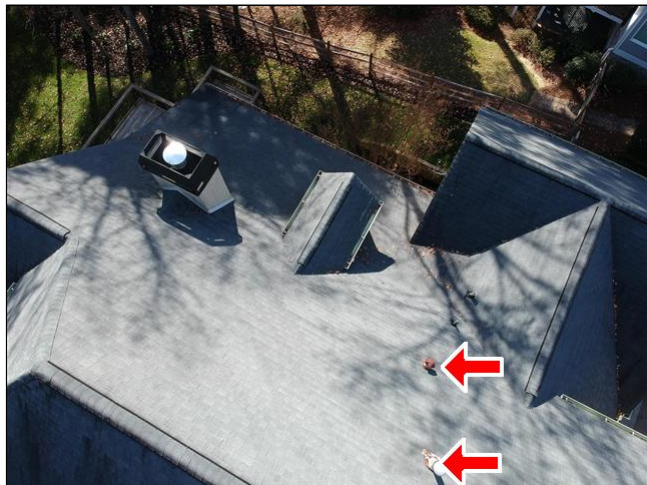
2.1 Item 2(Picture) rust on vents

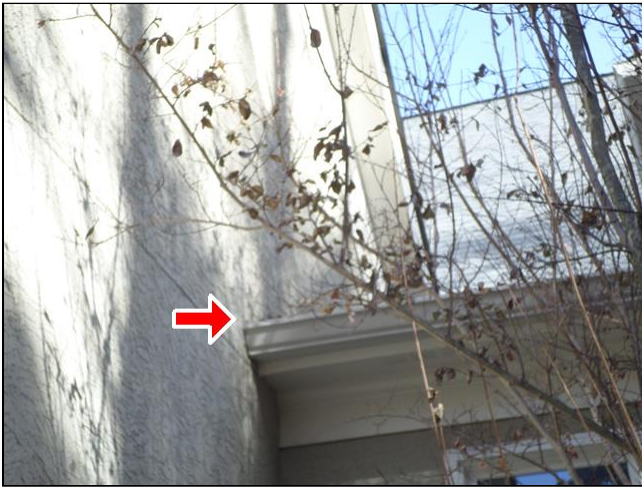
2.1 (3) Missing kickout flashing was noted between the gutters and stucco in the following locations: Recommend installation.

- Between the gutter and stucco on the right side of the dining room.
- Between the gutter and stucco above the right side of the two story foyer.
- Between the gutter and stucco above the right side of the eating area.
- Between the gutter and stucco above the right side of the living room.

2.1 Item 3(Picture) missing flashing

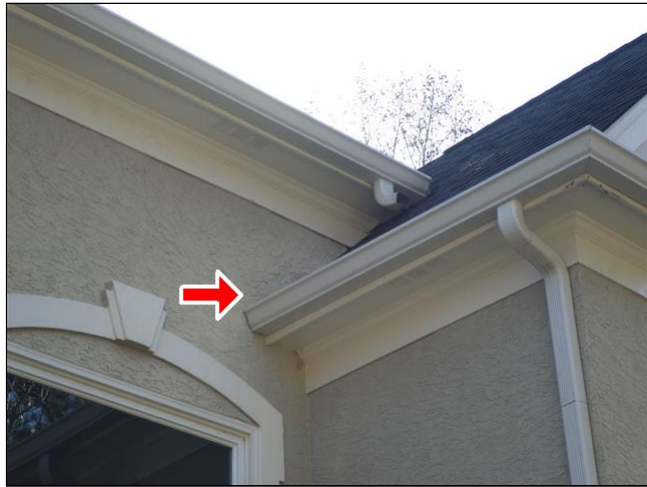
2.1 Item 4(Picture) missing flashing

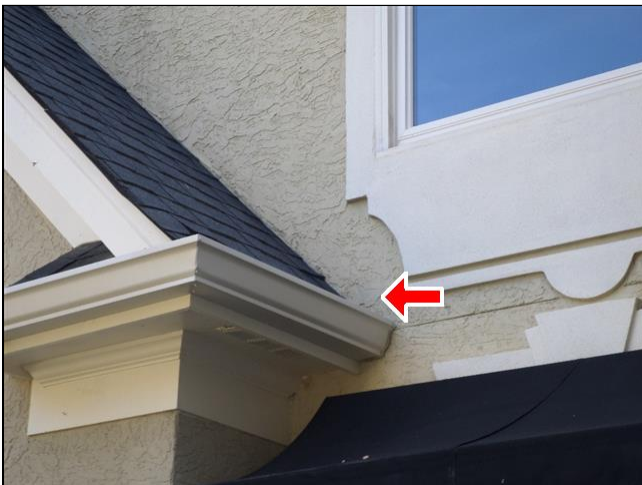
2.1 Item 5(Picture) missing flashing

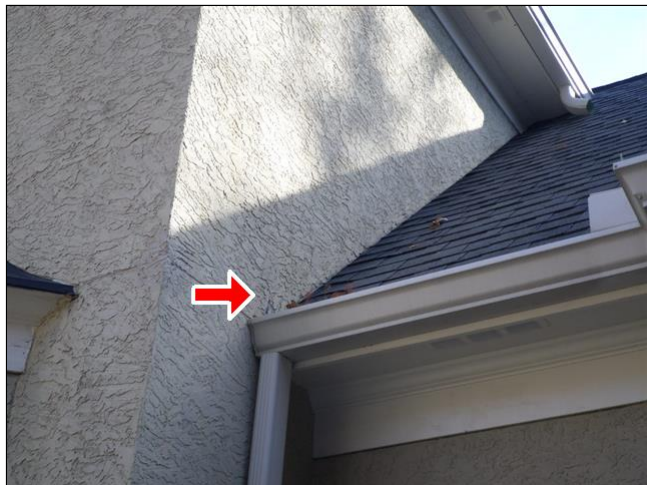
2.1 Item 6(Picture) missing flashing

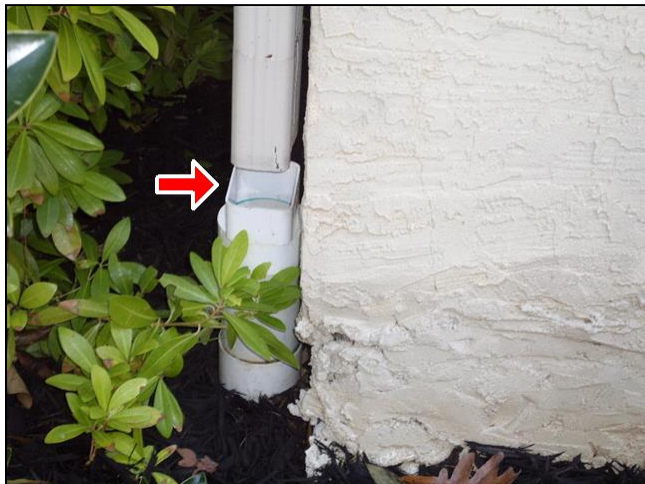
2.3 (2) The front left downspout was disconnected from the drainage pipe. Repair.

2.3 Item 1(Picture) disconnected pipe

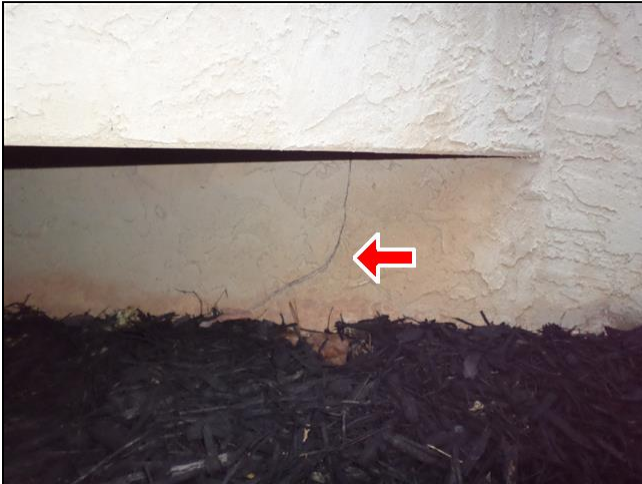
3.0 (1) Cracks were noted in the stucco and trim in various locations around the perimeter of the house. A large crack was also noted in the stucco below the front dining room bay window. Recommend further evaluation from a licensed contractor.

3.0 Item 1(Picture) crack in stucco

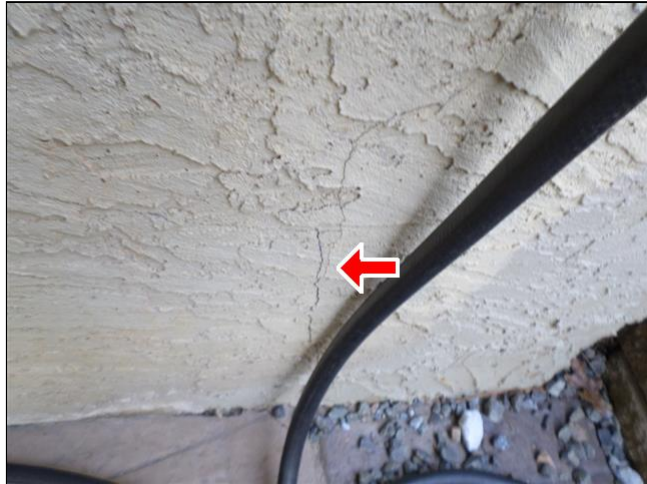
3.0 Item 2(Picture) crack in stucco

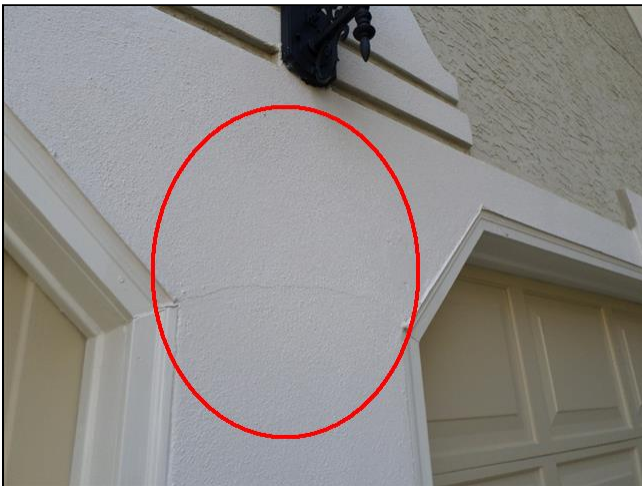
3.0 Item 3(Picture) crack in trim

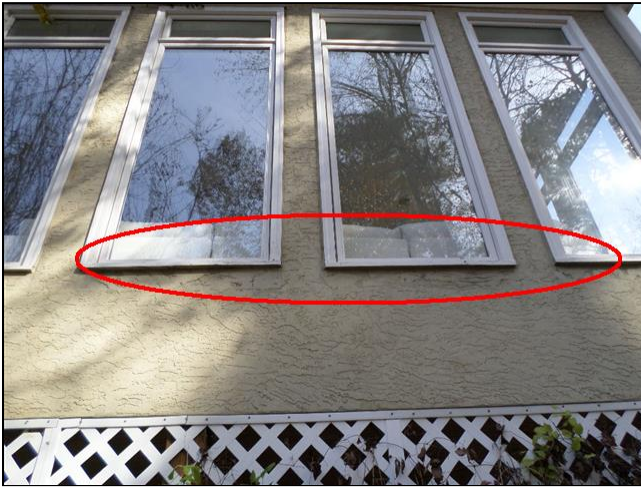
3.0 (3) Rot was noted in the following locations: Recommend further evaluation from a licensed contractor to evaluate all trim and repair.

- On the lower trim of the rear center exterior basement doors.
- On the lower trim of the front right bedroom windows.
- On the lower trim of the rear right sunroom window.
- On the lower trim of several right sunroom windows.
- On the upper trim of the rear left basement window.
- On the lower trim of the rear right family room window.
- On the lower trim and side of the right exterior garage entry door.
- On the upper trim above the right side of the dining room.
- Possible rot on the fascia trim above the left side of the front right bedroom.

3.0 Item 4(Picture) rotted trim

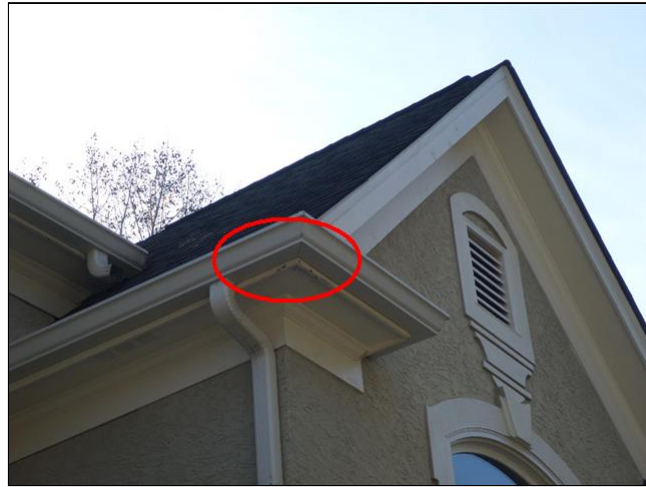
3.0 Item 5(Picture) possible rot

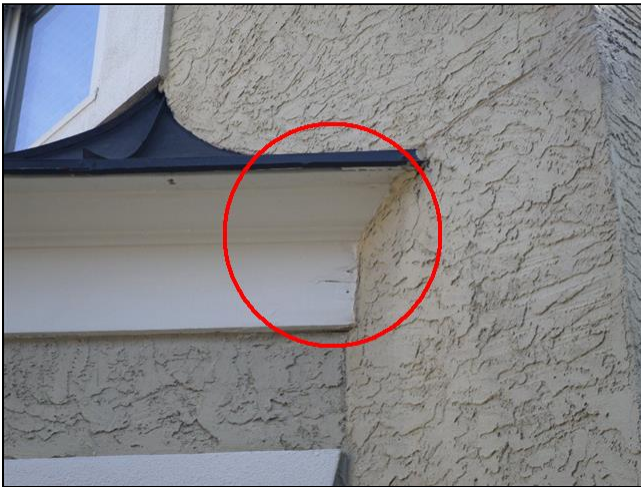
3.0 Item 6(Picture) rotted trim

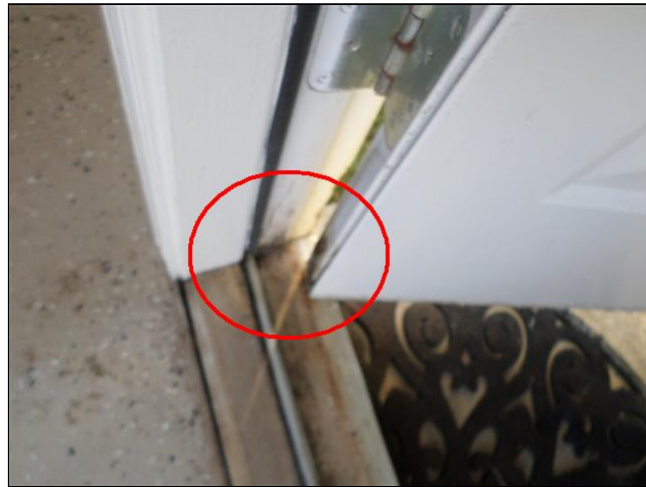
3.0 Item 7(Picture) rot on door and trim

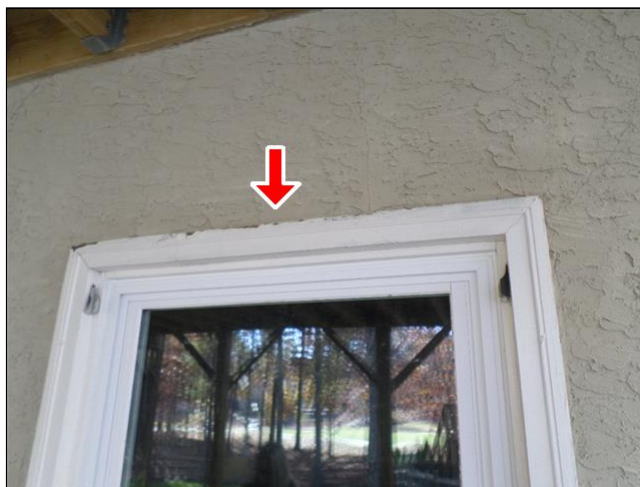
3.0 Item 9(Picture) rotted trim

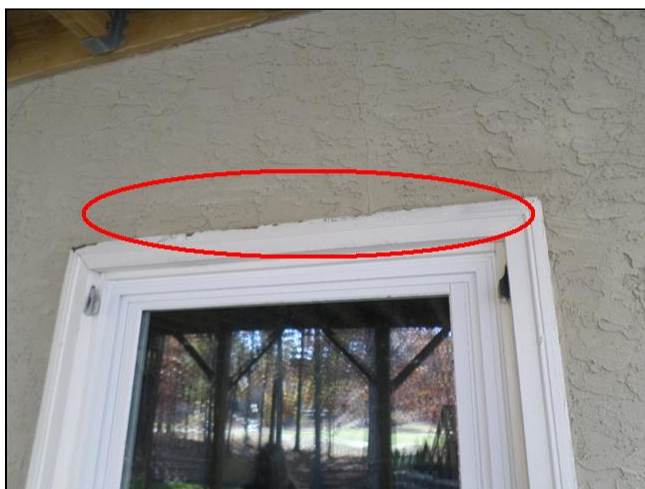
3.1 (2) No head flashing was noted above the rear left basement window. Install.

3.1 Item 1(Picture) missing flashing

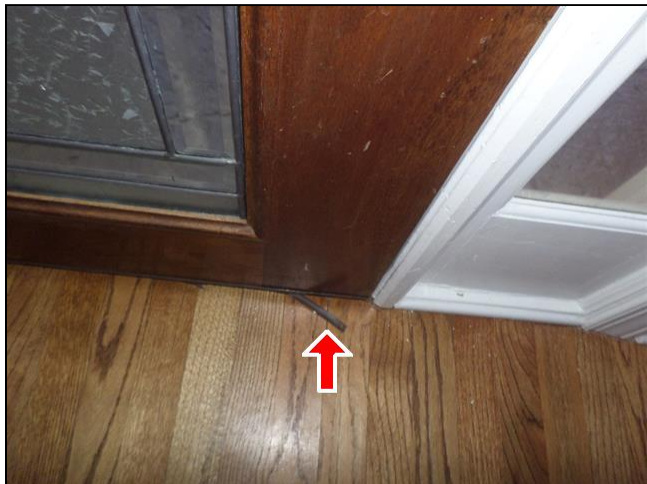
3.2 (5) Torn weather stripping was noted below the front door and rear exterior sunroom door. Repair.

3.2 Item 1(Picture) torn weather stripping

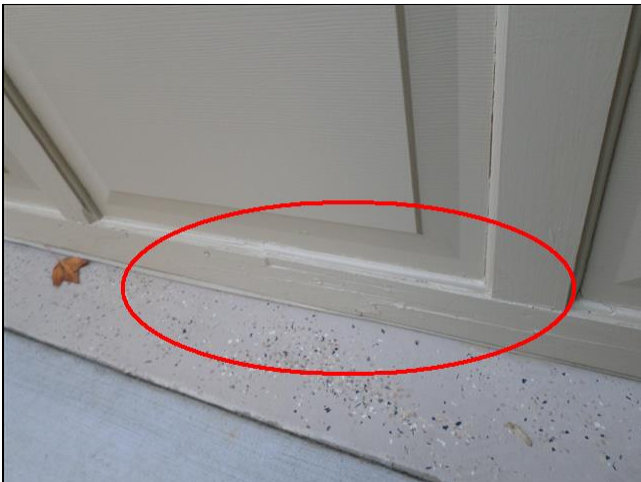
4.3 (1) The lower panel was damaged on the right garage door. Repair as necessary.

4.3 Item 1(Picture) damage on door panel

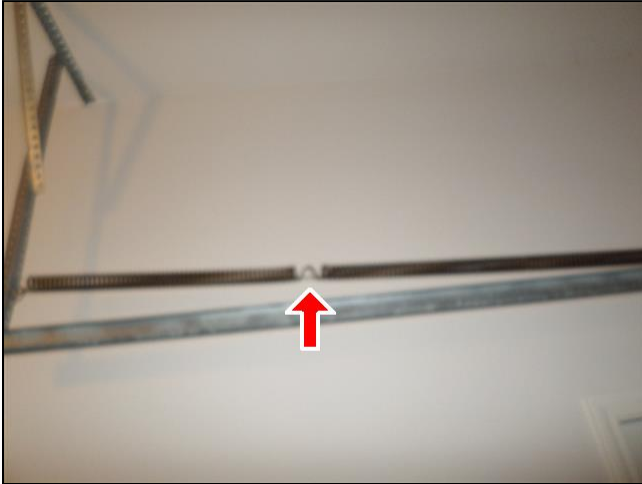
4.3 (3) The right spring was stretched out above the right garage door. Repair.

4.3 Item 2(Picture) worn spring

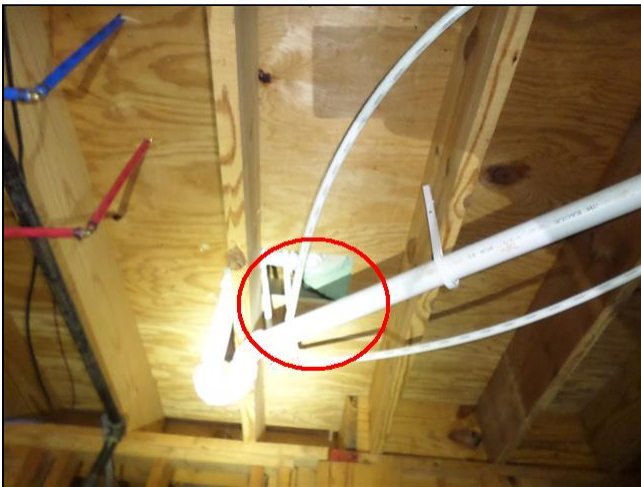
5.0 (1) No fire barrier was noted on the basement ceiling below the master bathroom tub. Recommend installation.

5.0 Item 1(Picture) open space

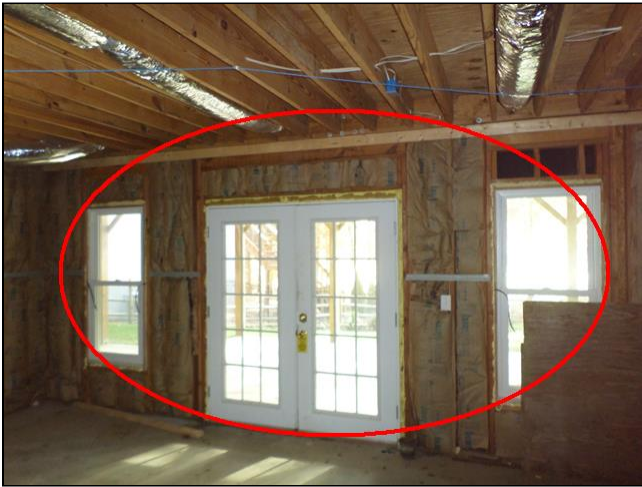
5.0 (3) Exposed paper was noted on the insulation installed on several exterior walls. Recommend covering for added fire safety.

5.0 Item 2(Picture) exposed paper

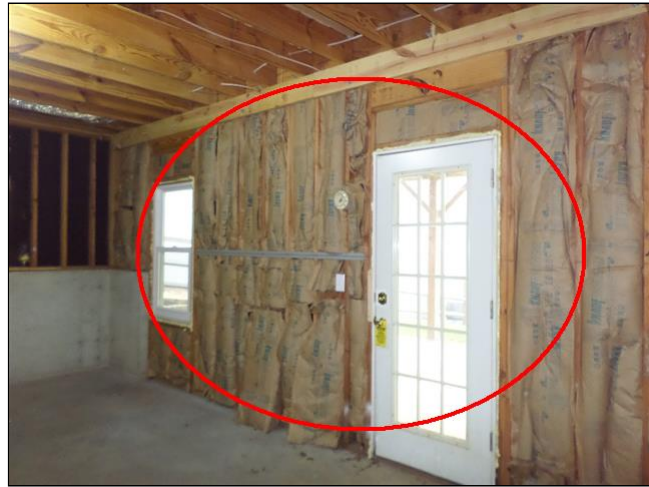
5.0 Item 3(Picture) exposed paper

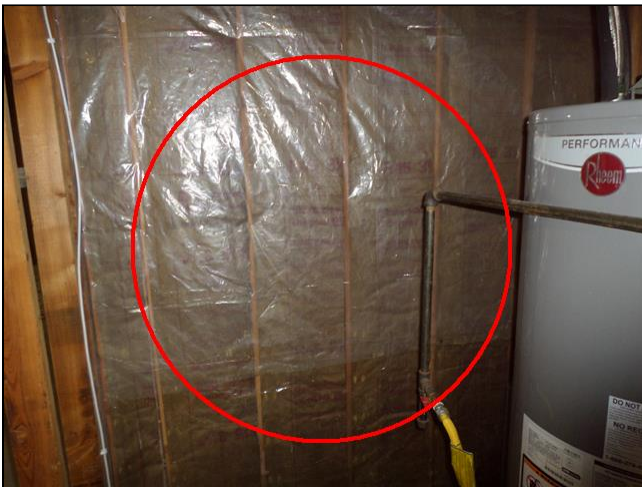
5.0 (4) Plastic was noted on several insulated walls around the basement stairs. Recommend removing plastic, due to the plastic can act as a double vapor barrier and trap moisture.

5.0 Item 4(Picture) plastic on walls

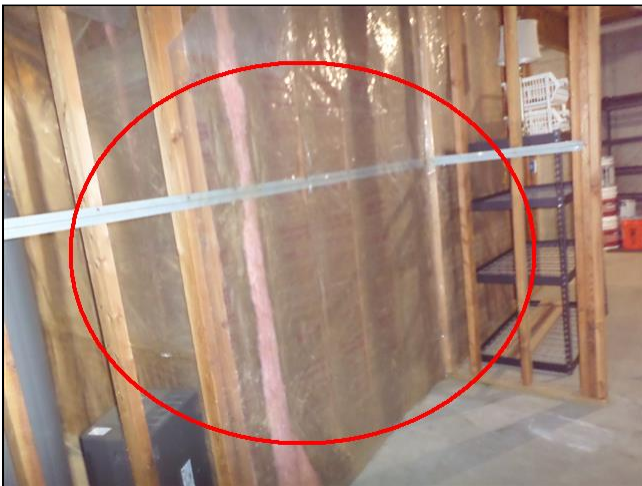
5.0 Item 6(Picture) plastic on walls

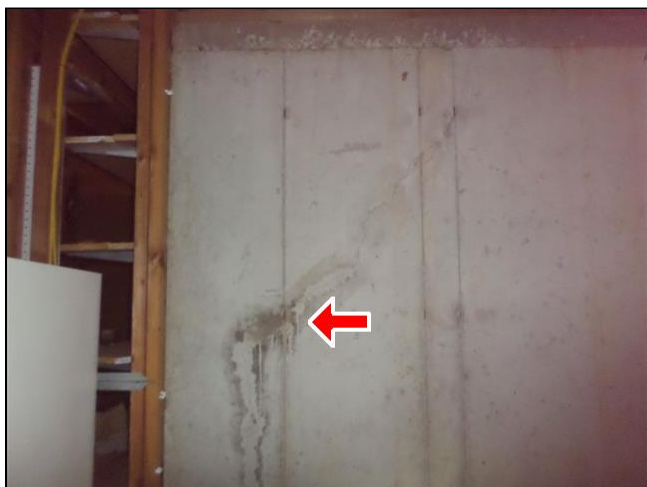
5.0 (6) Water spots were noted below several cracks on the foundation walls in the front right basement room. Recommend further evaluation from a licensed foundation expert.

5.0 Item 7(Picture) water spots

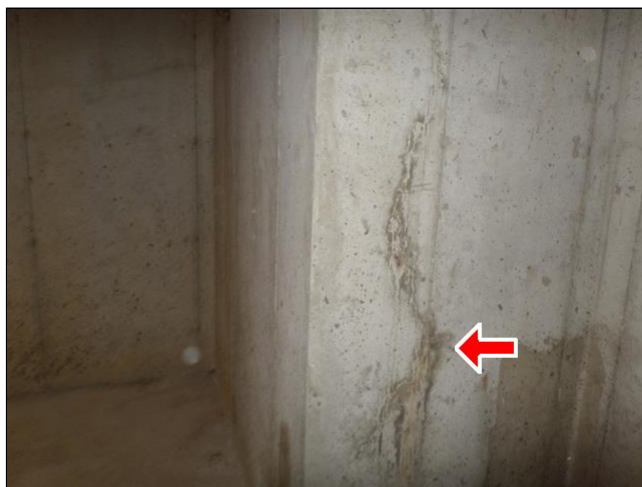
5.0 Item 8(Picture) water spots

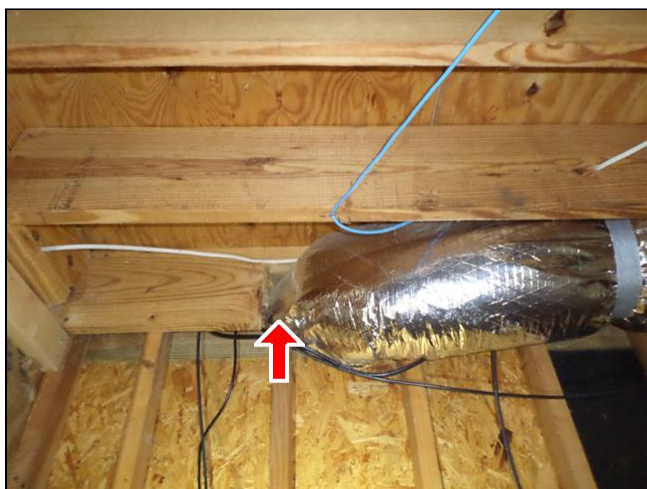
5.0 (7) One over notched 1st floor joist was noted next to the rear right corner in the rear center basement room. Recommend further evaluation from a licensed contractor.

5.0 Item 9(Picture) over notched joist

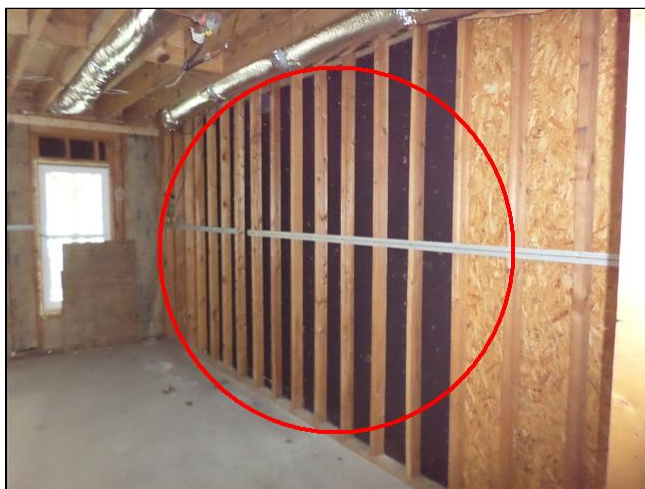
5.0 (8) Missing insulation was noted on several exterior walls. Recommend installation for added energy efficiency.

5.0 Item 10(Picture) missing insulation

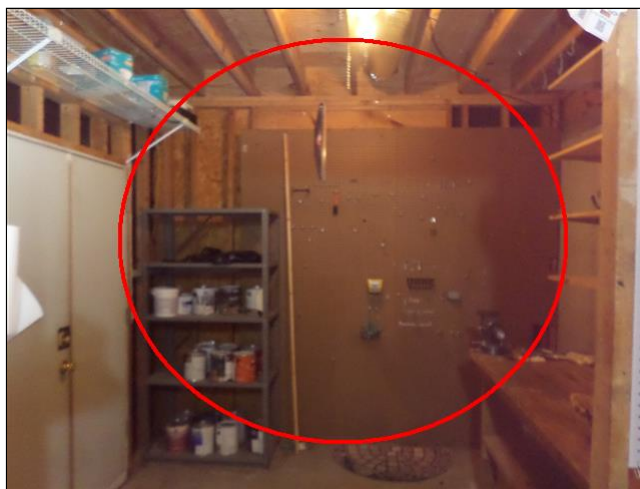
5.0 Item 11(Picture) missing insulation

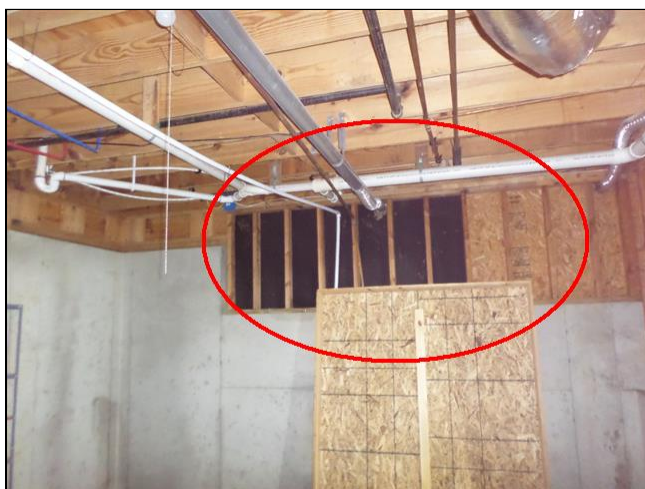
5.0 Item 12(Picture) missing insulation

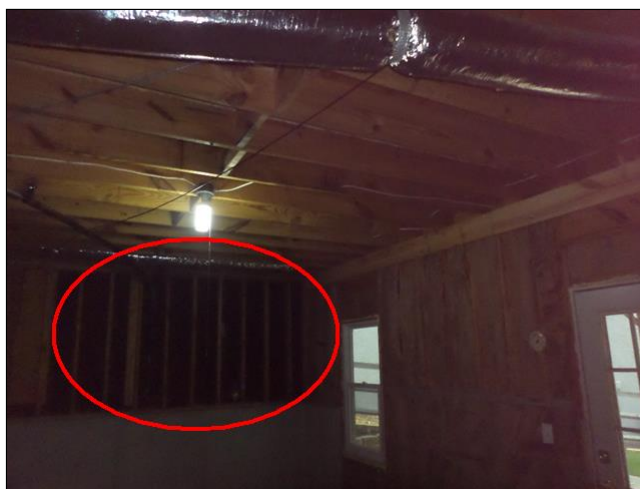
5.0 Item 13(Picture) missing insulation

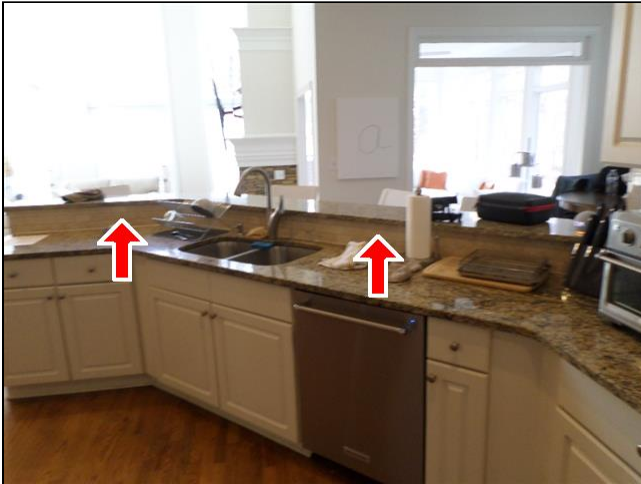
- 6.3 (1) Scratches were noted on the hardwood floors. Recommend further evaluation from a licensed flooring contractor.
- 6.3 (2) The subfloor was squeaky when tested. Repair.
- 6.5 No outlets were noted on the right and left side of the sink. Recommend installation for added convenience.

6.5 Item 1(Picture) missing outlets

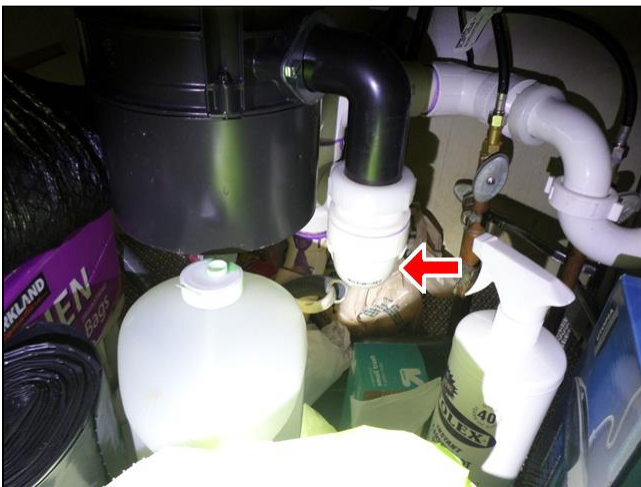
- 6.6 Several countertop outlets were not gfci rated outlets. Recommend replacing for added safety.
- 6.8 No p trap was noted on the drain pipe under the left side of the sink. Recommend further evaluation from a licensed plumber.

6.8 Item 1(Picture) missing p trap

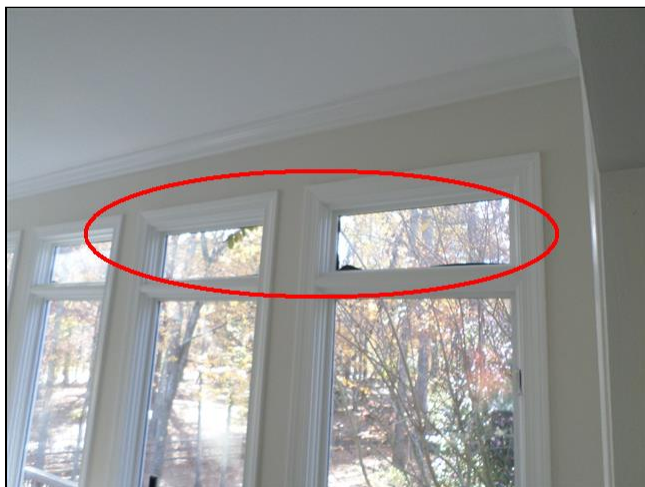
7.2 Loose swiggle seals were noted on several sunroom windows. Recommend replacing glass.

7.2 Item 1(Picture) loose seals

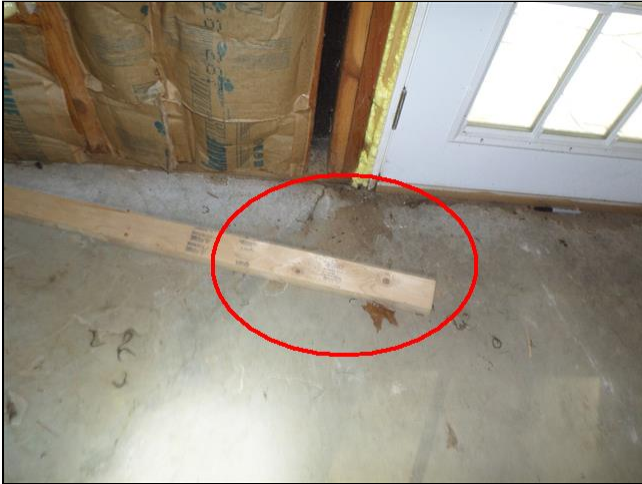
7.3 (4) Water spots were noted on the floor in the rear center basement room next to the exterior doors. Monitor for water intrusion.

7.3 Item 1(Picture) water spots

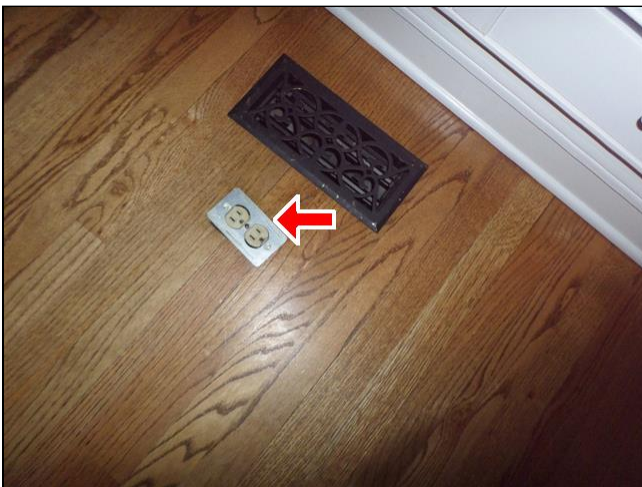
7.5 (2) Incorrect style cover was noted on the living room floor outlet. Recommend installing approved floor outlet cover.

7.5 Item 1(Picture) incorrect cover

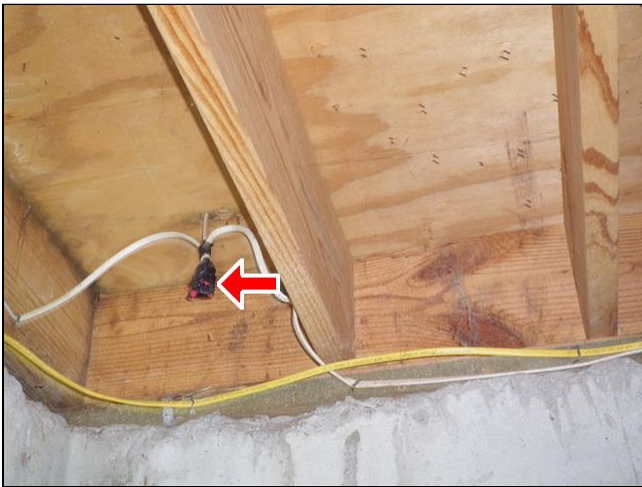
7.5 (3) Open wire splice was noted on the front wall in the front right basement room. Recommend installing a junction box.

7.5 Item 2(Picture) open splice

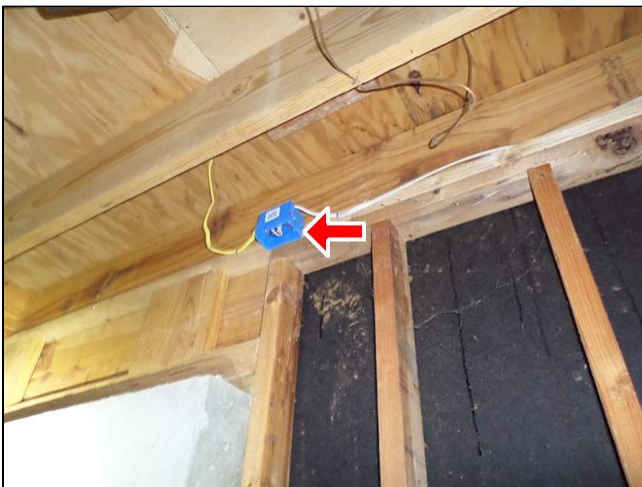
7.5 (5) One open junction box was noted in the center left basement room. Recommend installing a cover.

7.5 Item 3(Picture) open box

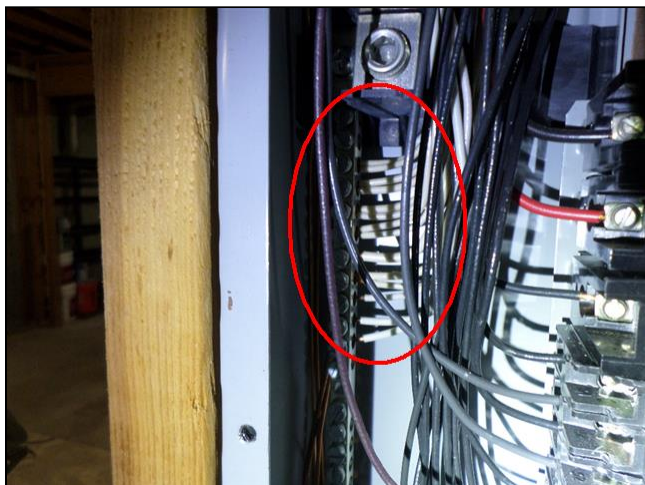
8.3 Several neutral wires were double tapped under the lugs on the buss bars. Recommend further evaluation from a licensed electrician regarding separating wires.

8.3 Item 1(Picture) double neutrals

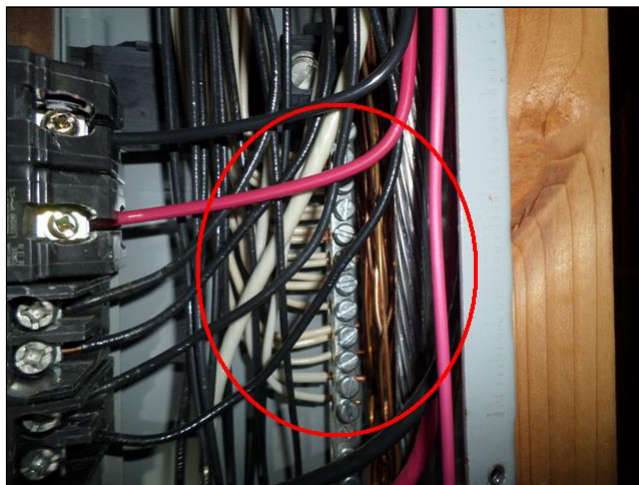
8.3 Item 2(Picture) double neutrals

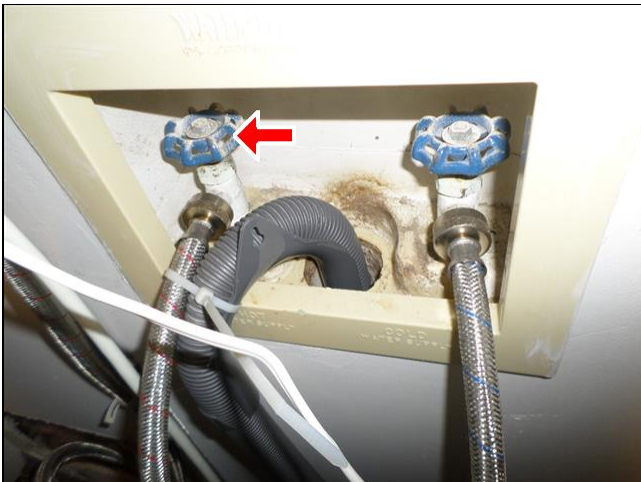
9.0 No red knob was noted on the washing machine control valves indicating the hot water valve. Repair.

9.0 Item 1(Picture) missing knob

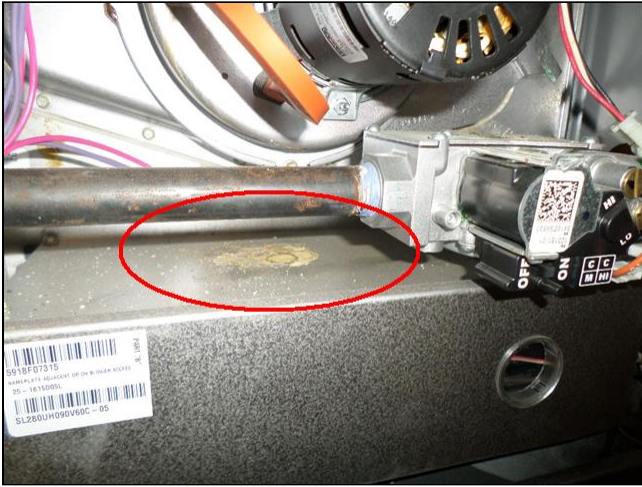
11.0 (3) Small water spots were noted inside the basement furnace near the burners. Monitor for issues.

11.0 Item 1(Picture) small spots

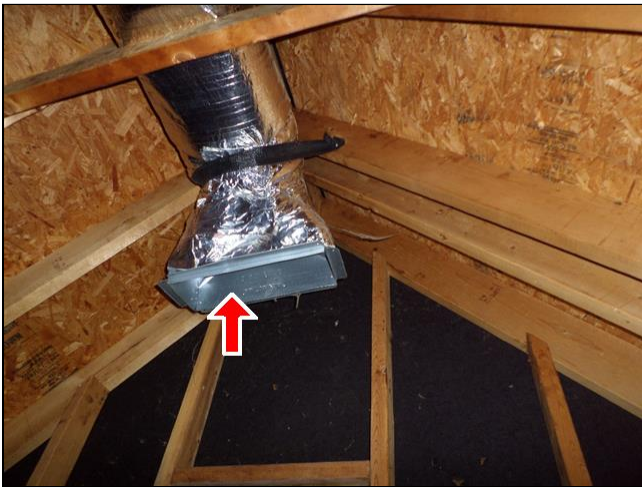
11.3 Open air ducts were noted next to the front and rear walls in the lower attic. Recommend sealing ducts.

11.3 Item 1(Picture) open duct

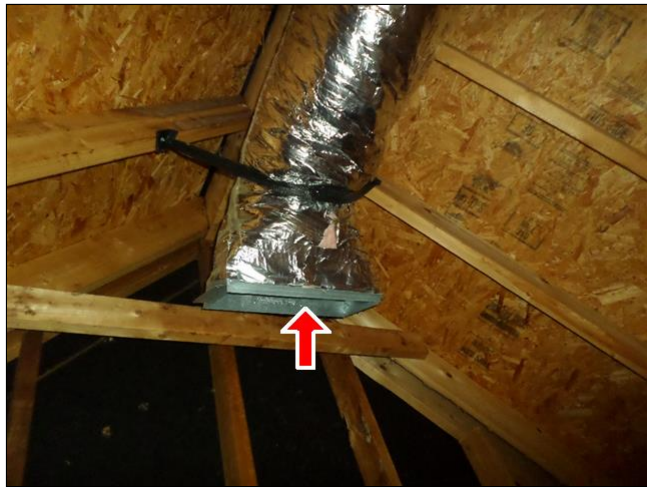
11.3 Item 2(Picture) open duct

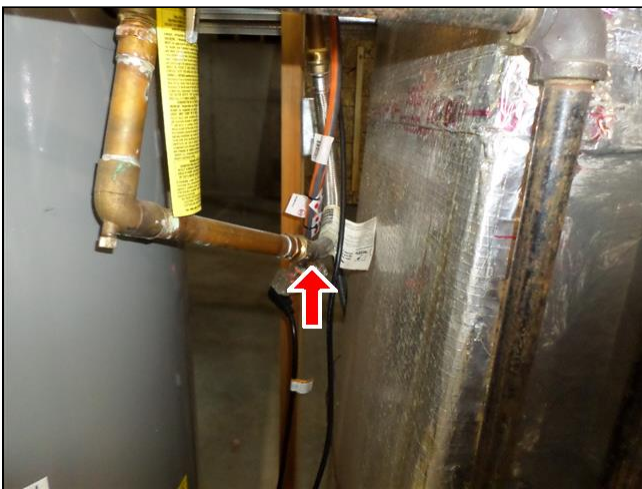
13.0 (1) The tpr valve drain was not located at the lowest point on the pipe. Repair.

13.0 Item 1(Picture) drain not at lowest point

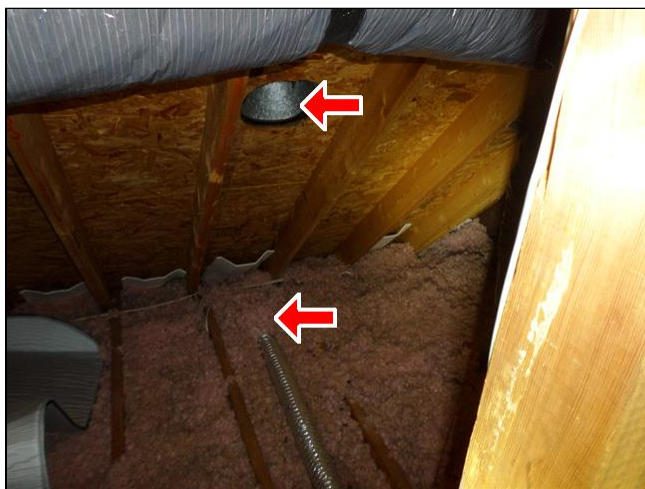
14.1.A One bathroom exhaust fan vent pipe was disconnected from the roof vent near the attic door. Repair.

14.1.A Item 1(Picture) pipe disconnected

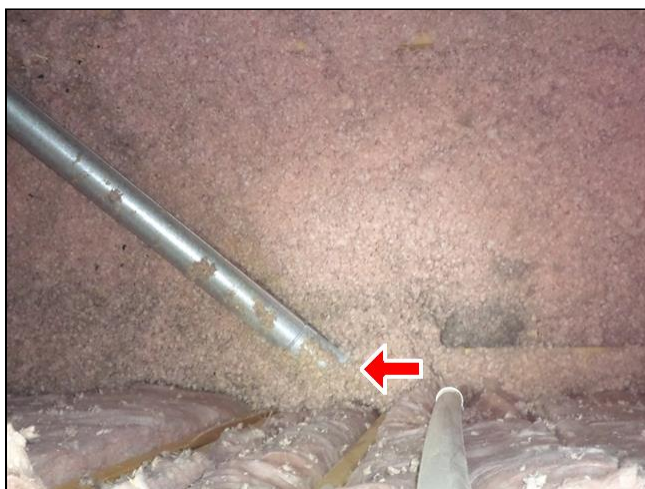
14.2.A (2) The basement furnace vent pipe was touching the insulation. Recommend a minimum of 1" clearance between the insulation and vent pipe.

14.2.A Item 1(Picture) vent touching insulation

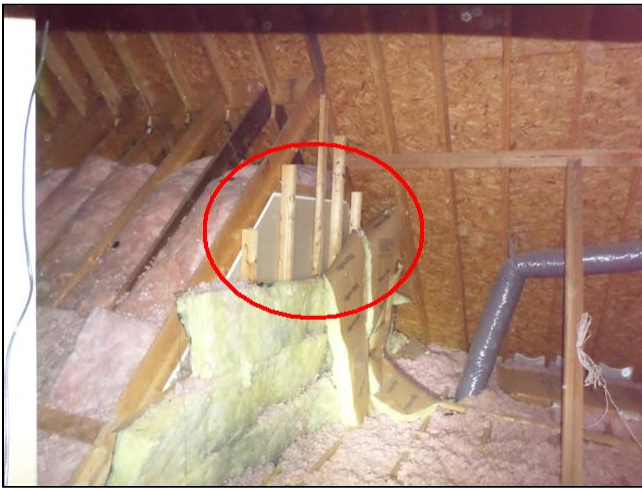
14.2.A (3) Loose batt insulation was noted on the front family room vertical wall. Re-secure.

14.2.A Item 2(Picture) loose insulation

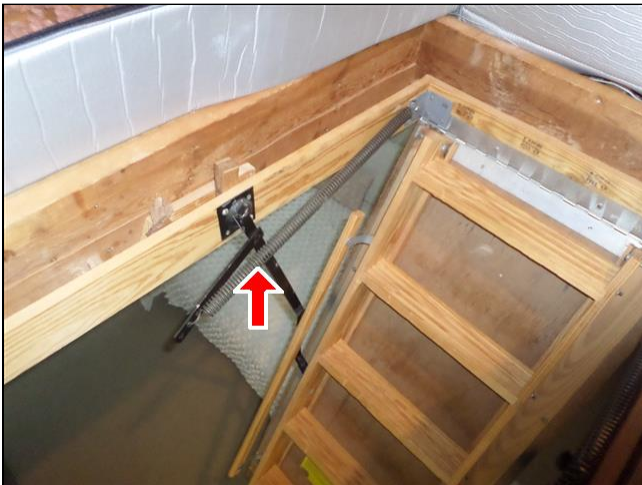
14.4.A (2) One spring arm was loose. Repair.

14.4.A Item 1(Picture) loose spring arm

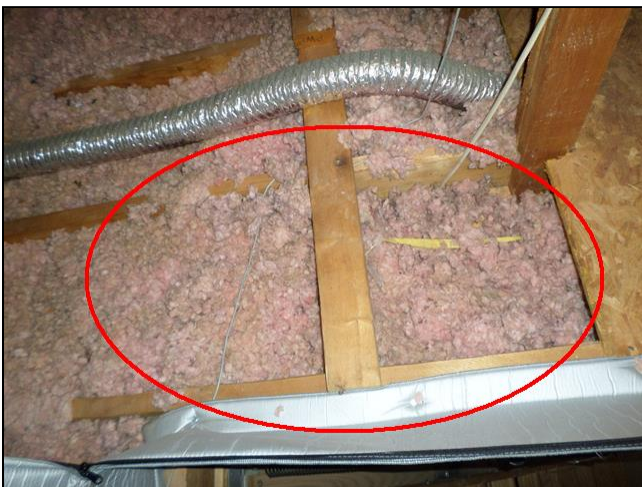
14.4.A (3) Missing flooring was noted next to the access door. Recommend installation for added convenience.

14.4.A Item 2(Picture) missing flooring

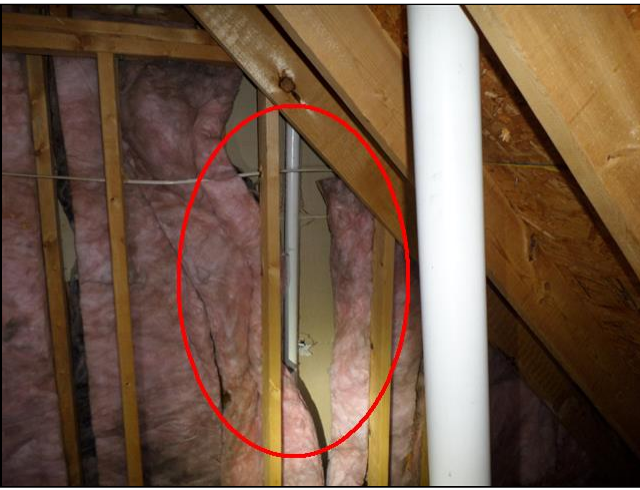
14.2.B Loose batt insulation was noted on the left vertical wall. Re-secure.

14.2.B Item 1(Picture) loose insulation

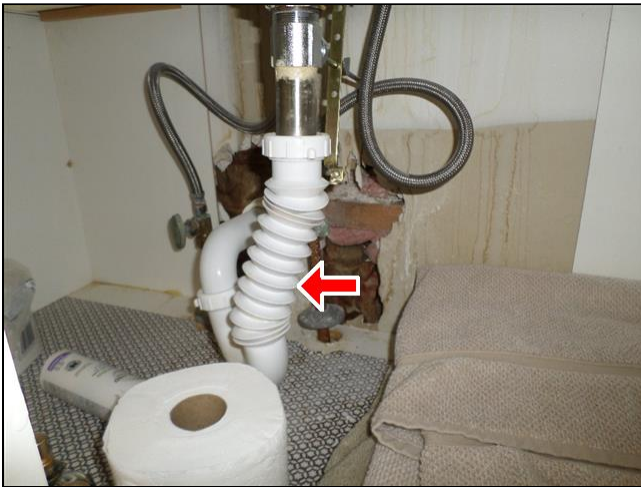
15.6.A (2) Accordion drain pipe was noted on the right sink drain. This type of piping is not permitted on drain pipes. Recommend replacing with a smooth wall drain pipe.

15.6.A Item 1(Picture) accordion drain

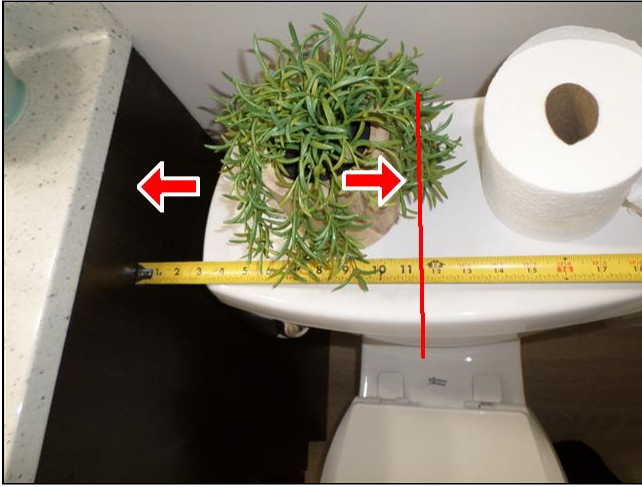
15.8.D The toilet was located too close to the sink cabinet. Recommend a minimum of 15" from the center of the toilet to a wall or cabinet.

15.8.D Item 1(Picture) toilet near cabinet
