## Inspection Report

**Property Address:**  
100 Main Street  
Anytown GA 30000

**Champ Home Inspections, Inc.**

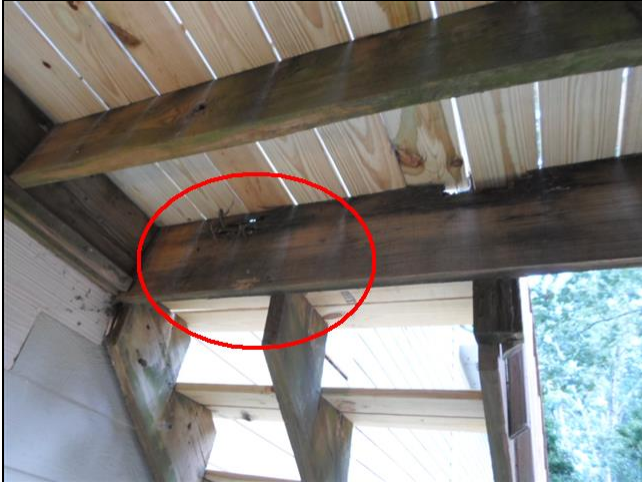
1.3 (2) Rot was noted on the left outer joist near the deck stairs. Repair.

1.3 Item 1(Picture) rot on joist

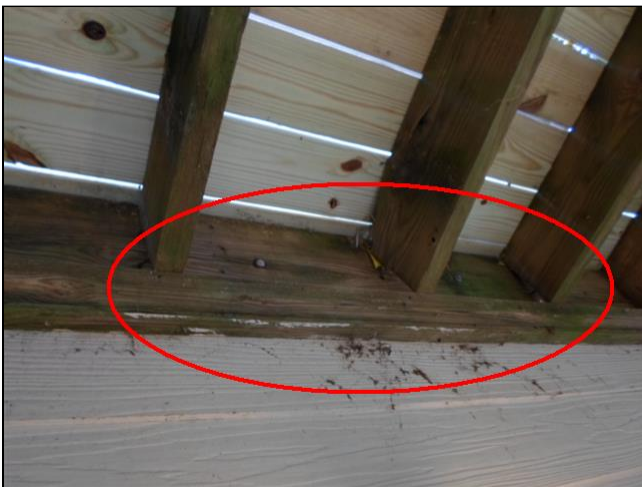
1.3 (3) Several deck joists were separating from the ledger connection causing inadequate bearing on wood. The ledger was also bowed outward at the connection to the house. Recommend further evaluation from a licensed contractor.

1.3 Item 2(Picture) ledger bowed

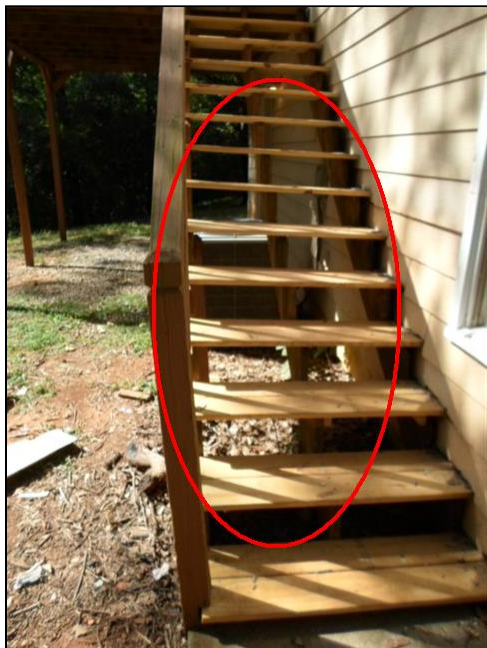
**1.5 (1)** The riser openings were too large for the stairs. The riser openings shall not allow the passage of a 4" or large diameter sphere. Repair.

1.5 Item 1(Picture) riser openings too large

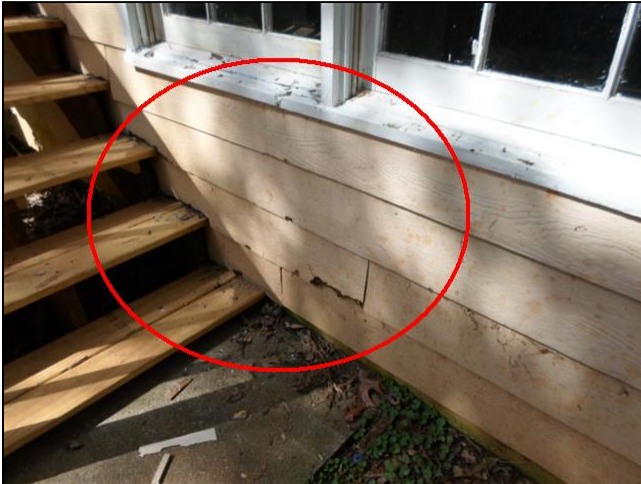
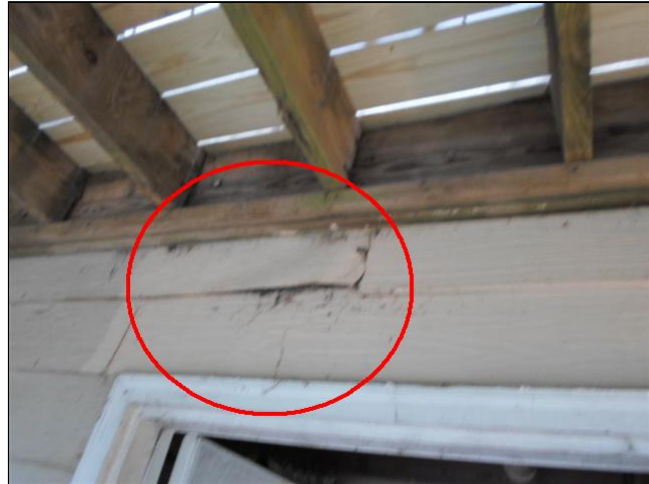
3.0 (1) Several siding boards were swelling or rotted at various locations on the front, left and rear sides of the house. Recommend further evaluation from a licensed contractor to evaluate all siding and repair as necessary.

3.0 Item 1(Picture) rot on siding

3.0 Item 2(Picture) rot on siding

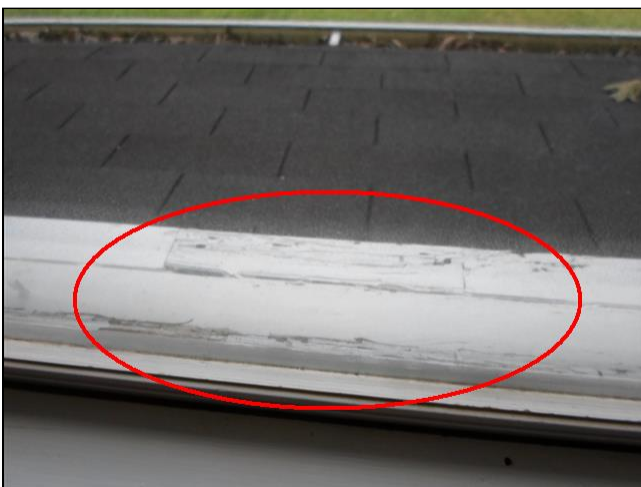
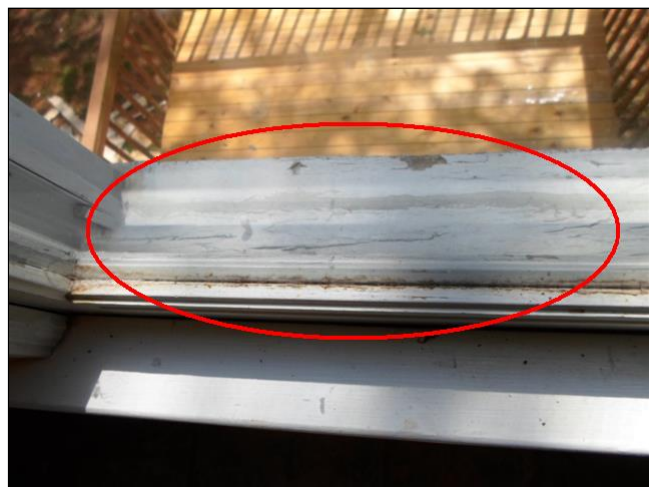
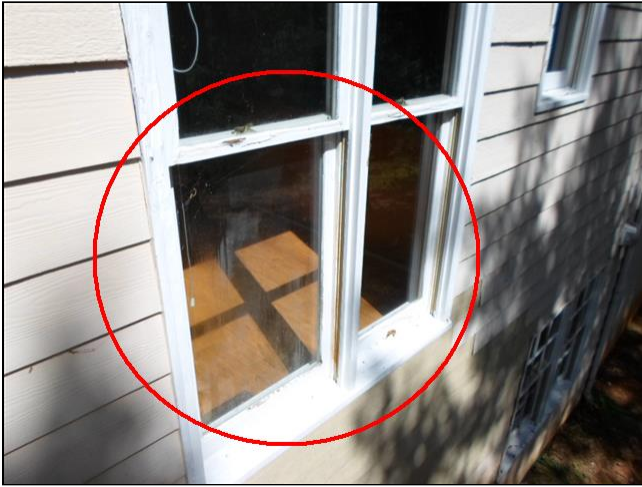
3.0 (3) Rot was noted in the following locations: Recommend further evaluation from a licensed contractor to evaluate all trim and repair.

- On the rear master bathroom window.
- On the front master bedroom windows.
- On the rear kitchen windows.
- On the front family room windows.
- On the rear left bedroom window.
- On the front left bedroom windows.
- On the front left upper fascia trim.
- On the front left lower corner trim.
- On the front shutters.
- On the front right corner trim.
- On the chimney corner trim boards.
- On the rear left fascia and soffit trim boards.
- On the rear basement windows.

3.0 Item 3(Picture) rotted trim

3.0 Item 4(Picture) rotted trim

3.0 Item 5(Picture) rotted trim

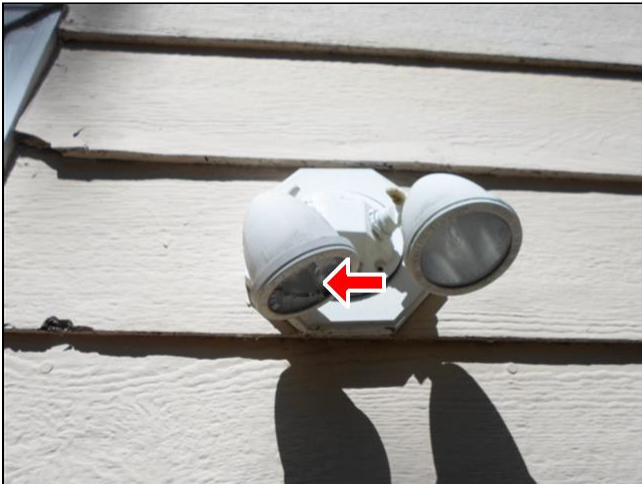
3.4 (1) The rear spot light in the deck area was damaged. Repair.

3.4 Item 1(Picture) damaged light

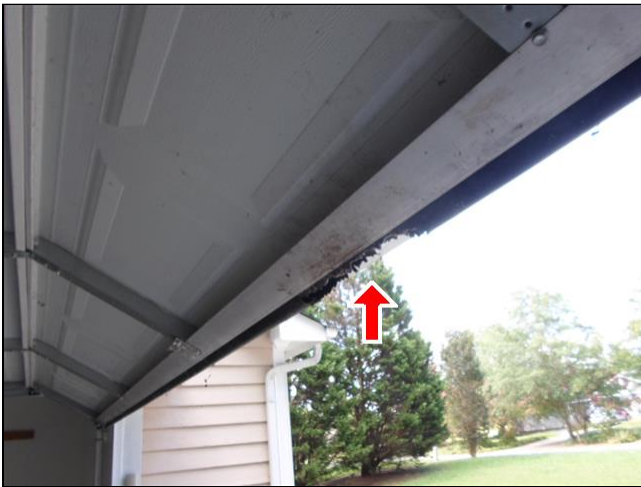
4.3 (1) Torn weather stripping was noted on the bottom of the garage door. Repair.

4.3 Item 1(Picture) torn weather stripping

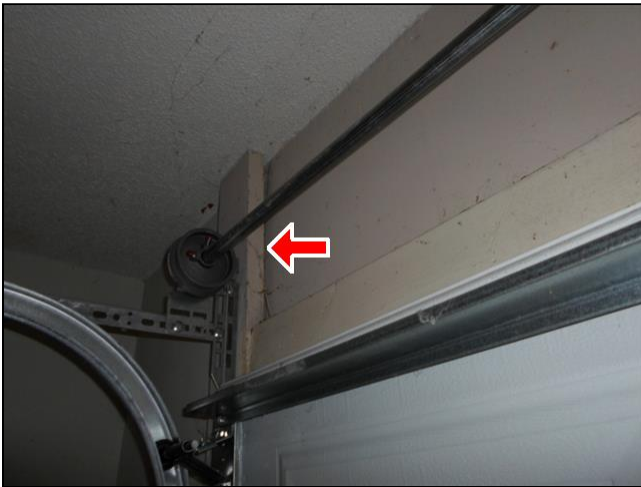
4.3 (2) The right mounting board was pulling away from the wall. Repair.

4.3 Item 2(Picture) mount pulling away

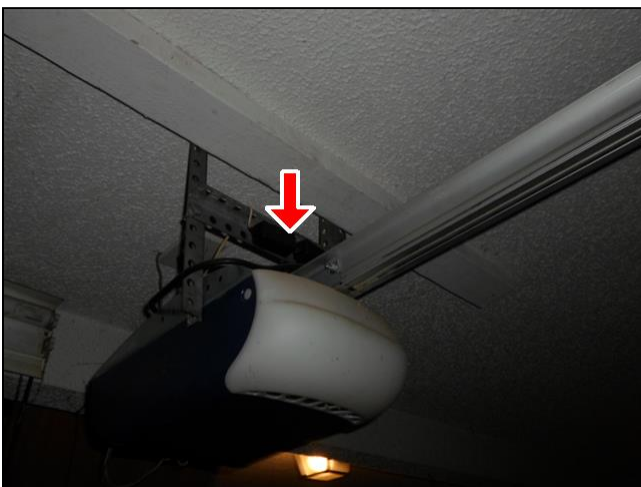
4.4 The safety sensors were installed together next to the ceiling. Recommend installing sensors between 5" - 6" above the floor.

4.4 Item 1(Picture) sensors too high

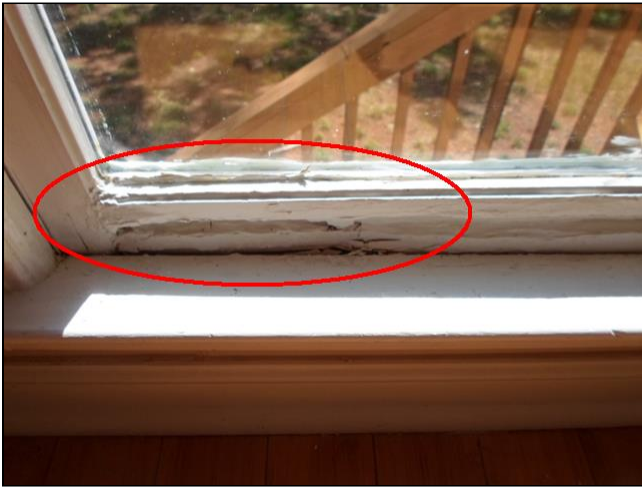
**6.2 (1)** Rot was noted on one window sash in the eating area. Repair.

6.2 Item 1(Picture) rot on window

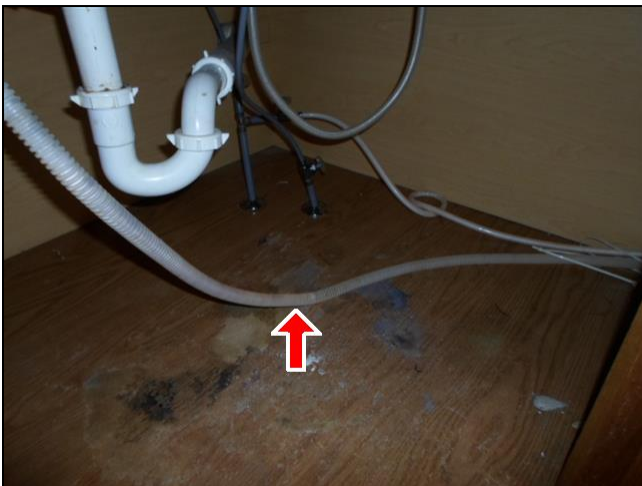
**6.10 (1)** The dishwasher drain pipe was not secured properly in a high loop fashion to help prevent from siphoning of water back into the dishwasher. Repair.

6.10 Item 1(Picture) no high loop

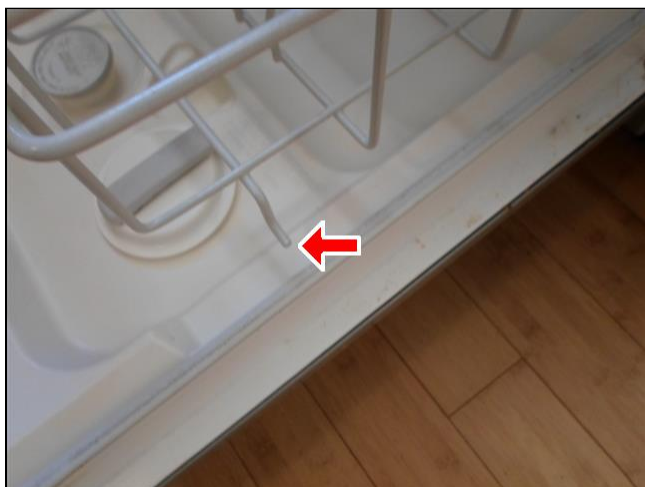
6.10 (2) Several missing wheels were noted on the bottom rack in the dishwasher. Repair.

6.10 Item 2(Picture) missing wheels

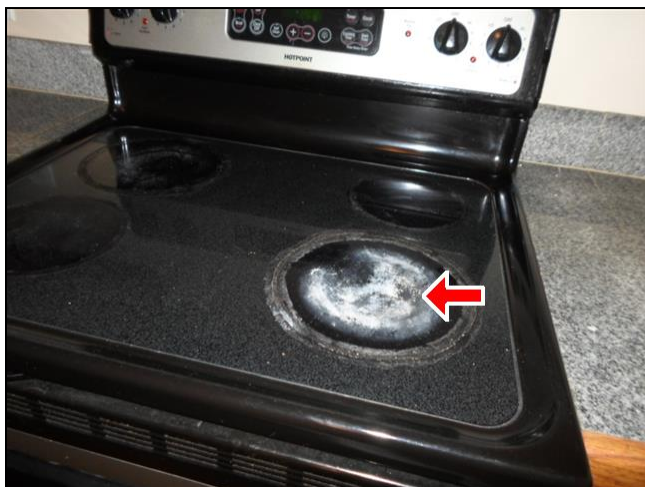
6.12 (2) Several marks were noted on the cooktop. Repair.

6.12 Item 1(Picture) marks on cooktop

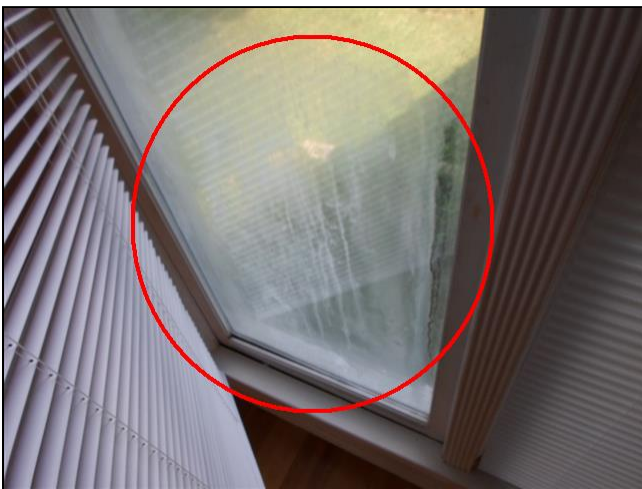
7.2 (2) Several fogged window sashes were noted on the front, right and rear family room windows. The foyer sidelight windows were also fogged. Recommend replacing glass.

7.2 Item 1(Picture) fogged window

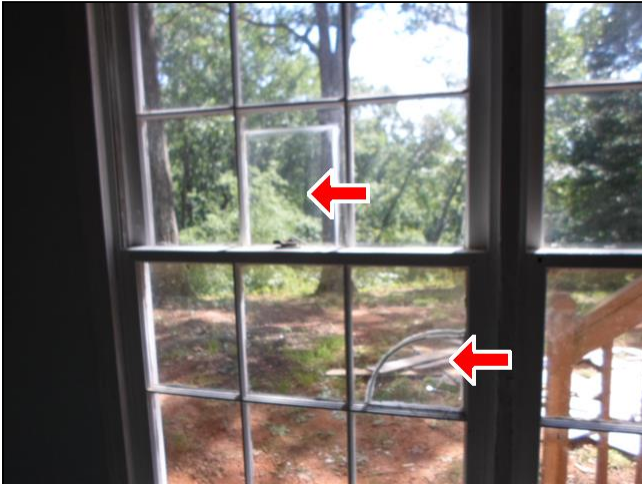
7.2 (3) One broken window pane was noted on the front family room windows. Two broken window panes were also noted on the rear basement windows. Repair.

7.2 Item 2(Picture) broken panes

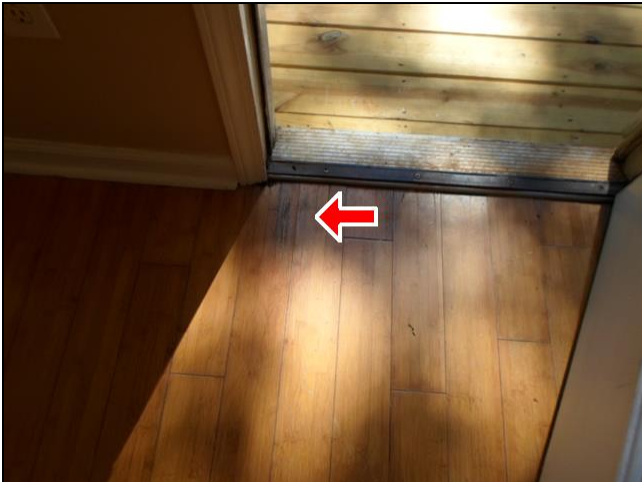
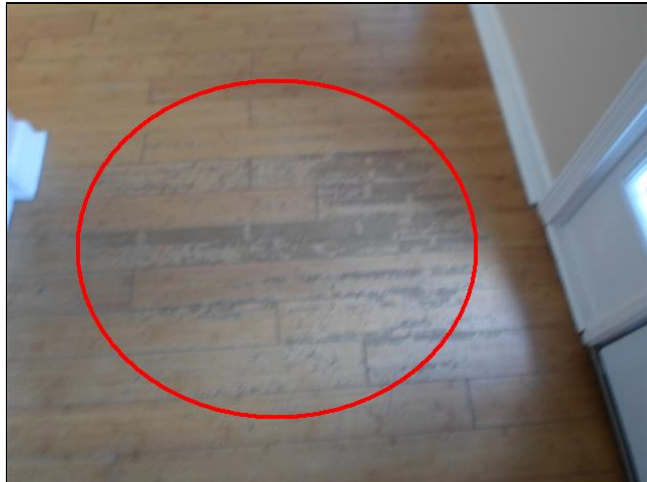
7.3 The 1st floor hardwood floors were damaged in several areas. Rot was also noted on the floor next to the rear exterior family room door. Repair.

7.3 Item 1(Picture) rot on floor

7.3 Item 2(Picture) damaged floor

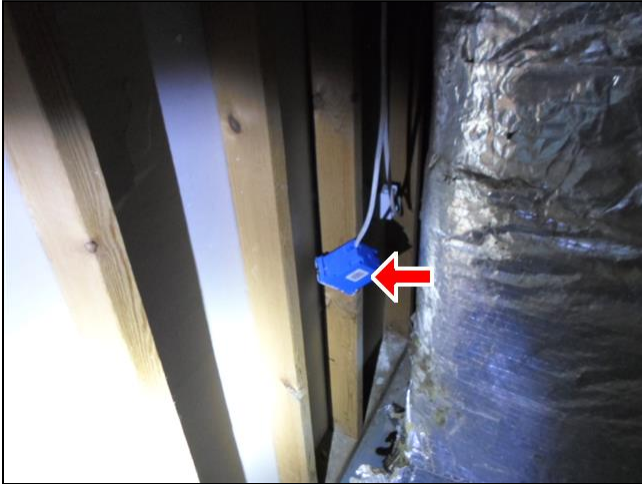
7.5 One loose switch was noted near the heat pump. Repair.

7.5 Item 1(Picture) loose switch

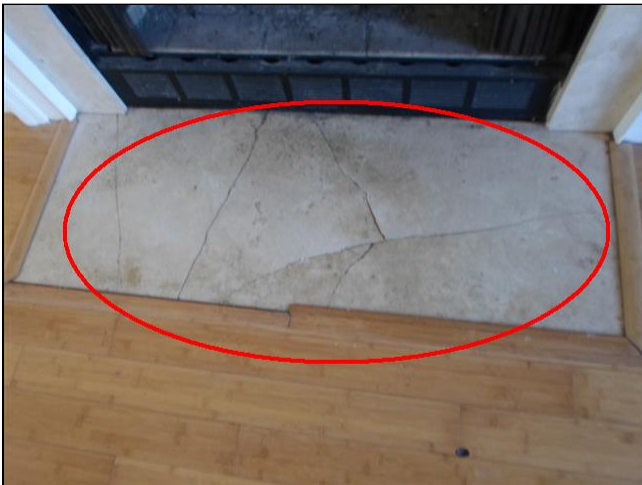
7.7 (1) The hearth was damaged. Repair.

7.7 Item 1(Picture) damaged hearth

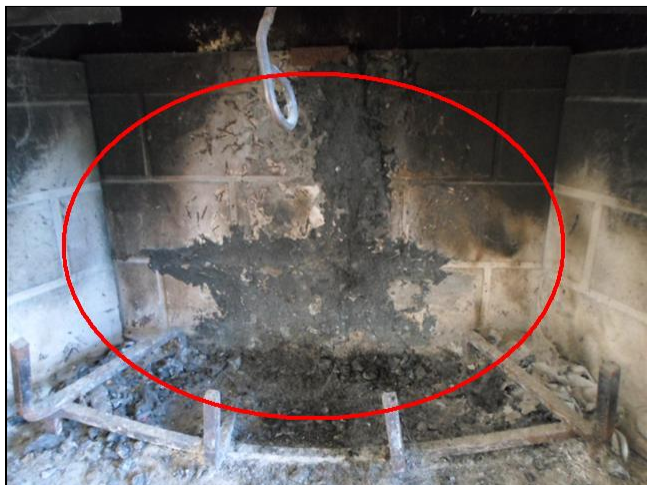
7.7 (3) Cracks were noted on the rear wall of the fireplace firebox. Repair.

7.7 Item 2(Picture) cracks in fireplace

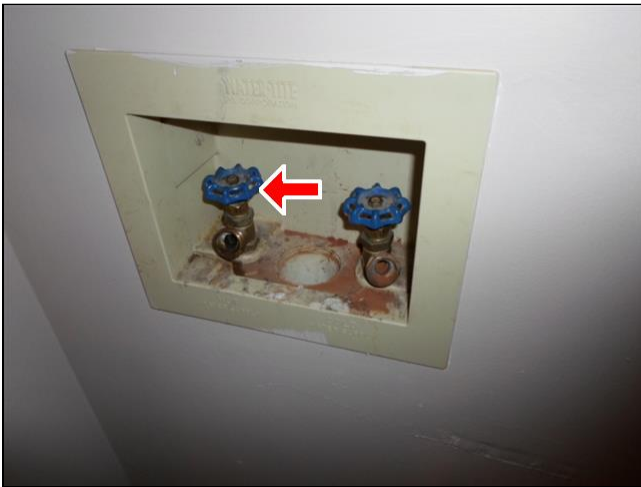
9.0 No red knob was noted on the washing machine control valves indicating the hot water valve. Repair.

9.0 Item 1(Picture) missing red knob

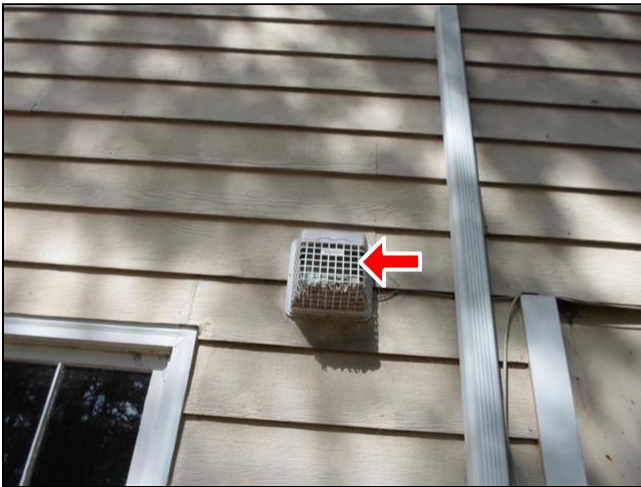
9.1 (1) A screen was noted on the rear exterior dryer vent. Recommend removing for added fire safety.

9.1 Item 1(Picture) screen on vent

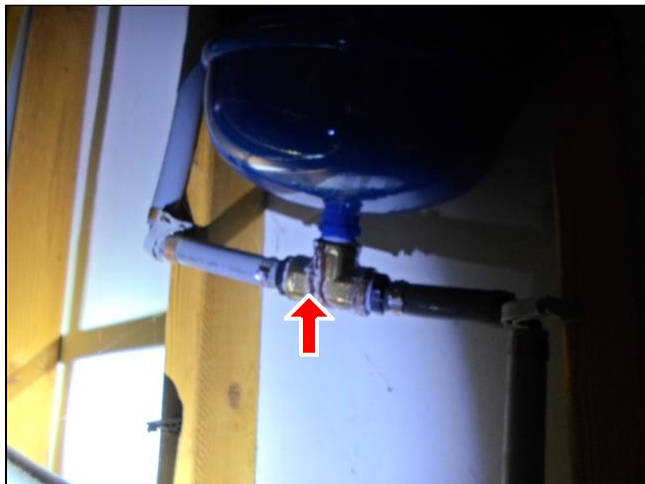
10.1 (4) Corrosion was noted on the fitting for the thermal expansion tank. Repair.

10.1 Item 1(Picture) corrosion on fitting

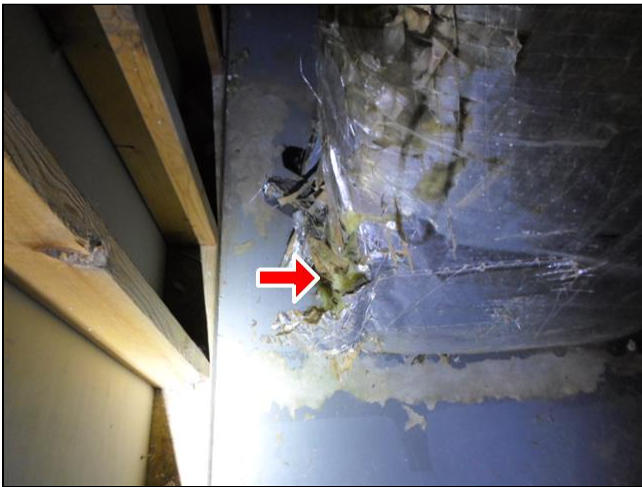
**11.3 (1)** Torn insulation was noted on the air duct below the heat pump. Repair.

11.3 Item 1(Picture) torn insulation

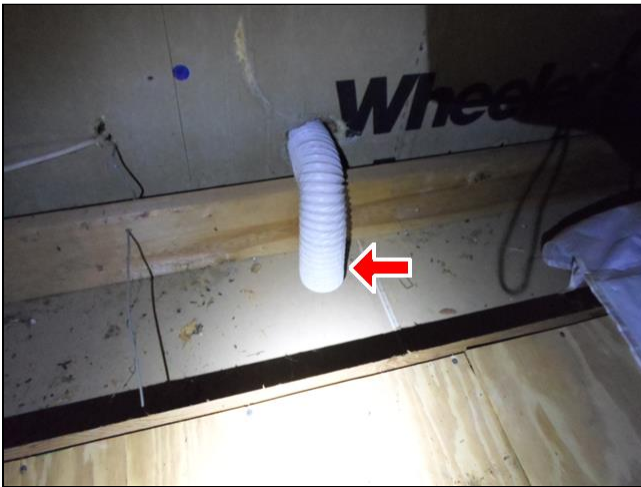
14.1.A The half bathroom fan was vented into the attic. Recommend venting to the exterior of the house.

14.1.A Item 1(Picture) fan in attic

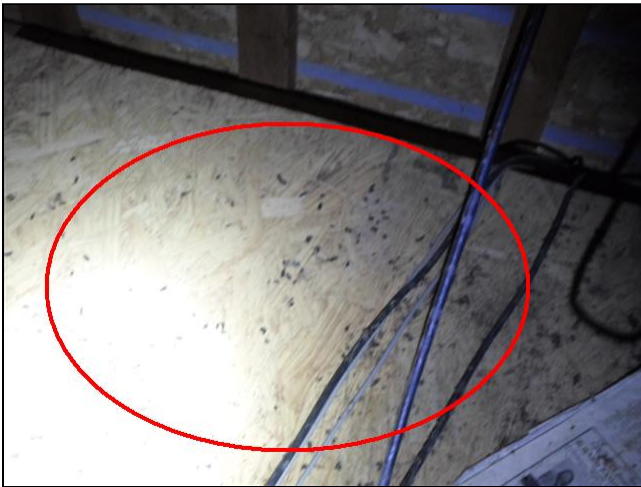
14.5.A (1) Rodent droppings were noted in the attic. Recommend further evaluation from a licensed pest control company.

14.5.A Item 1(Picture) rodent droppings

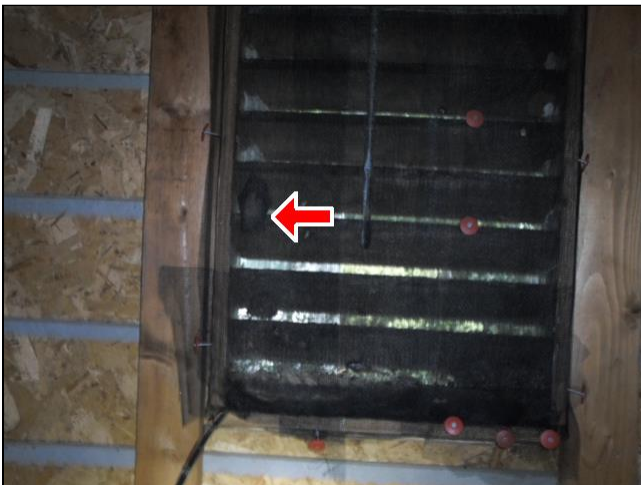
14.5.A (2) A bat was noted on the left gable vent. Recommend further evaluation from a licensed pest control company.

14.5.A Item 2(Picture) bat on vent

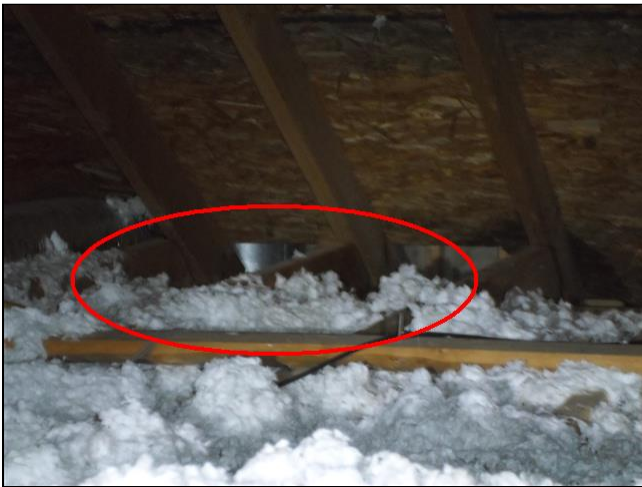
14.0.B (1) No fire barrier was noted between the chimney and attic space. Repair.

14.0.B Item 1(Picture) missing fire barrier

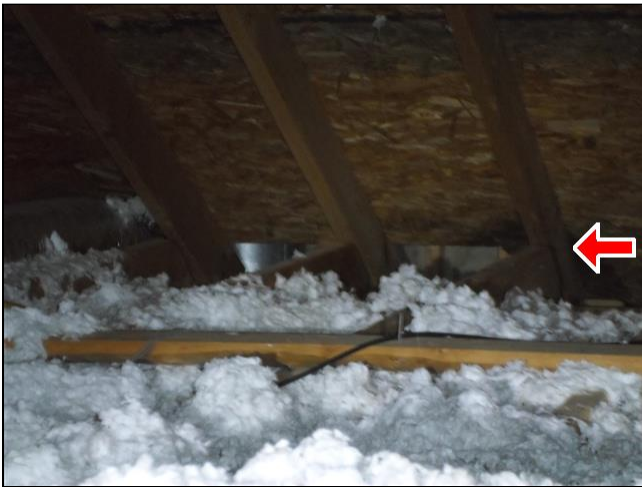
14.0.B (2) Water spots were noted on the right sheathing next to the chimney. Recommend further evaluation from a licensed roofer and monitor for leaks.

14.0.B Item 2(Picture) water spot

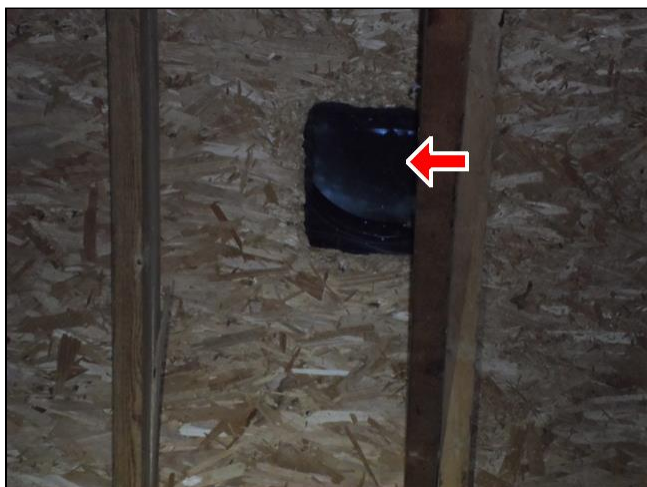
14.1.B (2) Dents were noted in the passive vents of the attic. Recommend further evaluation from a licensed roofer to determine if hail damage is present on the roof.

14.1.B Item 1(Picture) dents in vents

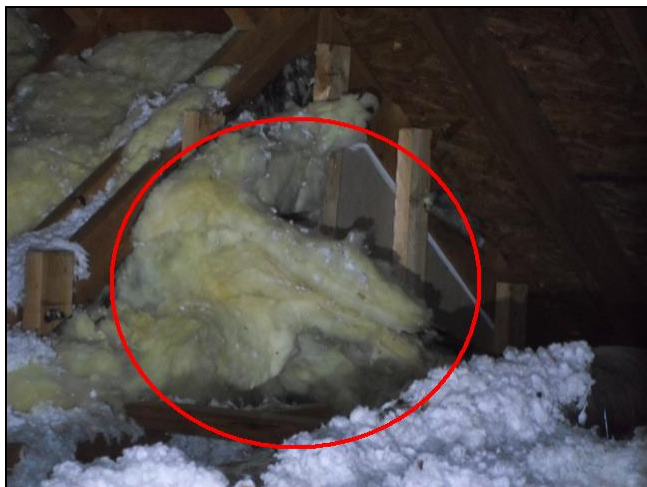
14.2.B Loose insulation was noted above the master bathroom. Re-secure.

14.2.B Item 1(Picture) loose insulation

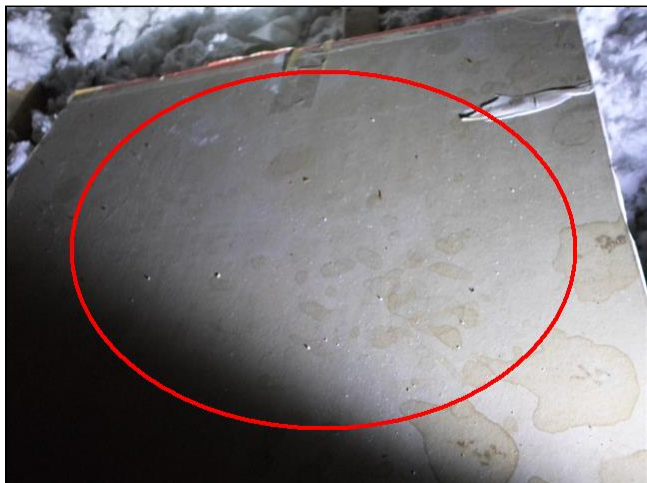
14.4.B No insulation was noted on the attic entry door. Recommend installation for added energy efficiency.

14.4.B Item 1(Picture) missing insulation

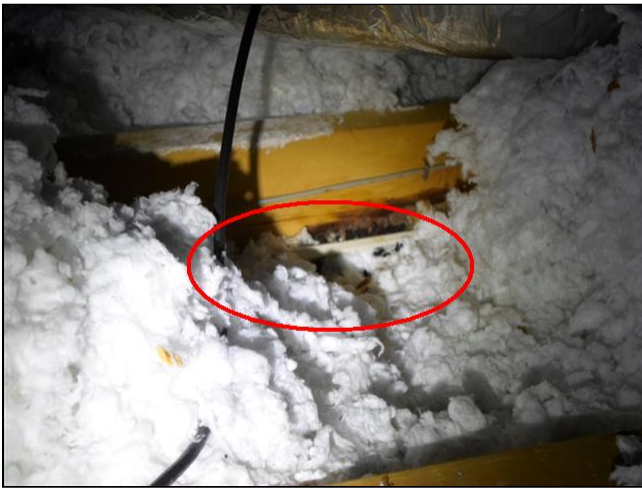
14.5.B Rodent droppings were noted in the attic. Recommend further evaluation from a licensed pest control company.

14.5.B Item 1(Picture) rodent droppings

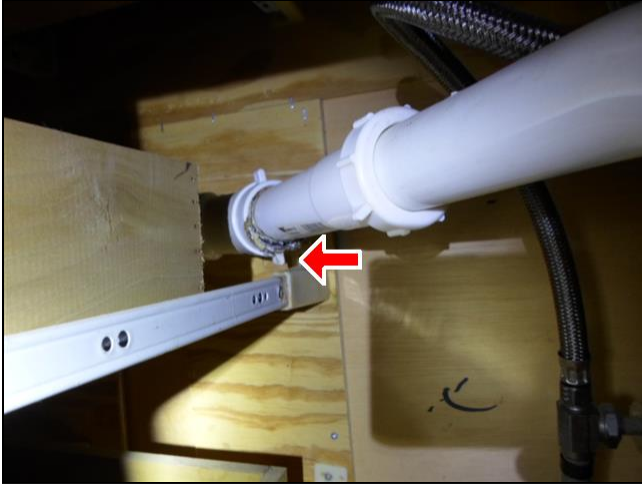
**15.6.B** Water spots were noted below the rear sink drain pipe. Monitor for leaks.

15.6.B Item 1(Picture) water spot

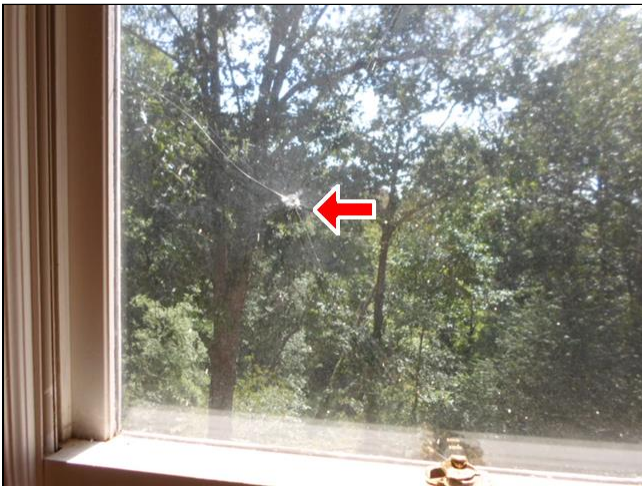
**16.2.A** The top sash was broken on the rear window. Repair.

16.2.A Item 1(Picture) broken window

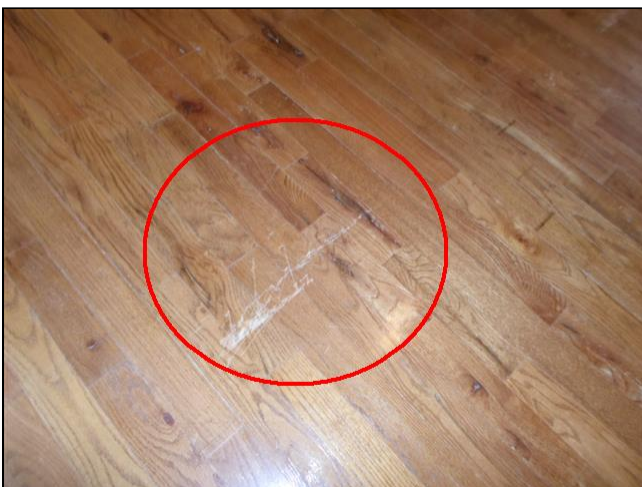
**16.3.B** The hardwood floors were damaged. Repair.

16.3.B Item 1(Picture) damaged floors

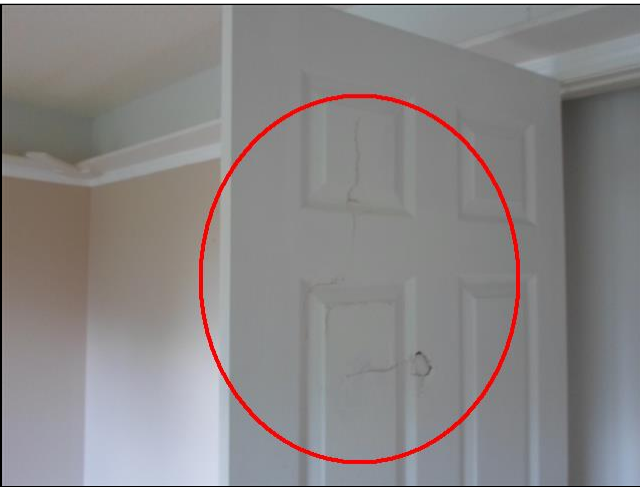
16.4.B The closet door was damaged. Repair.

16.4.B Item 1(Picture) damaged door
