Home Inspection Report

Property Address:
123 Main Street
Any Town GA 30000

Champ Home Inspections Inc.

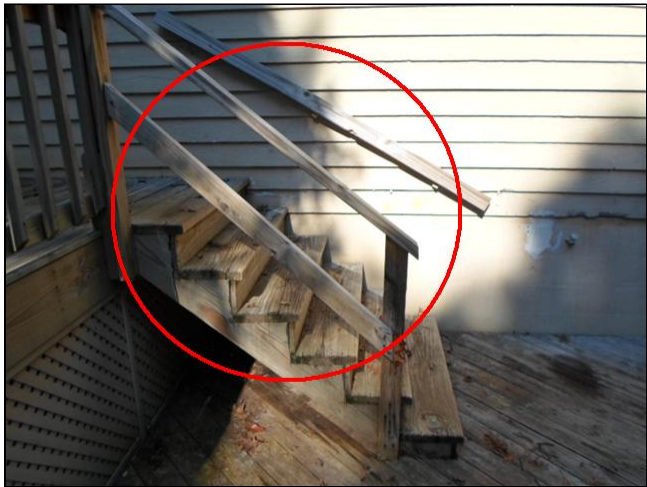
1.2 Item 1(Picture) missing pickets

- 1.1 Typical cracking noted on driveway.
- 1.2 (1) Missing pickets were noted on the rear deck stair hand railings. Recommend installation.

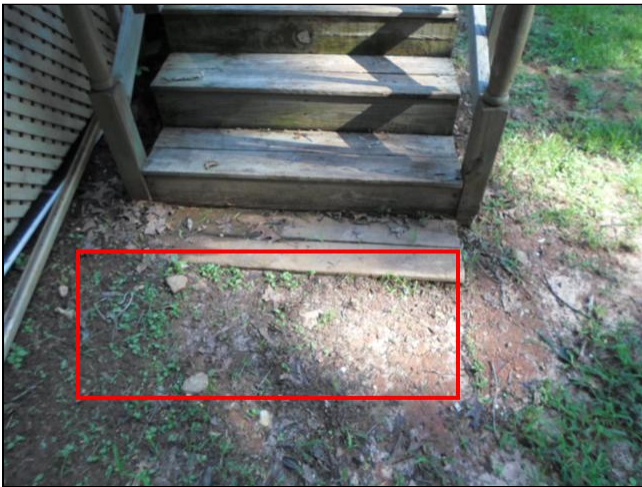
1.2 Item 2(Picture) missing landing

1.2 (2) No landing was noted for the rear deck stairs. Recommend installation.

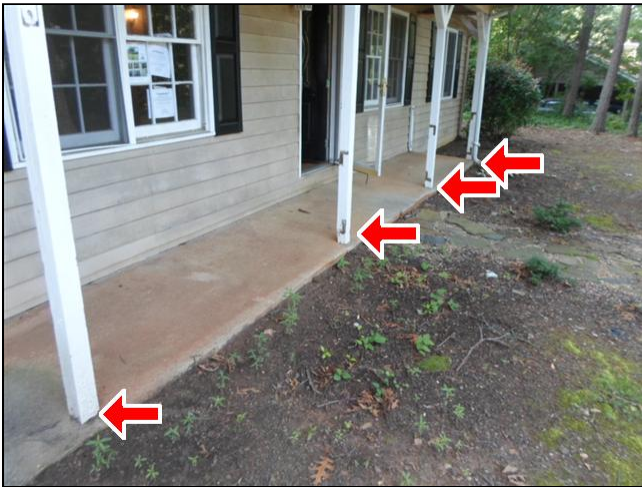
1.3 Item 1(Picture) posts not secure to ground

1.3 The covered porch posts were not secured properly to the ground. Repair.

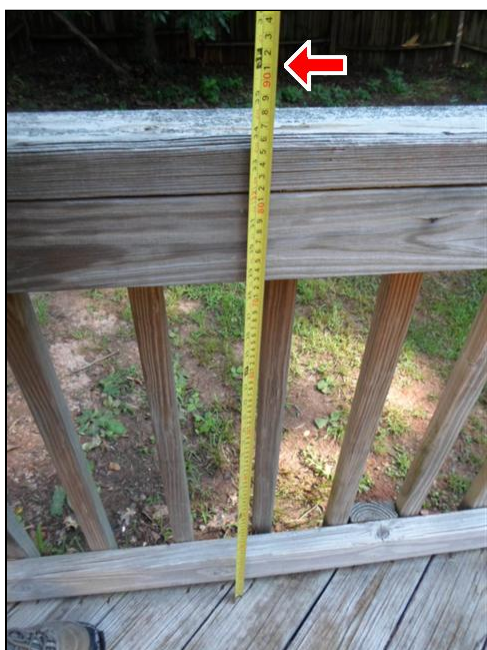
1.4 Item 1(Picture) low railings

1.4 (1) The guard railings were too low. Recommend a minimum guard railing height of 36".

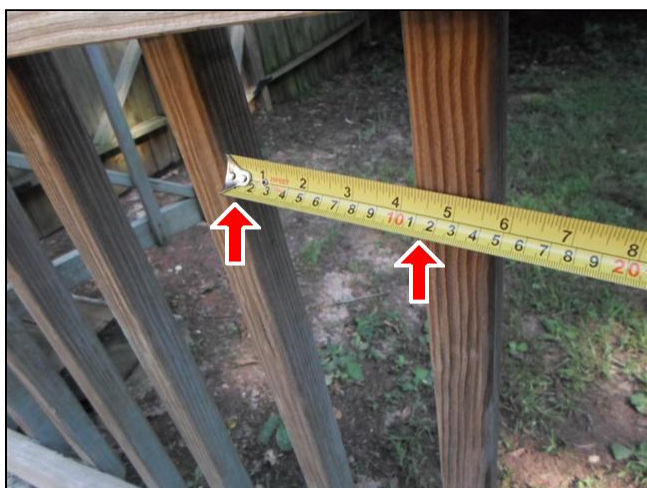
1.4 Item 2(Picture) picket spacing too far apart

1.4 (2) The guard railing picket spacings were too far apart. Recommend a maximum picket spacing of 4".

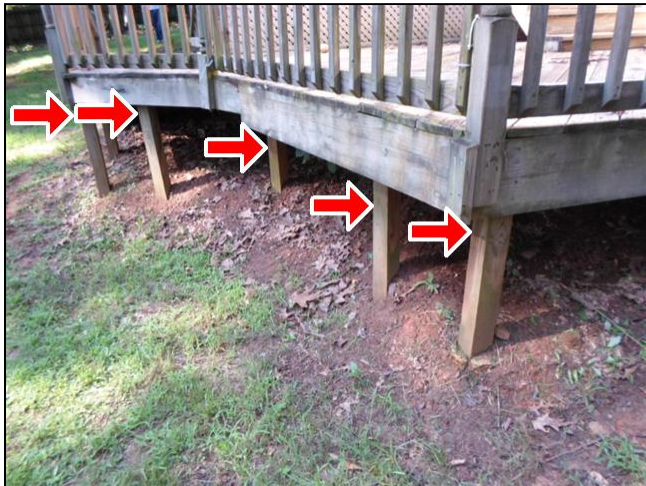
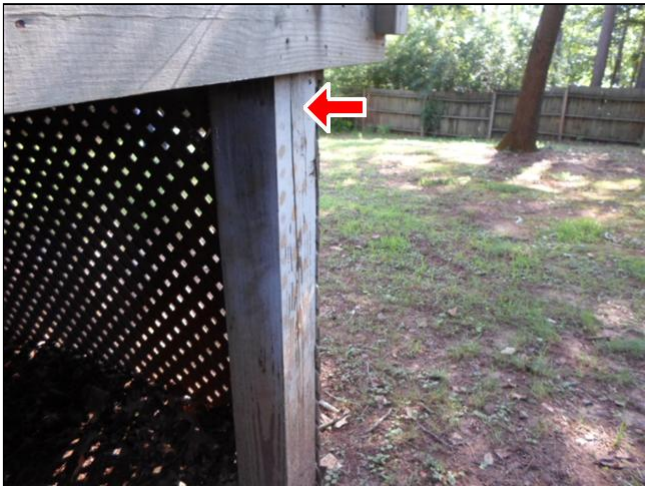
1.4 Item 3(Picture) posts attached to side of joists

1.4 (3) The deck posts were attached to the sides of the deck joists. Recommend installing additional boards to the sides of the posts between the ground and bottom of the joists for direct support of the deck.

1.4 Item 4(Picture) post attached to side of joist

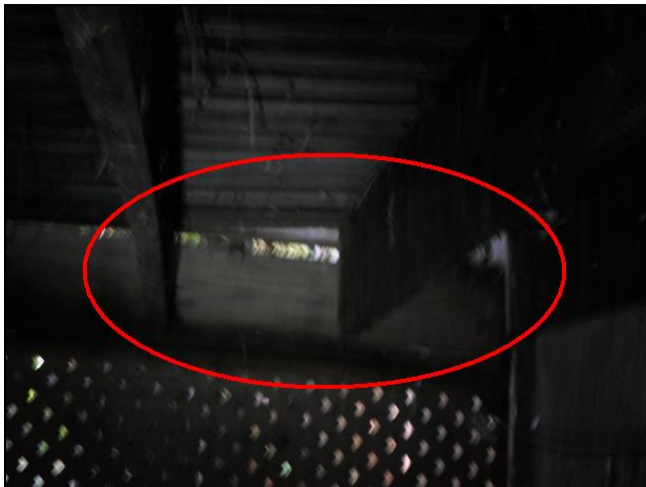
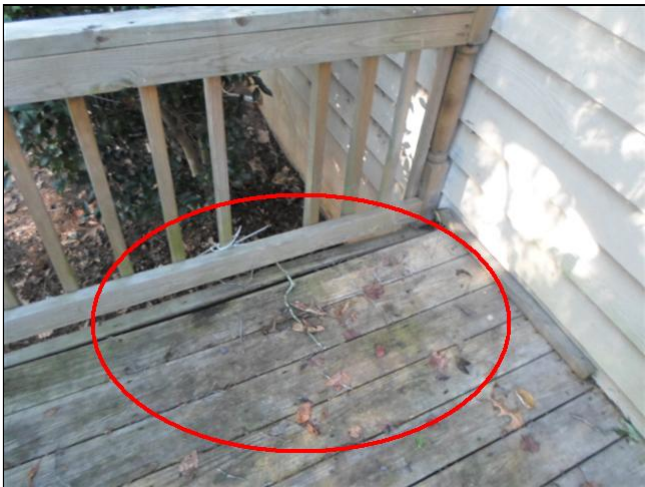
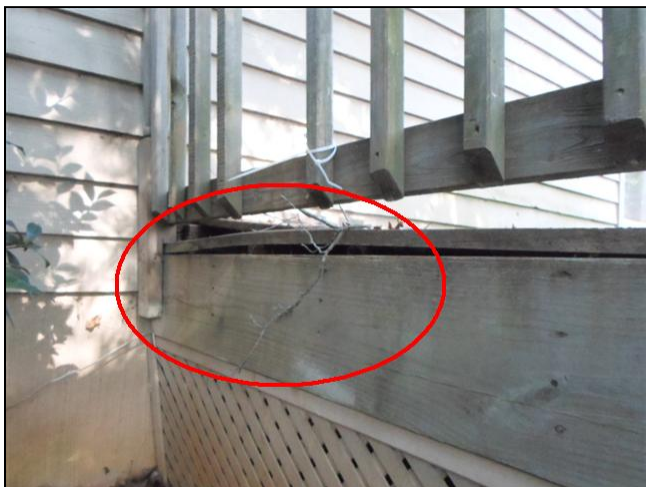
1.4 Item 5(Picture) band separating from joists

1.4 (4) The outer band was separating from the joists on the right side of the upper deck. Recommend further evaluation from a licensed contractor.

1.4 Item 6(Picture) band separating on deck

1.4 Item 7(Picture) band separating on deck

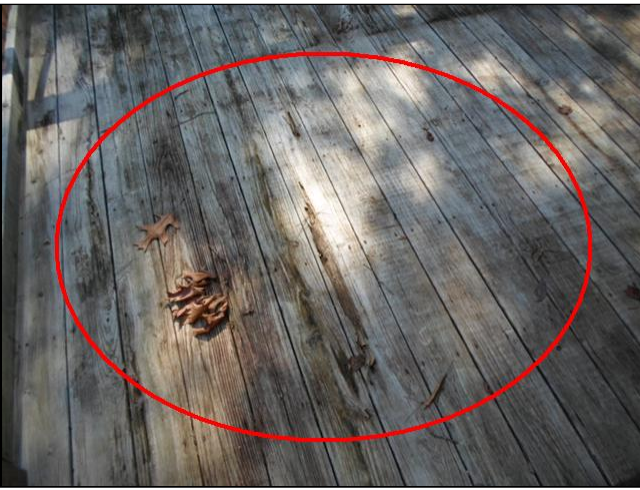
1.4 Item 8(Picture) damaged floor boards

1.4 (5) Several floor boards were worn and damaged. Repair.

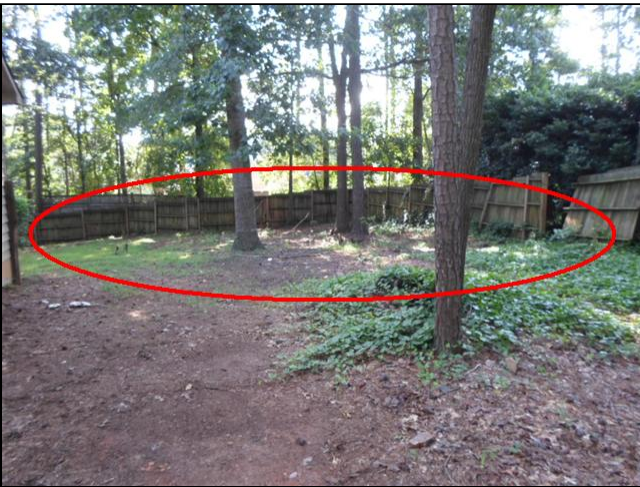
1.5 Item 1(Picture) missing fence sections

1.5 Several fence sections were missing on the right side of the back yard. Repair.

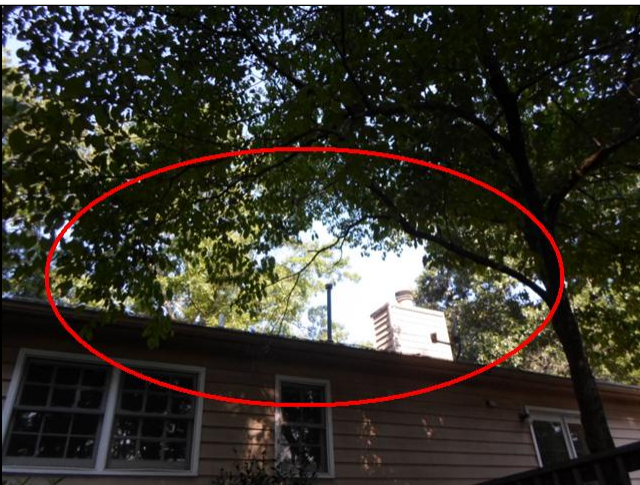
1.6 Item 1(Picture) over hanging tree branches

1.6 Recommend trimming over hanging tree branches noted on the rear side of the house.

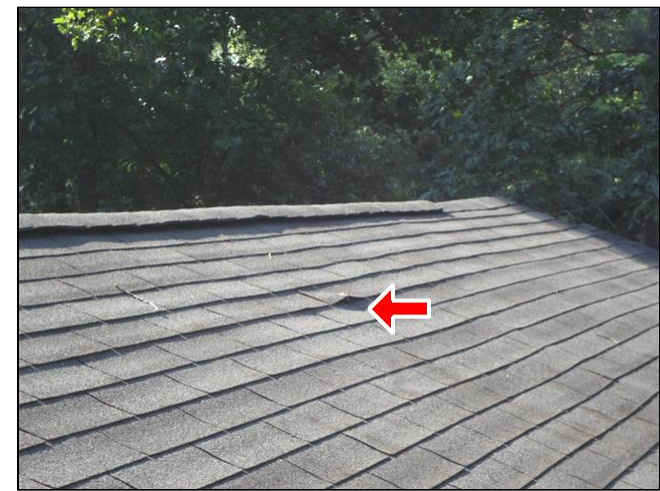
2.0 Item 1(Picture) cupped shingle

2.0 (1) One cupped shingle was noted on the front center part of the roof. Repair.

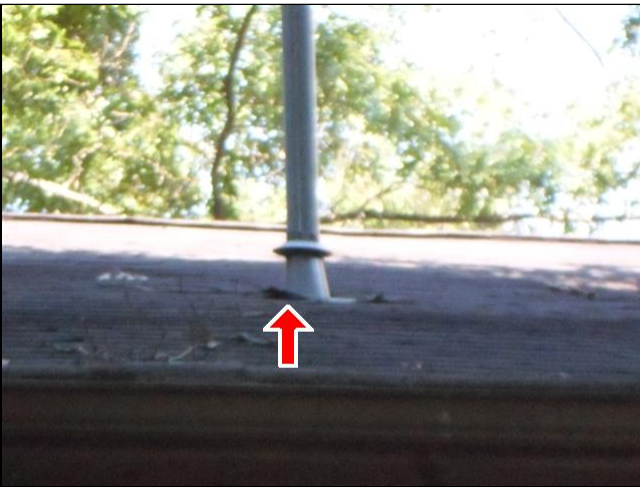
2.1 Item 1(Picture) loose vent

2.1 (1) The water heater vent pipe was loose on the rear side of the roof. Repair.

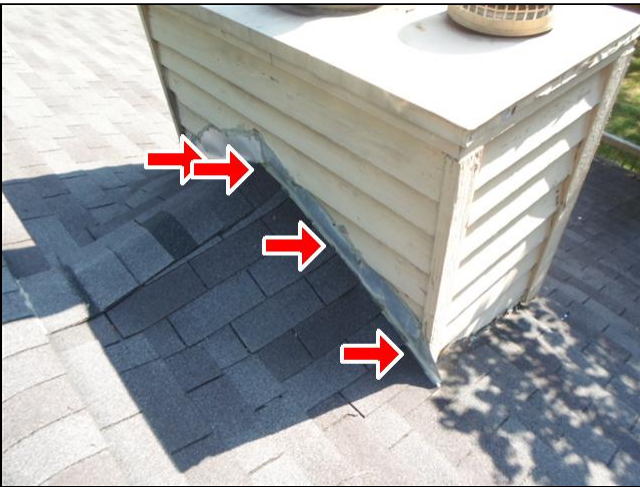
2.1 Item 2(Picture) improper flashing

2.1 (2) Improper flashing was noted around the chimney. Recommend further evaluation from a licensed roofer.

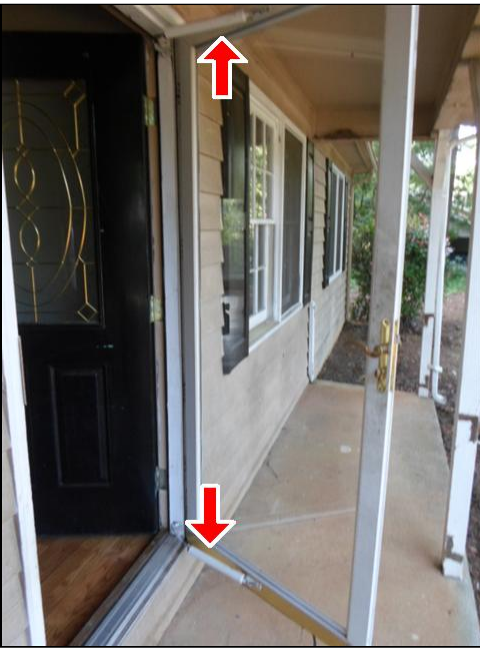
3.2 Item 1(Picture) damaged hardware

3.2 (1) The front storm door hardware was damaged. Repair.

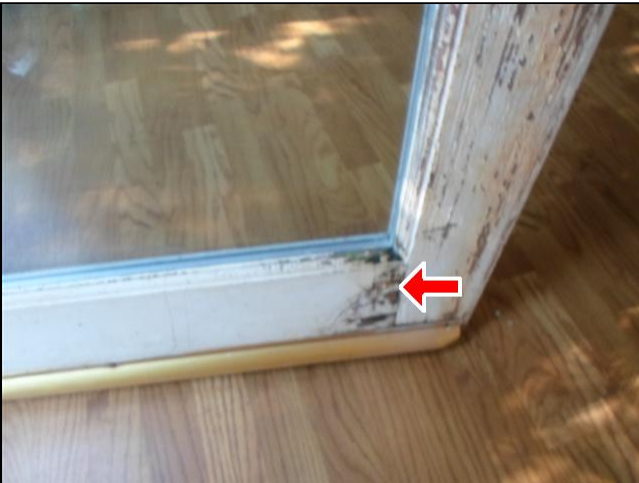
3.2 Item 2(Picture) rot on door

3.2 (2) Rot was noted on the lower part of the back door. Repair.

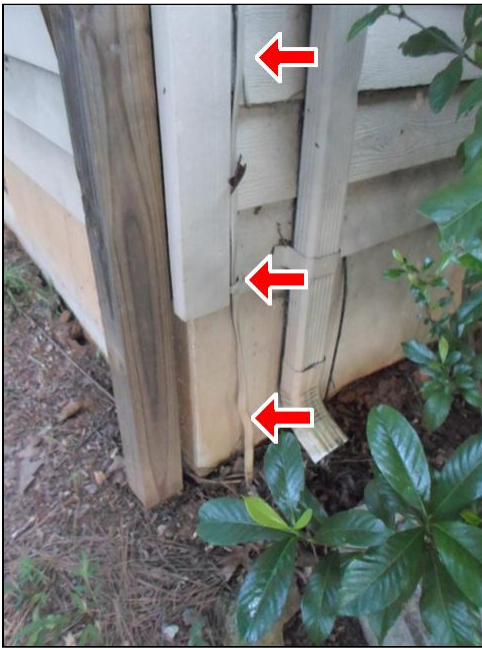
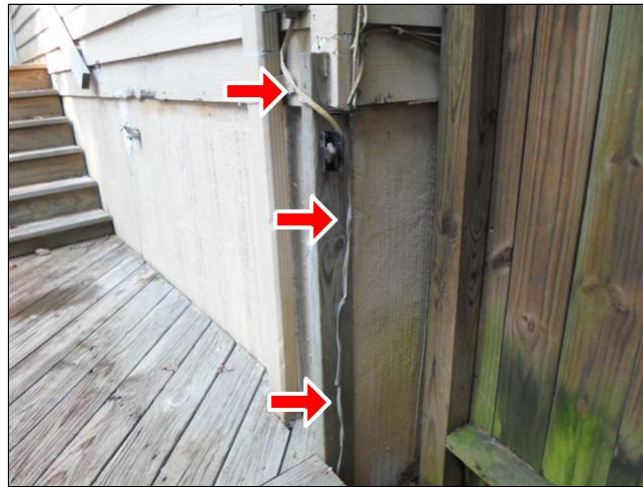
3.4 Item 1(Picture) missing conduit on wire

3.4 No conduit was noted on the electrical wires at both rear corners of the house. Recommend installation.

3.4 Item 2(Picture) missing conduit on wire

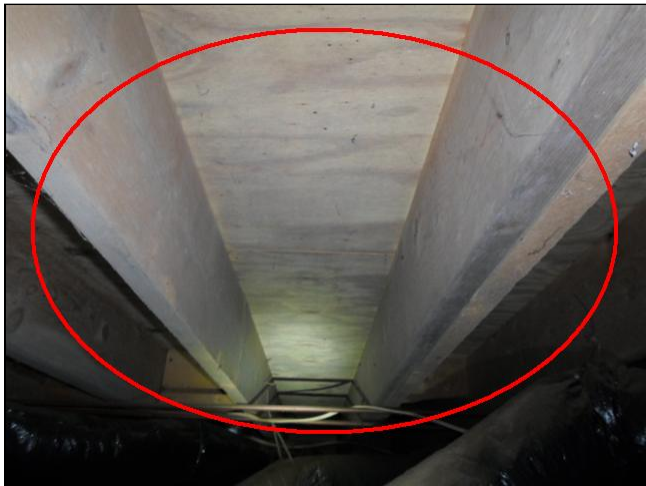
4.0 Item 1(Picture) missing insulation

4.0 No insulation was noted between the floor joists. Recommend installing a minimum of R-19 batt insulation for added energy efficiency.

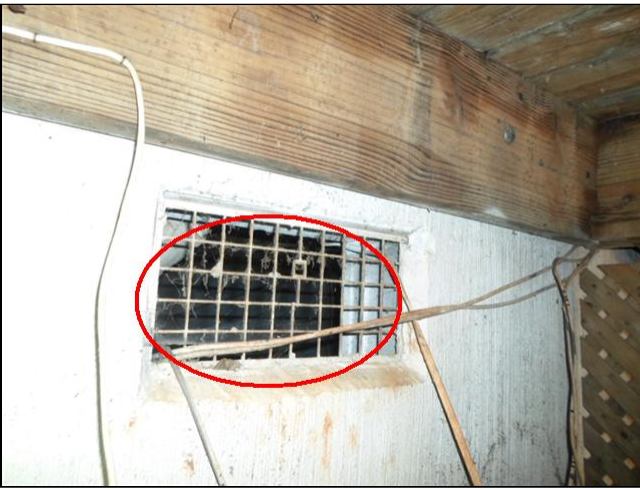
4.1 Item 1(Picture) missing screen

4.1 (1) Several crawl space vent cover screens were torn or missing. Repair.

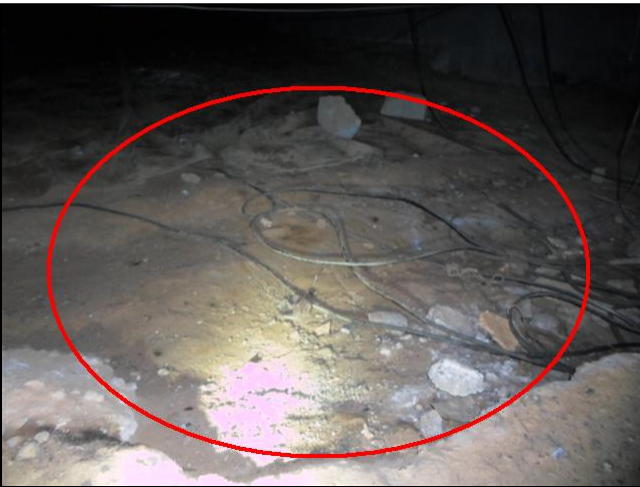
4.1 Item 2(Picture) missing vapor barrier

4.1 (2) Part of the vapor barrier was missing in the crawl space. Recommend installation.

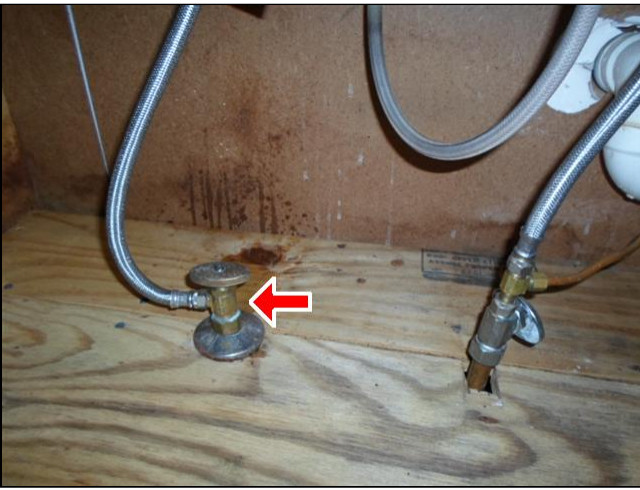
5.8 Item 1(Picture) leaking valve

5.8 (1) The sink hot water shut off valve leaked inside the cabinet when tested. Repair.

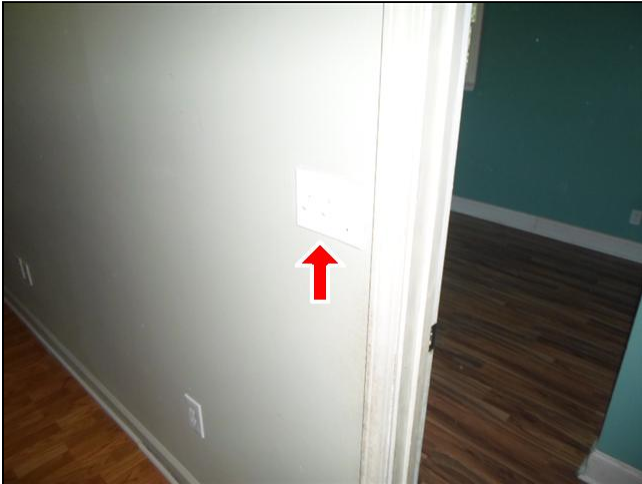
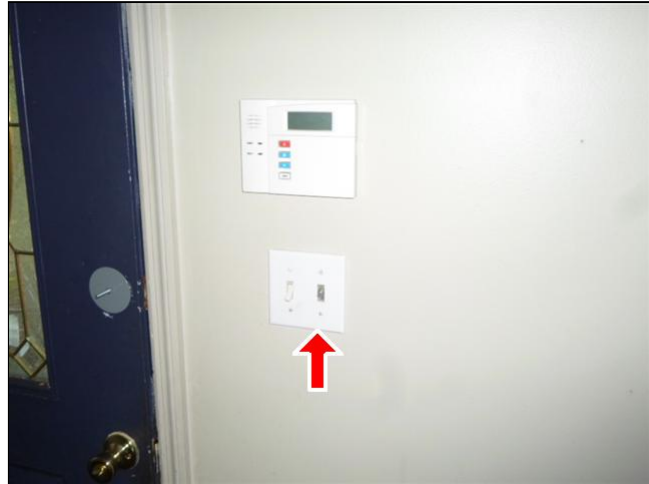
6.5 Item 1(Picture) unable to determine use of switch

6.5 (1) I was unable to determine the use for several wall switches in the living room. Recommend further evaluation from a licensed electrician.

6.5 Item 2(Picture) unable to determine use of switch

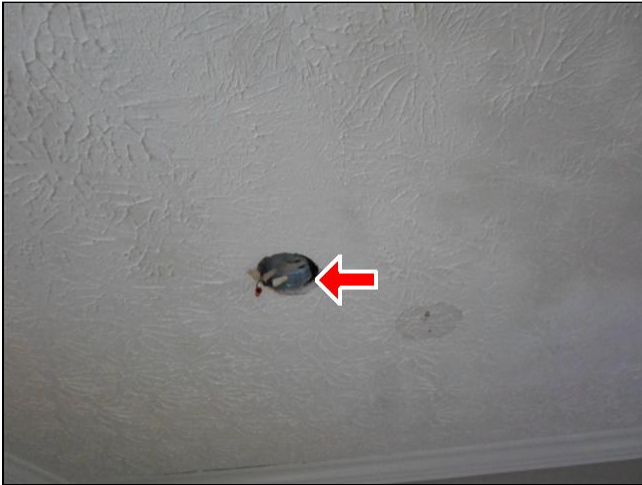
6.5 Item 3(Picture) missing light

6.5 (2) The dining room ceiling light was missing during the inspection. Install.

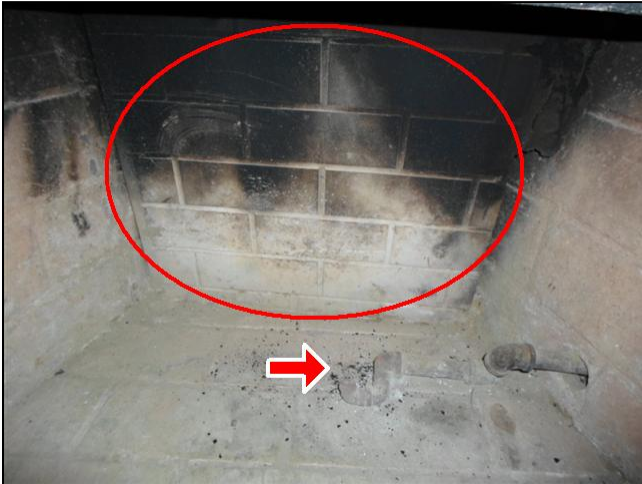
6.8 Item 1(Picture)

6.8 (2) The rear panel was loose and the gas burner was missing. Recommend further evaluation from a licensed chimney sweep.

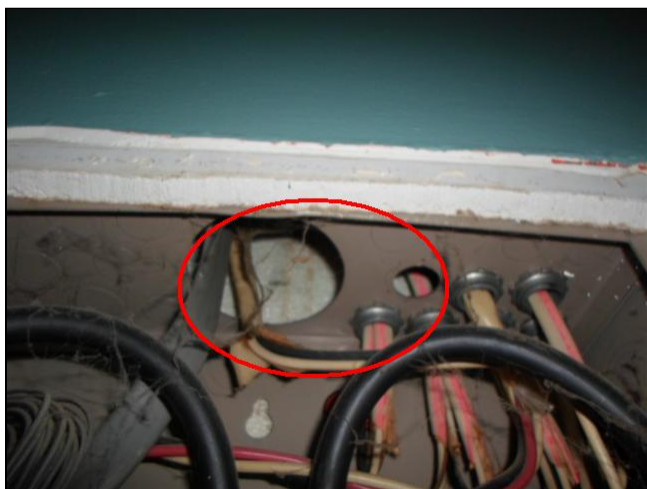
7.1 Item 1(Picture) open knockout and missing wire connector

7.1 One open knockout and missing wire connector were noted on the top of the panel box. Repair.

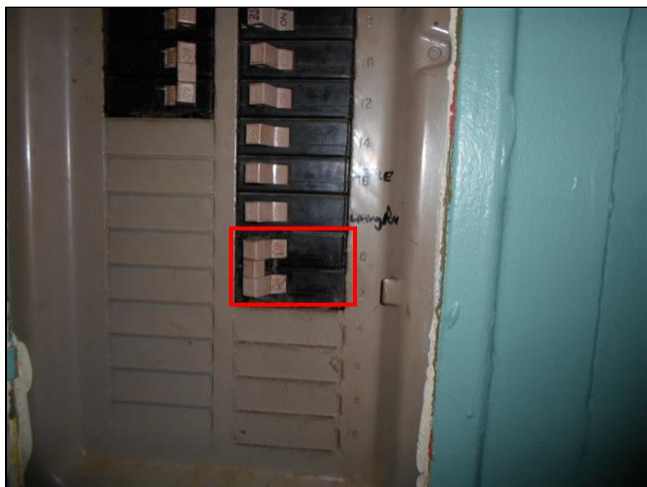
7.2 Item 1(Picture) over fused breaker

7.2 The 30 amp breaker labeled for the ac unit was overfused based on the maximum breaker rating labeled on the side of the ac unit. Recommend further evaluation from a licensed electrician.

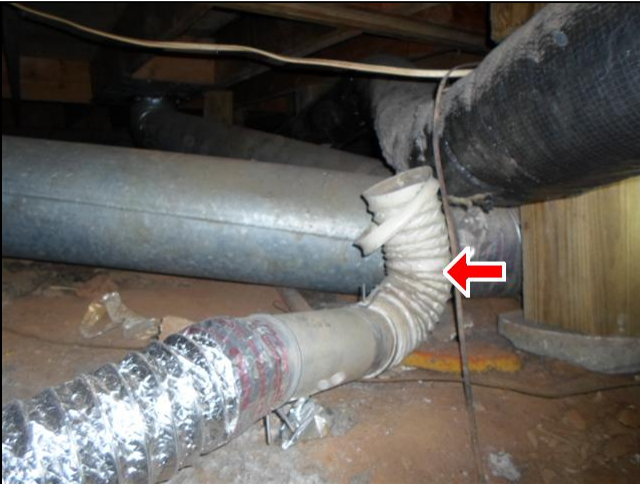
8.1 Item 1(Picture) plastic dryer vent

8.1 Part of the dryer vent was plastic and the dryer vent was disconnected in the crawl space. Recommend installing a new metal dryer vent that terminates to the exterior of the house.

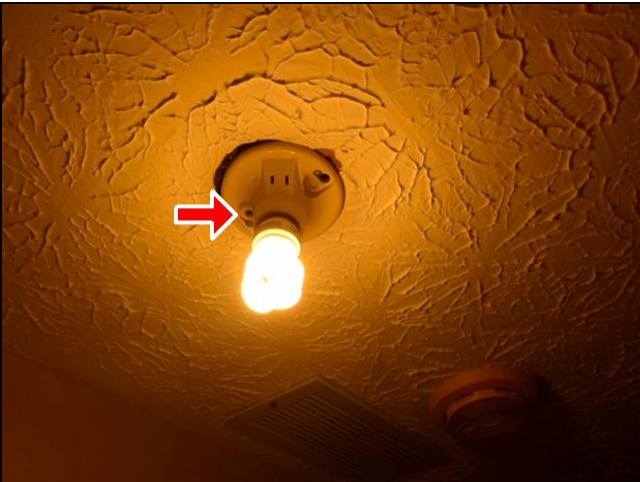
8.2 Item 1(Picture) missing pull cord and cover

8.2 No cover was noted on the ceiling light and the pull cord was missing. Recommend replacing light with a light and cover for added fire safety.

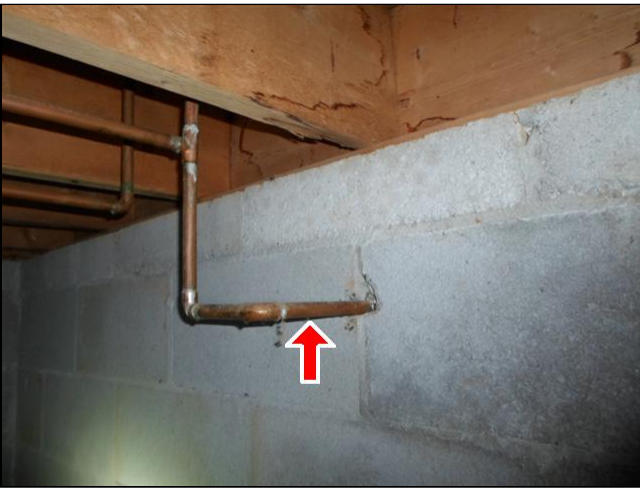
9.1 Item 1(Picture) missing shut off valve

9.1 (1) No interior shut off valve was noted in the crawl space for the rear exterior hose bibb. Recommend installation.

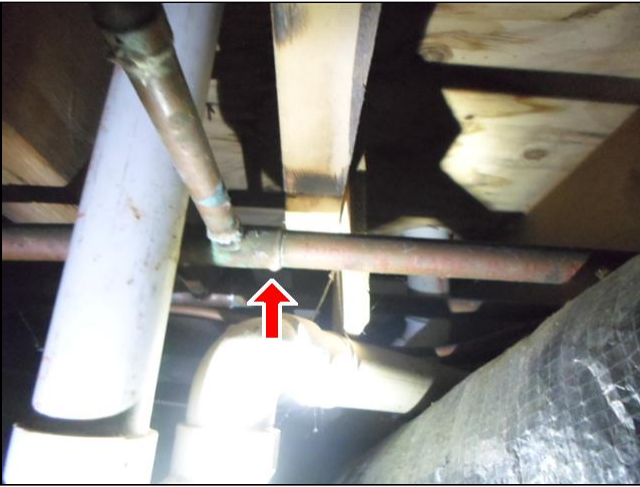
9.1 Item 2(Picture) water dripping from water line

9.1 (2) Water was noted dripping from water lines below the bathroom areas. Recommend further evaluation from a licensed plumber.

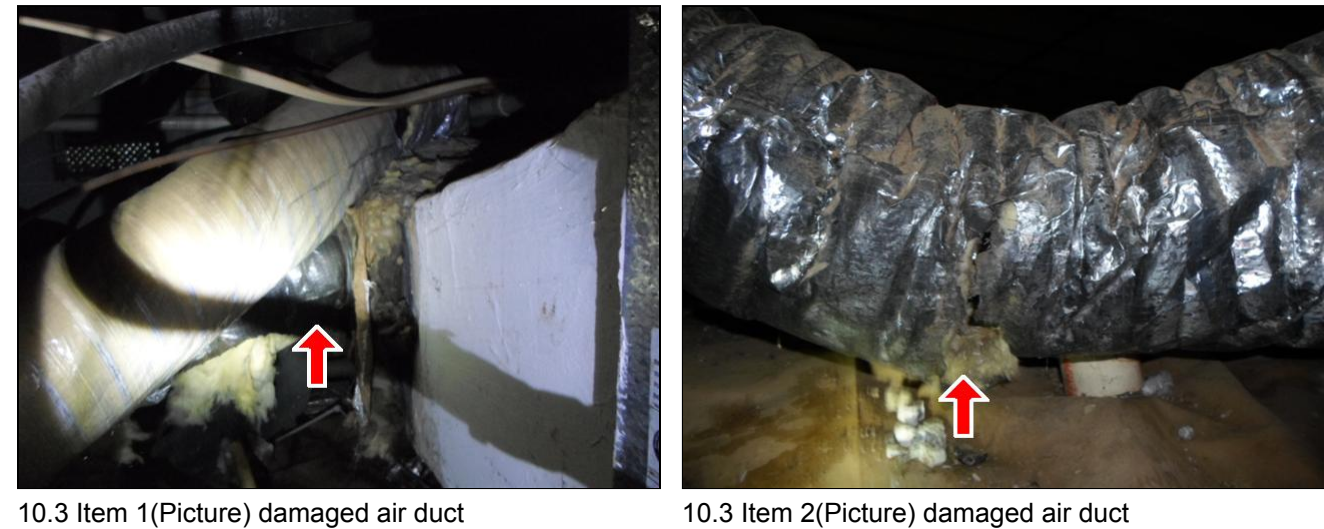
- 10.1 Rust was noted on the furnace vent pipe. Recommend further evaluation from a licensed HVAC contractor.
- 10.3 Several air ducts were damaged in the crawl space. Recommend further evaluation from a licensed HVAC contractor.

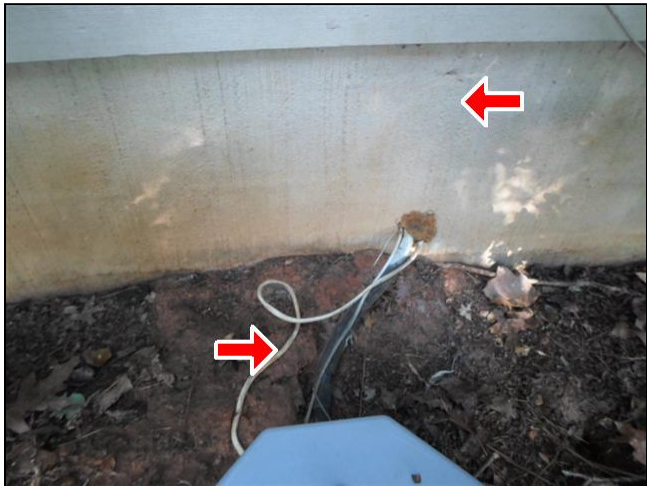
11.0 Item 1(Picture) missing conduit and disconnect breaker

- 11.0 (1) The ac unit did not operate when tested. Recommend further evaluation from a licensed HVAC contractor.
- 11.0 (2) No conduit was noted on the electrical wire next to the ac unit. No disconnect breaker was also noted next to the ac unit. Recommend further evaluation from a licensed HVAC contractor.

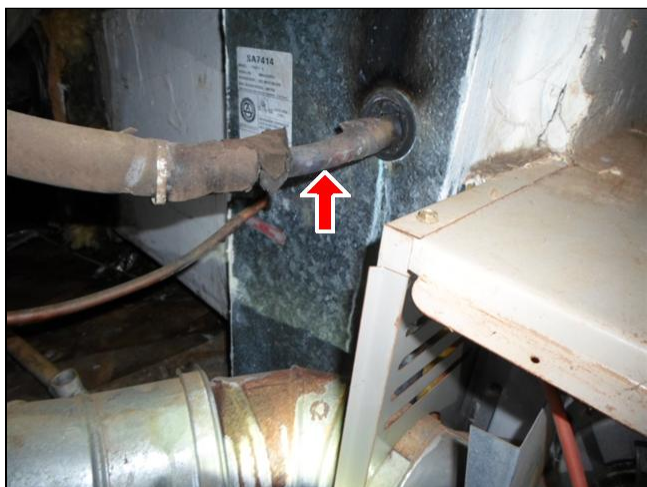
11.0 Item 2(Picture) torn ac line

11.0 (3) Torn insulation was noted on the ac line next to the furnace. Repair.

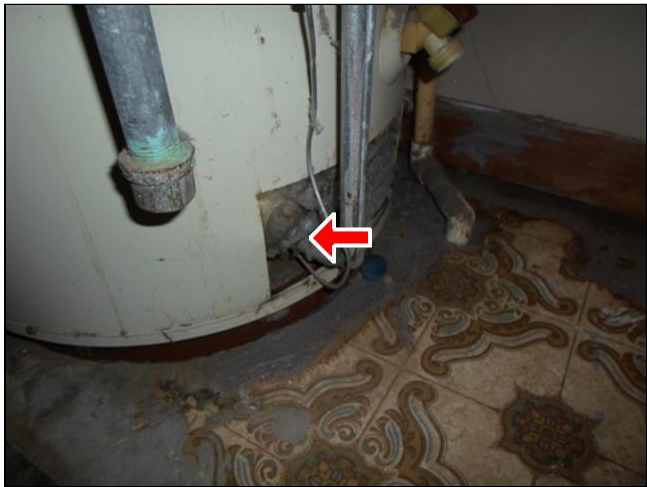
12.0 Item 1(Picture) missing cover

- 12.0 (1) The water heater was beyond its designed age life. Budget for replacement.
- 12.0 (2) The pilot light access cover door was missing. Install.

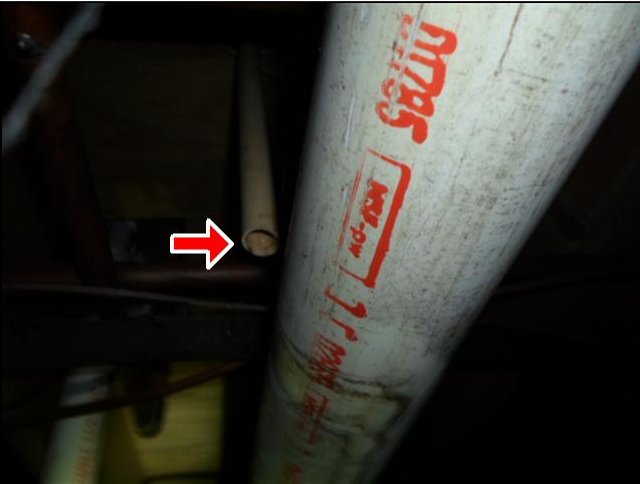
12.0 (3) The temperature and pressure relief valve was discharging into the crawl space. Recommend terminating pipe to the exterior of the house and further evaluation from a licensed plumber.

12.0 Item 2(Picture) pipe leaking and discharges in crawl space

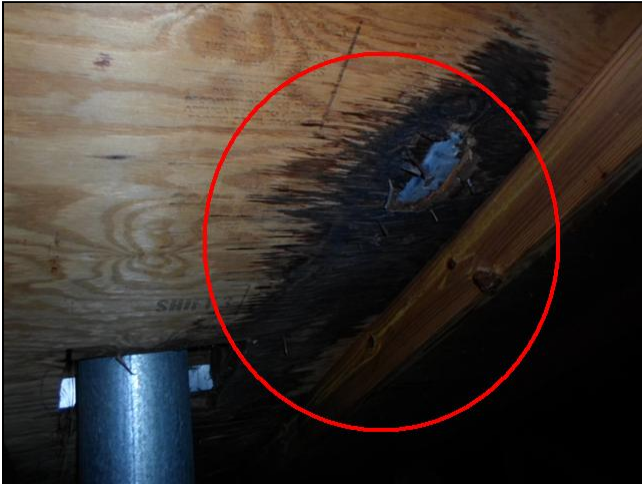
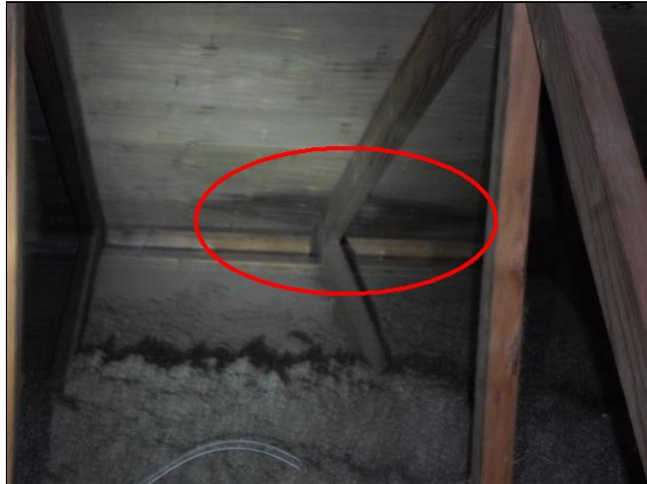
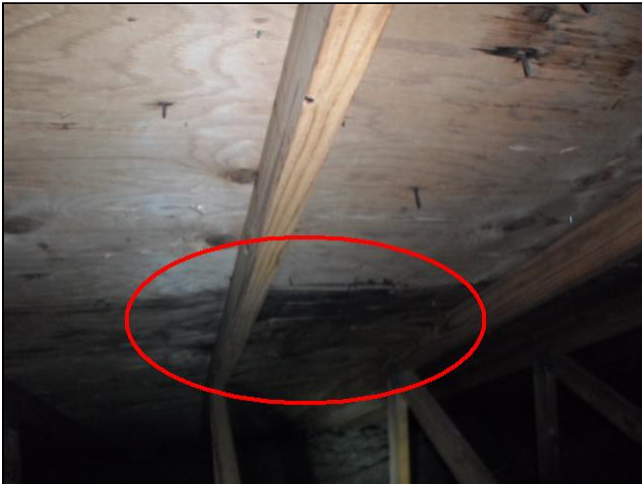
13.0 Item 1(Picture) water spots

13.0 (1) Water spots were noted on the front attic sheathing above the covered porch and rear attic sheathing around the chimney. Recommend further evaluation from a licensed roofer and monitor for leaks.

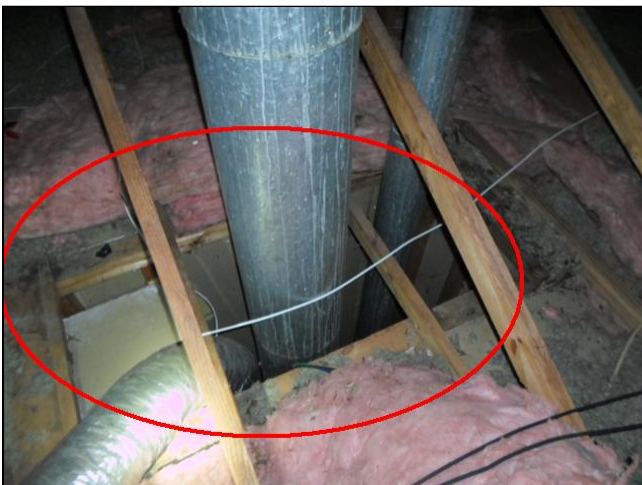
13.0 Item 4(Picture) open cavity space

13.0 (2) Recommend sealing open cavity space noted around the chimney for added energy efficiency and as a fire barrier.

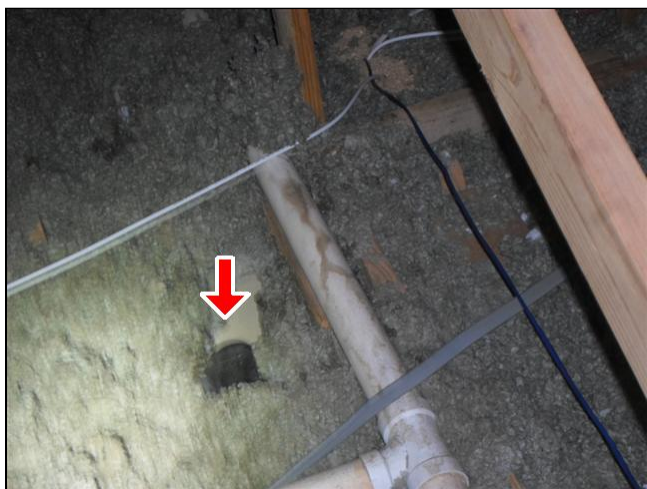
13.1 Item 1(Picture) fan terminates in attic

13.1 (2) The guest bathroom fan was vented into the attic. Recommend venting to the exterior of the house.

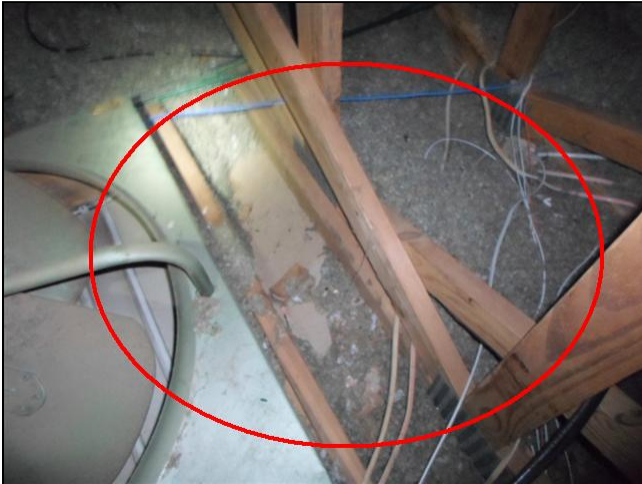
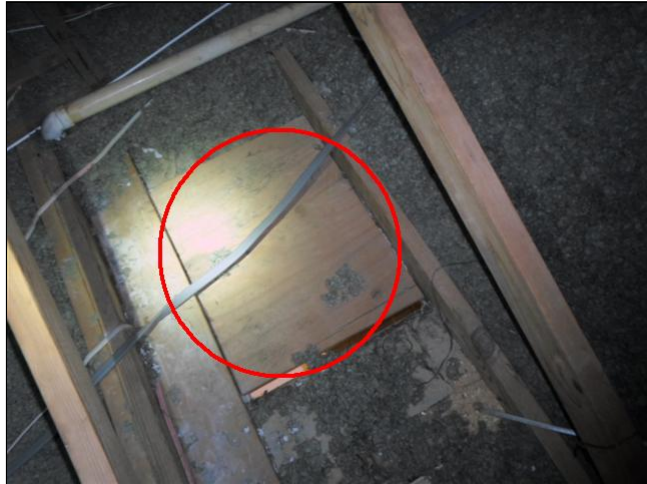
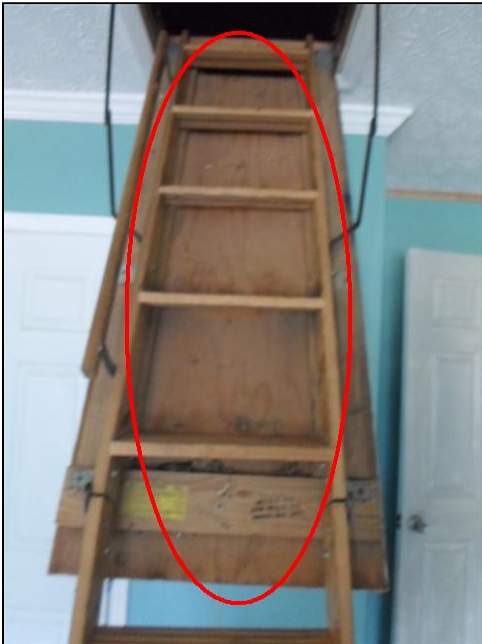
13.2 Item 1(Picture) low insulation

13.2 Low levels of insulation were noted throughout the attic and no insulation were noted on the attic doors. Recommend installing additional insulation for added energy efficiency.

13.2 Item 2(Picture) missing insulation

13.2 Item 3(Picture) missing insulation

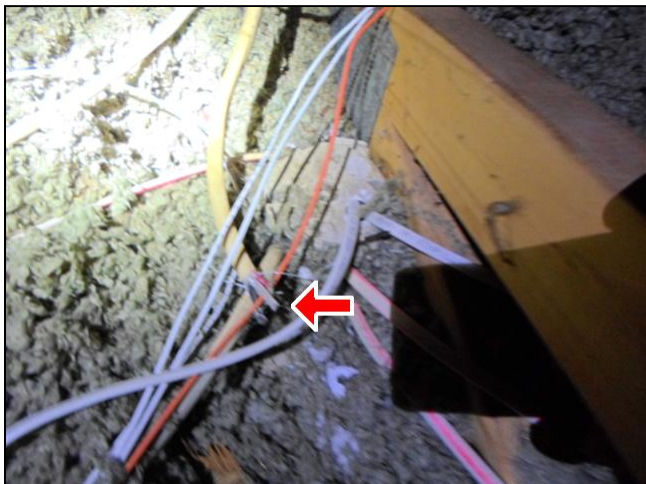
13.3 Item 1(Picture) loose wires

13.3 One loose set of wires was noted in the rear center part of the attic. Recommend installing wires inside a junction box with a cover.

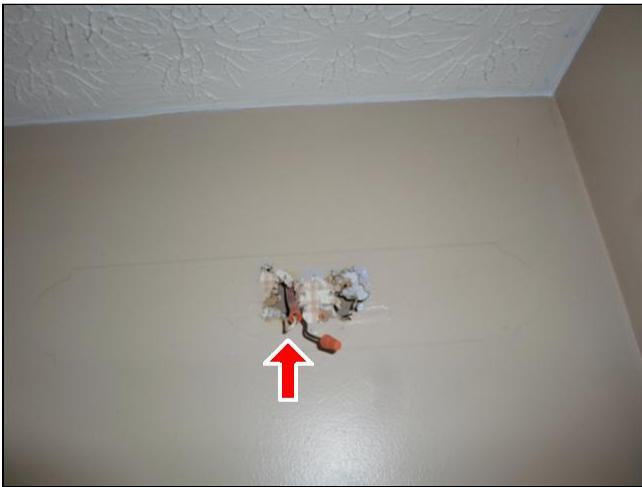
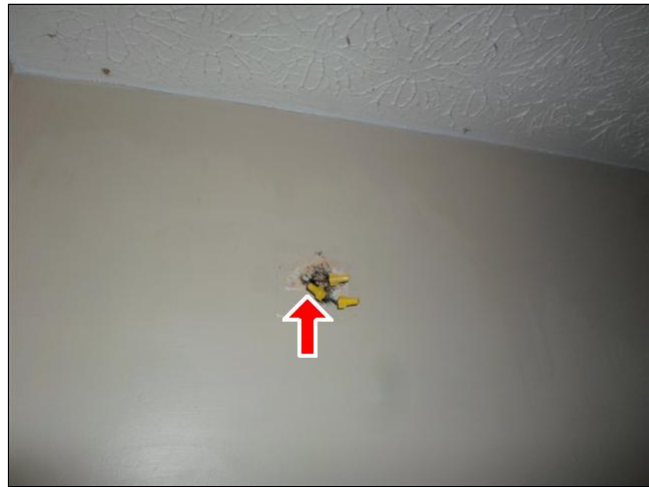
14.4 Item 1(Picture) missing light

14.4 (2) Both bathroom lights were missing during the inspection. Install.

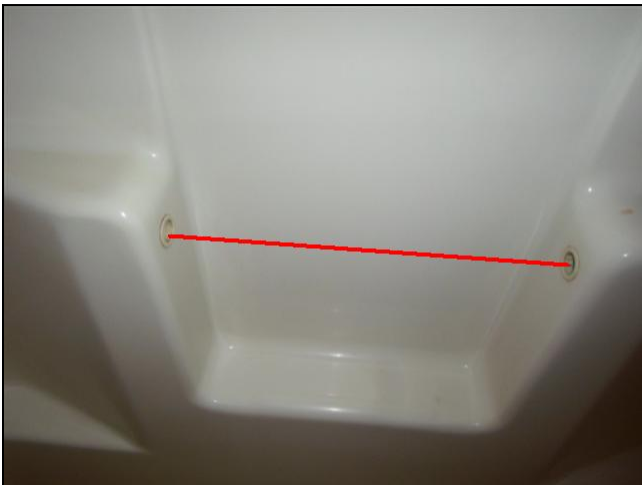
14.7 Item 1(Picture) missing bar

14.7 Both bathroom shower heads were missing during the inspection. The guest bathroom tub handle was also missing. Install.

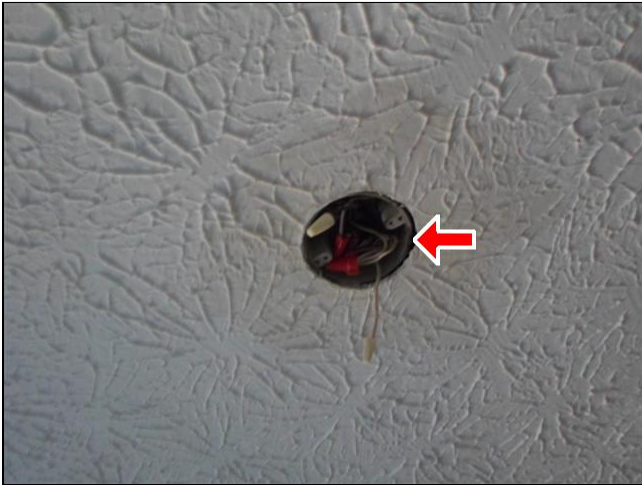
15.6 Item 1(Picture) missing light

15.6 (2) The ceiling light was missing in the front center bedroom. Install.

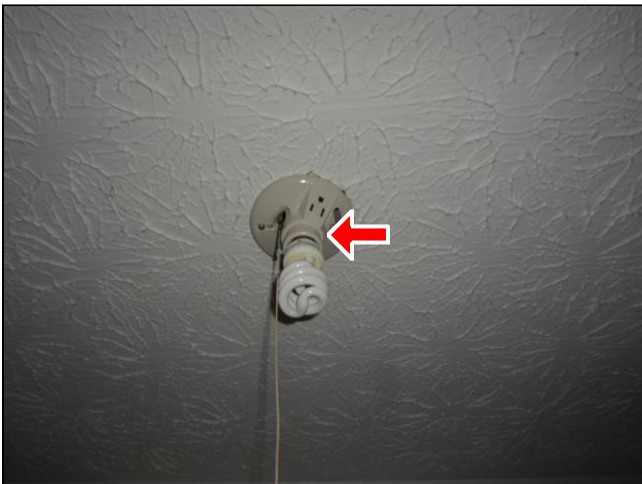
15.6 Item 2(Picture) missing light cover

15.6 (3) No cover was noted on the master bedroom closet light. Recommend installation for added fire safety.
