Inspection Report

Property Address:
123 Anytown Street
Lot #265
Anytown GA 30000

Champ Home Inspections, Inc.

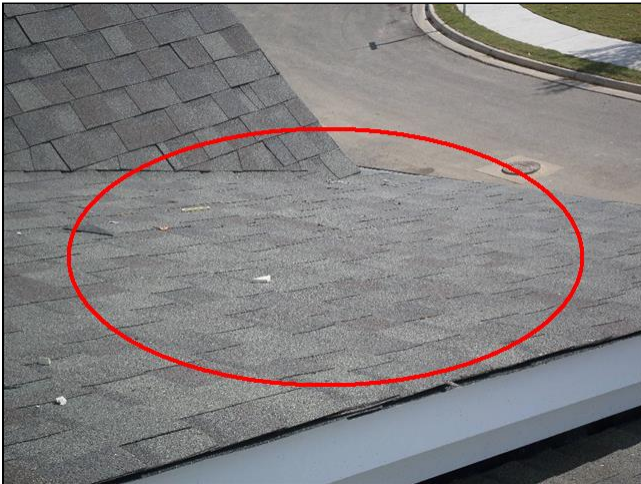
2.0 (1) Roofing debris was noted in various locations on the roof. Recommend cleaning.

2.0 Item 1(Picture) debris on roof

(1) Roofing debris was noted in various locations on the roof. Recommend cleaning.

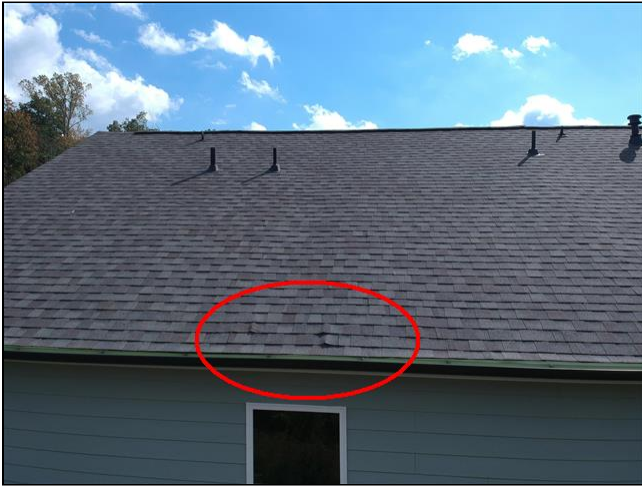
2.0 (2) Cupped shingles were noted on the rear side of the roof next to the upper gutter. Cupped shingles were also noted on the front right side of the roof. Recommend further evaluation from the builders roofer to evaluate the entire roof and repair.

2.0 Item 2(Picture) cupped shingles

(2) Cupped shingles were noted on the rear side of the roof next to the upper gutter. Cupped shingles were also noted on the front right side of the roof. Recommend further evaluation from the builders roofer to evaluate the entire roof and repair.

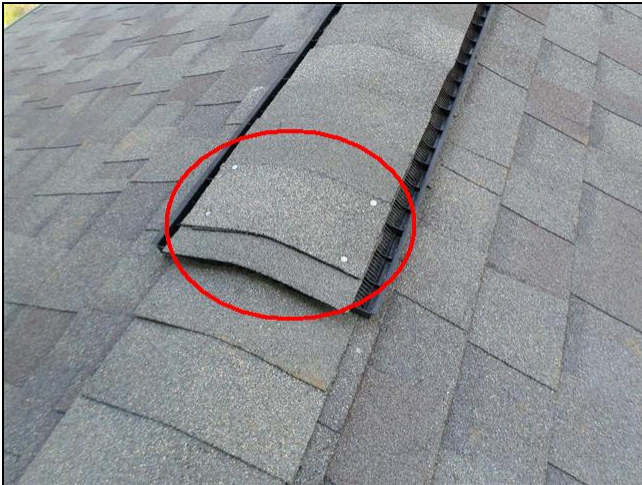
2.1 (1) Exposed nails were noted on the ridge vent above the rear eating area. Recommend sealing.

2.1 Item 1(Picture) exposed nails

(1) Exposed nails were noted on the ridge vent above the rear eaving area. Recommend sealing.

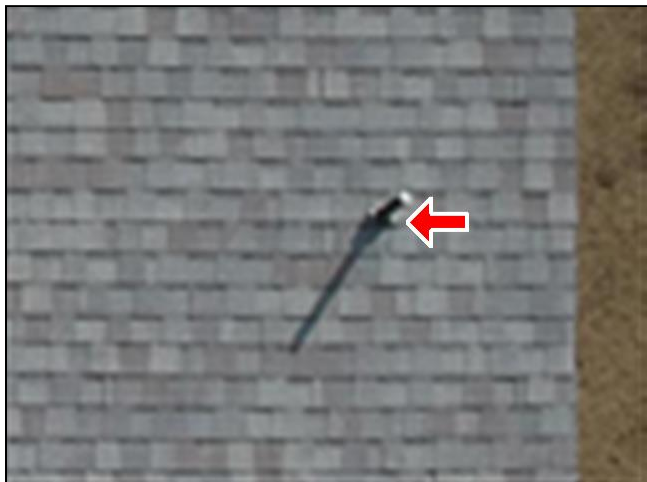
2.1 (2) A plumbing vent pipe boot was missing on the rear left side of the roof. Recommend further evaluation from the builders roofer.

2.1 Item 2(Picture) missing boot

(2) A plumbing vent pipe boot was missing on the rear left side of the roof. Recommend further evaluation from the builders roofer.

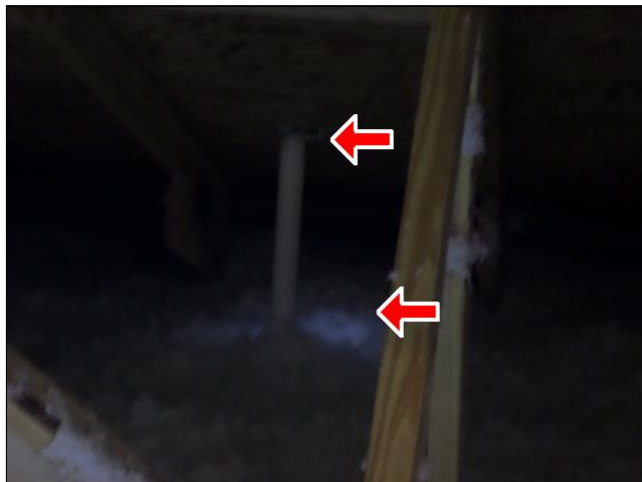
2.1 Item 3(Picture) daylight in attic

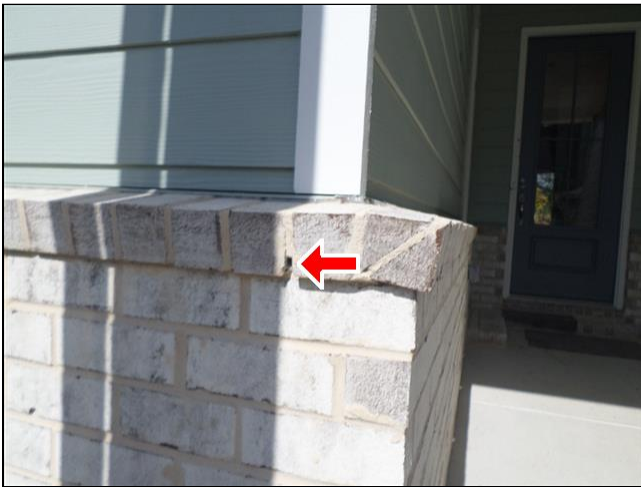
3.0 (1) Recommend sealing open mortar joint noted in the brick at the front left corner of the porch.

3.0 Item 1(Picture) open joint

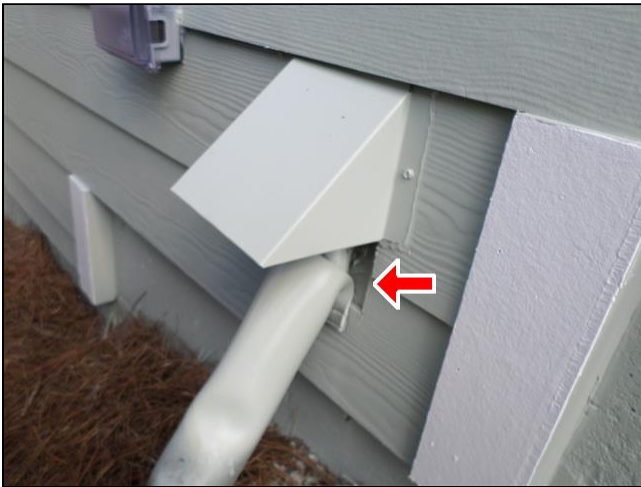
3.0 (2) Exposed osb was noted on the left side of the house at the ac line set. Repair.

3.0 Item 2(Picture) exposed osb

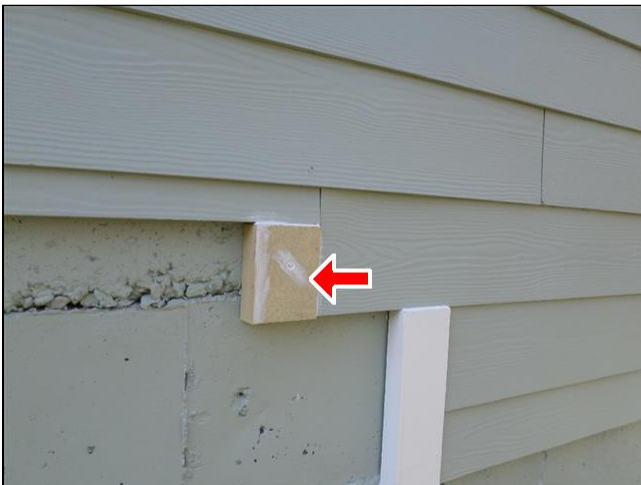
3.0 (3) One un-painted piece of trim was noted on the right side of the house. Repair.

3.0 Item 3(Picture) un-painted trim

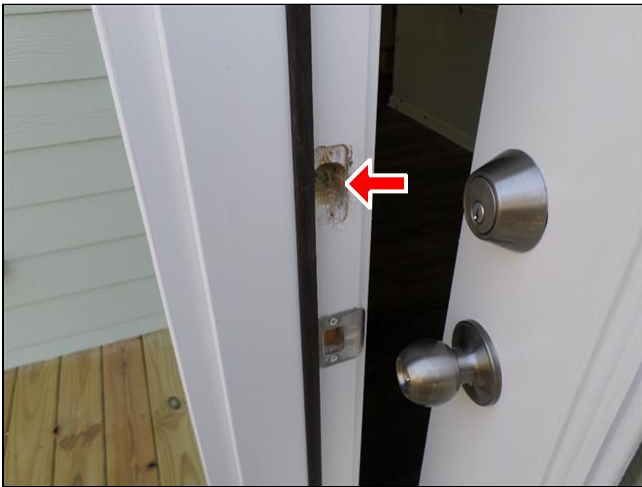
3.2 One strike plate was missing on the rear exterior family room door. Install.

3.2 Item 1(Picture) missing strike plate

One strike plate was missing on the rear exterior family room door. Install.

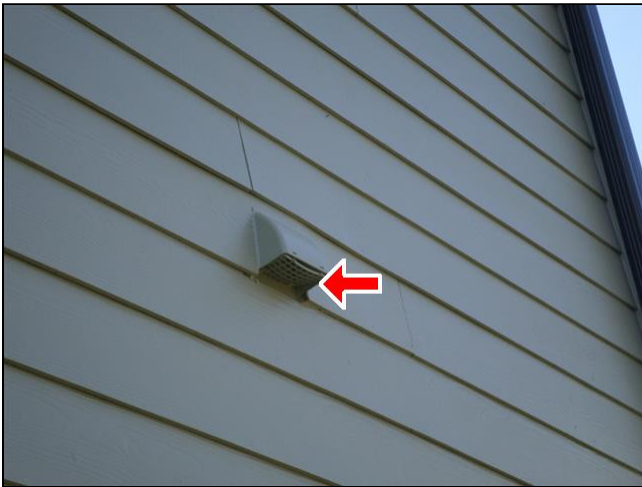
3.4 (1) One loose vent screen was noted on the rear left side of the house. Repair.

3.4 Item 1(Picture) loose screen

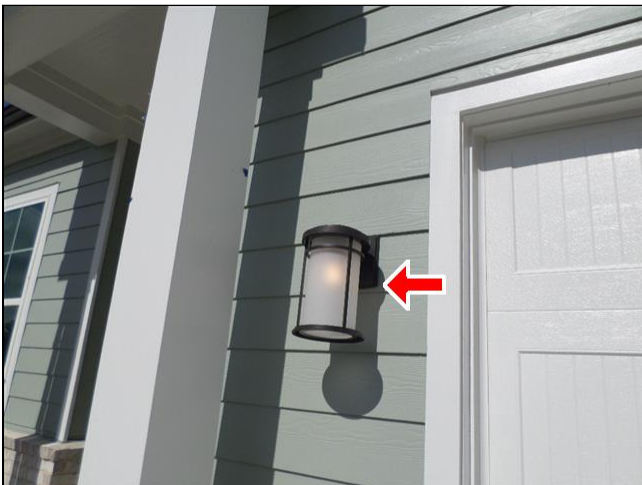
3.4 (2) Recommend sealing open gap noted around the left couch light next to the garage.

3.4 Item 2(Picture) open gap

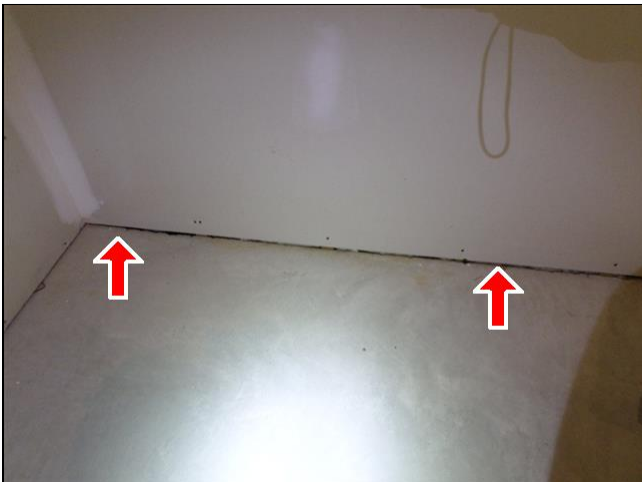
4.1 Recommend sealing open gap noted along rear wall at the slab connection.

4.1 Item 1(Picture) open gap

Recommend sealing open gap noted along rear wall at the slab connection.

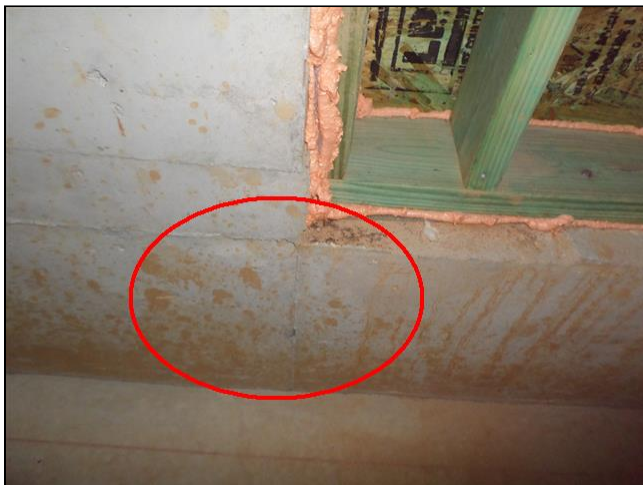
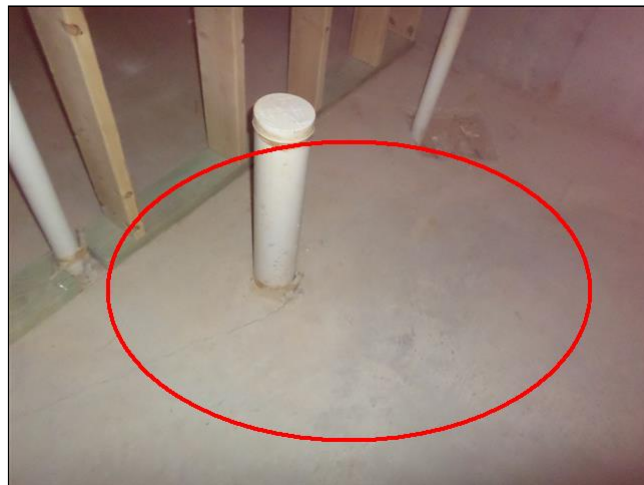
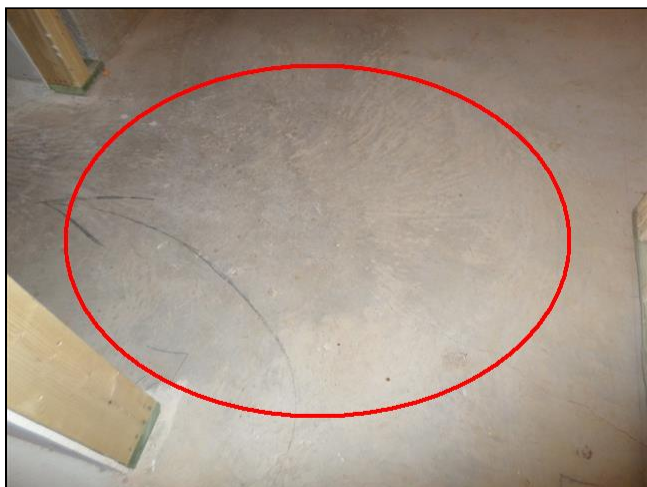
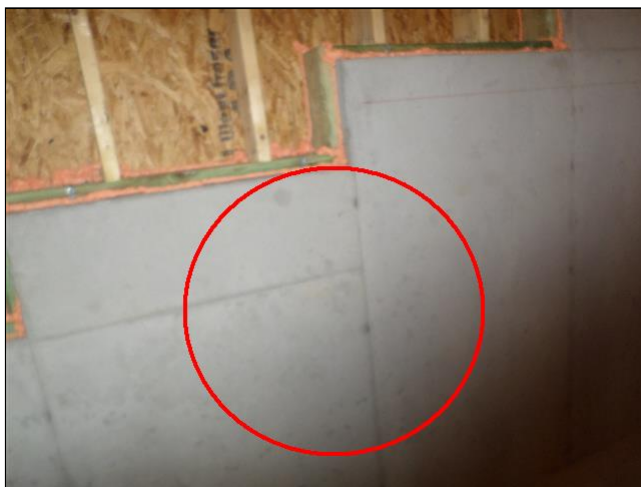
5.0 (1) Small diameter cracks of 1/8" or less were observed in the basement slab and several foundation walls. Cracks in concrete are common and are often the result of settling or shrinkage during the drying / curing process. In general, these do not present a problem unless a significant crack or settling is observed. Cracks may be sealed to reduce the potential for moisture and soil gases including radon to enter the basement.

5.0 Item 1(Picture) crack on wall

5.0 Item 2(Picture) crack on slab

5.0 Item 3(Picture) crack on slab

5.0 Item 4(Picture) crack on wall

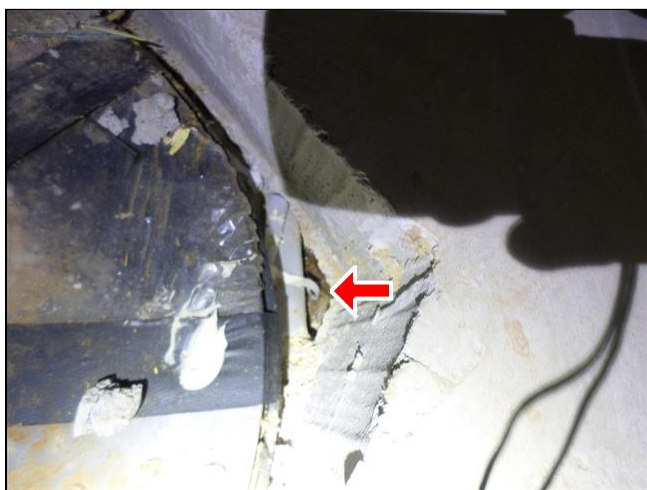
5.0 (2) Water was noted next to the sewage ejector pump basin. Recommend ensuring area is dry.

5.0 Item 5(Picture) water next to basin

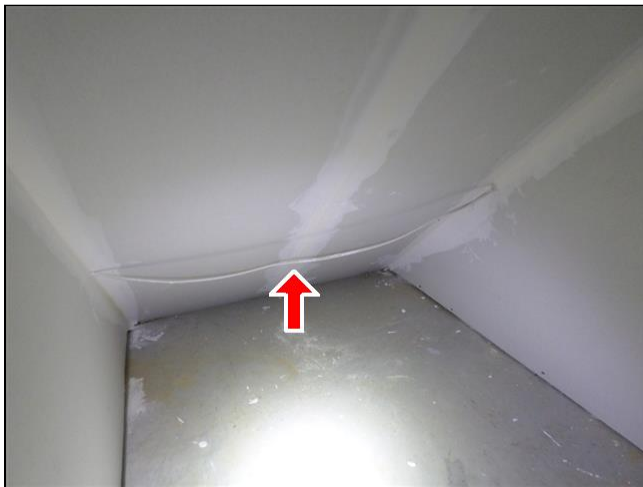
7.5 A loose wire was noted below the basement stairs. Repair.

7.5 Item 1(Picture) loose wire

A loose wire was noted below the basement stairs. Repair.

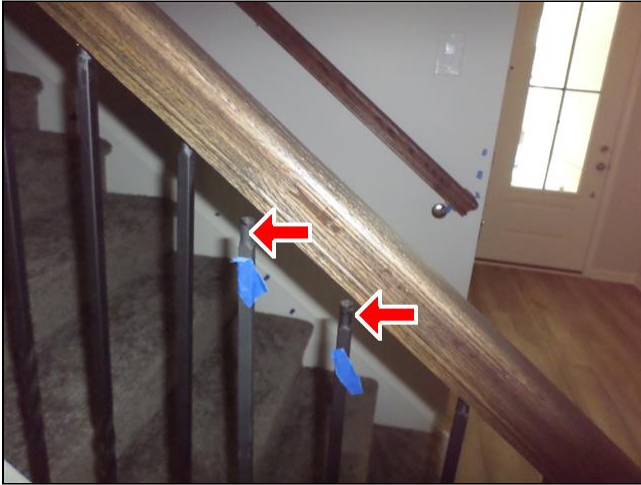
7.8 Two spindles were loose on the foyer stair hand railing. Repair.

7.8 Item 1(Picture) loose spindles

Two spindles were loose on the foyer stair hand railing. Repair.

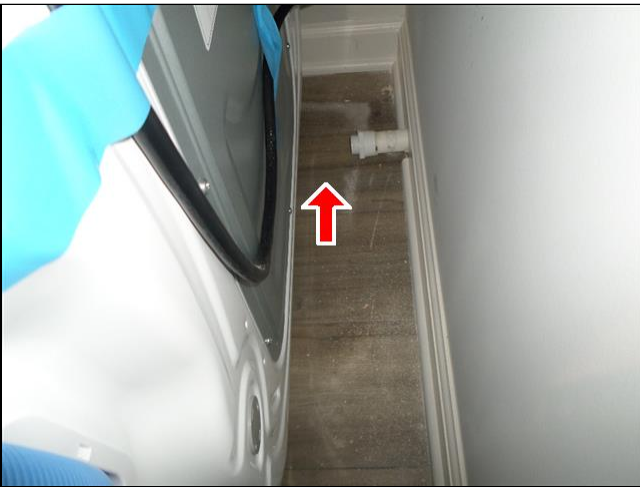
9.4 The washing machine over flow pan was missing during the inspection. Install.

9.4 Item 1(Picture) missing pan

The washing machine over flow pan was missing during the inspection. Install.

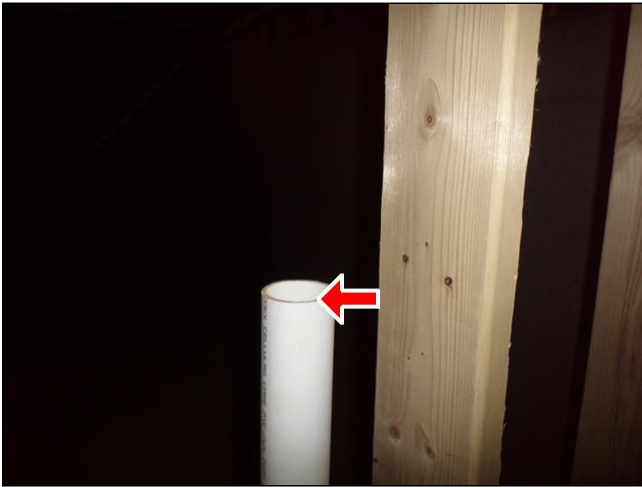
10.2 (2) A cap was missing on a drain pipe in the basement bathroom. Install.

10.2 Item 1(Picture) missing cap

(2) A cap was missing on a drain pipe in the basement bathroom. Install.

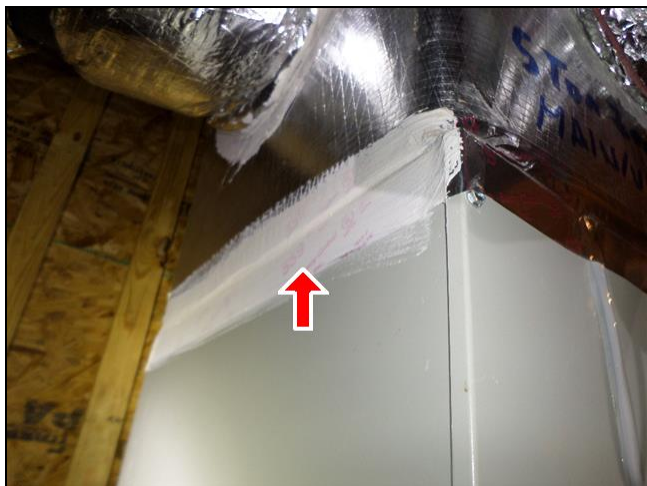
11.3 The foil tape for the joints at the HVAC unit is visible behind the mastic. This indicates that the mastic sealant is of not sufficient thickness. Per industry standards, the mastic should be 0.08 inches or 2 mil. in thickness.

See GA DCA 2011 Amendments to IECC 2009 403.2.4 for compliance requirements.

11.3 Item 1(Picture) visible words

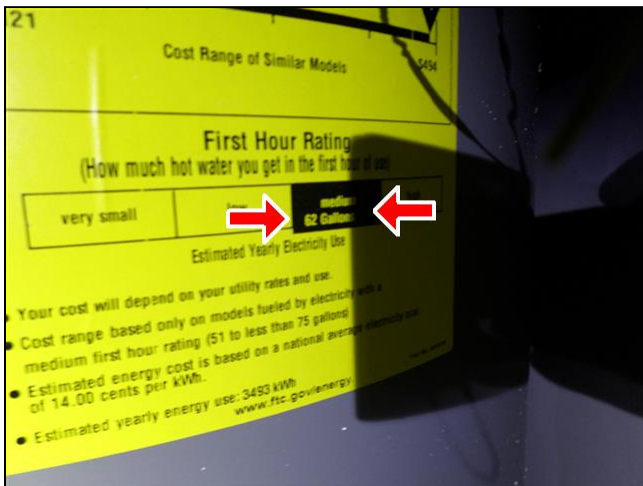
13.0 The water heater is too small based on the Georgia State Amendments to the International Plumbing Code. For a 4 bedroom and 3 1/2 bathroom house the minimum first hour rating for a water heater is 74 gallons. Recommend upgrading water heater size. https://www.dca.ga.gov/sites/default/files/ipc_2022_amendments.pdf

13.0 Item 1(Picture) first hour rating

The water heater is too small based on the Georgia State Amendments to the International Plumbing Code. For a 4 bedroom and 3 1/2 bathroom house the minimum first hour rating for a water heater is 74 gallons. Recommend upgrading water heater size. https://www.dca.ga.gov/sites/default/files/ipc_2022_amendments.pdf

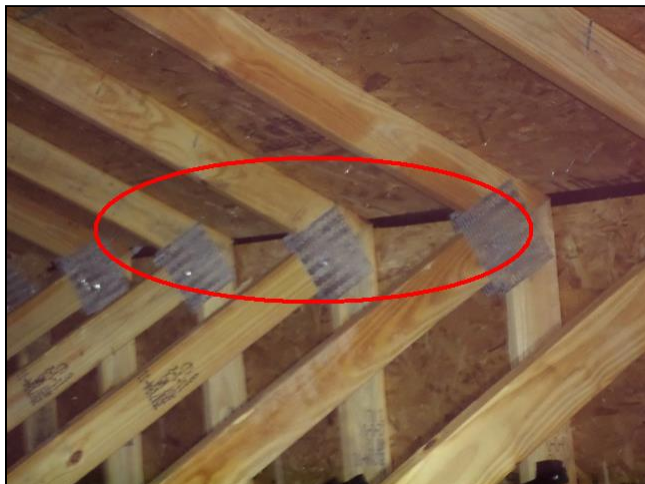
14.1.B A small gap was noted in several areas at the ridge vent. Recommend further evaluation from the builders roofer to ensure proper upper ventilation.

14.1.B Item 1(Picture) small gap

A small gap was noted in several areas at the ridge vent. Recommend further evaluation from the builders roofer to ensure proper upper ventilation.

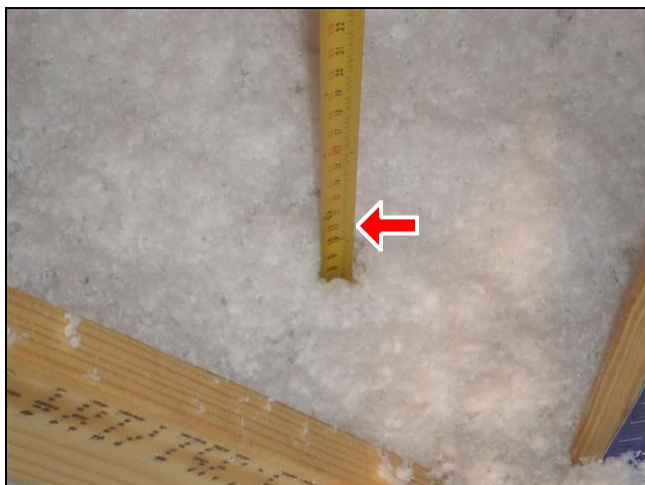
14.2.B (1) The blown insulation is too low. Recommend installing a minimum of R 38 value. Per the International Energy Conservation Code, 2015 edition with 2020 Georgia Amendments, Table 402.1.2 requires R-38 insulation in attics.

14.2.B Item 1(Picture) low insulation

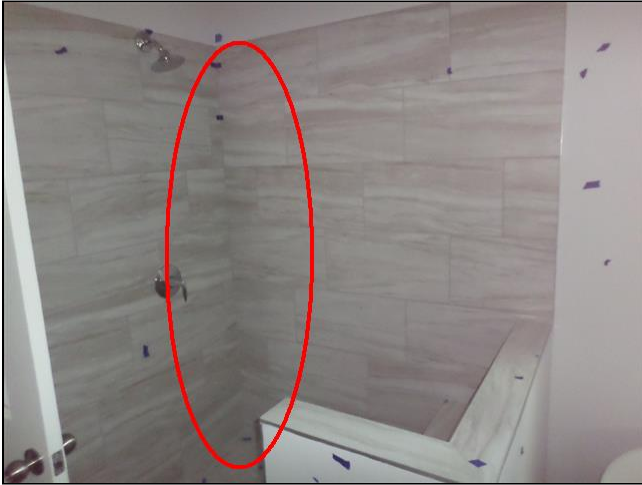
15.7.A (2) Recommend sealing open grout joint in the corner of the shower.

15.7.A Item 1(Picture) open gap

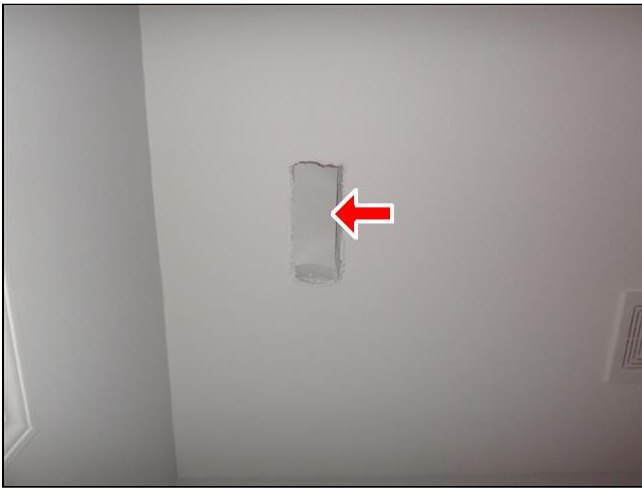
15.3.C (1) The ceiling vent cover was missing. Install.

15.3.C Item 1(Picture) missing vent

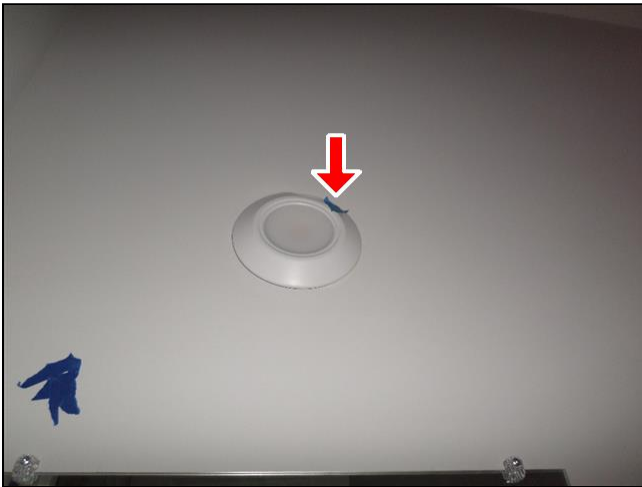
15.3.C (2) The wall recessed light was loose. Repair.

15.3.C Item 2(Picture) loose light

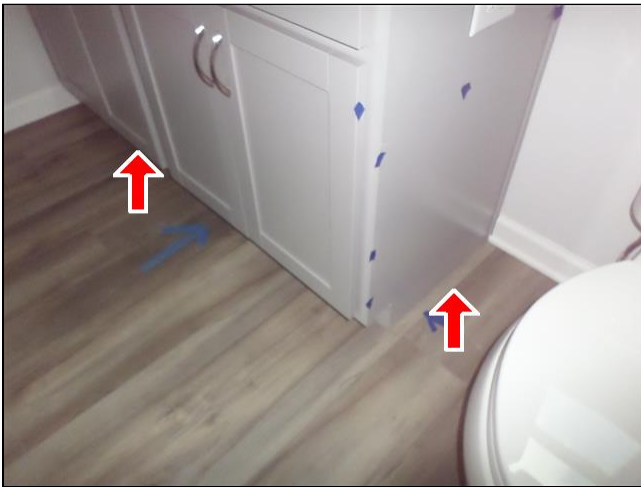
15.5.D Missing shoe molding was noted on the sink cabinet. Install.

15.5.D Item 1(Picture) missing trim

Missing shoe molding was noted on the sink cabinet. Install.

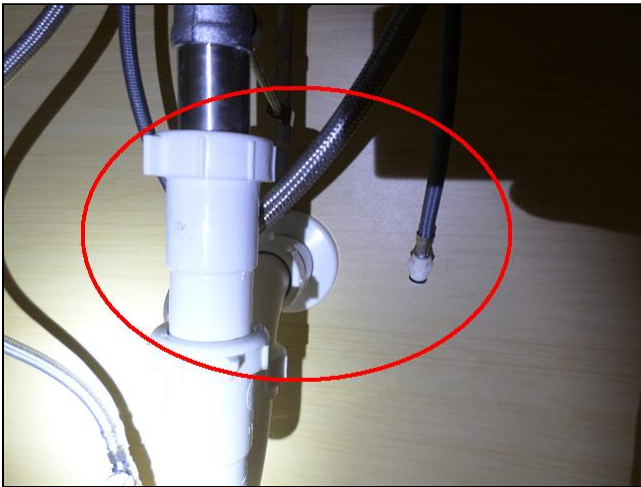
15.6.D The water lines were not connected on the sink faucets at the time of the inspection. Install.

15.6.D Item 1(Picture) water lines not connected
