Inspection Report

Property Address:
123 Anytown Street
Anytown GA 30000

Champ Home Inspections, Inc.

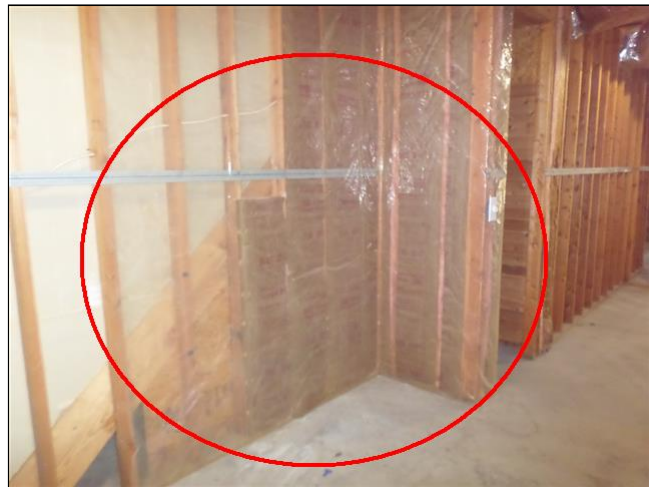
5.0 Item 5(Picture) plastic on walls

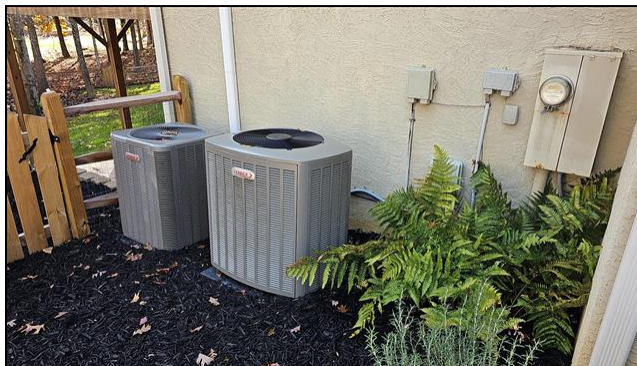
12.0 (2) The ac units were not tested, due to the outside temperature was below 65 degrees. Damage could occur to the ac units if the units are operated. Recommend servicing units prior to the next cooling season.

12.0 (3) The ac units were un-level. Recommend re-leveling units.

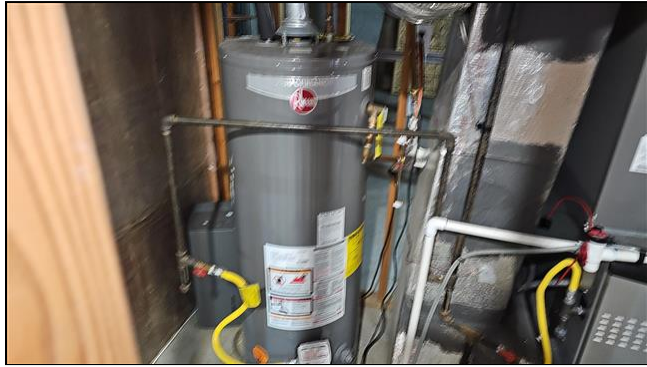
13.0 (1) The tpr valve drain was not located at the lowest point on the pipe. Repair.

13.0 (2) The water heater was near its designed age life. *The unit was producing sufficient hot water during the inspection.* Budget for replacement.

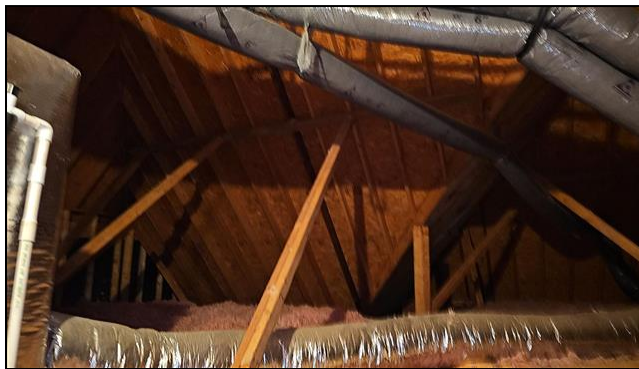
upper attic

14.1.A One bathroom exhaust fan vent pipe was disconnected from the roof vent near the attic door. Repair.

14.2.A (1) Low levels of insulation were noted in the attic. Recommend installing additional insulation for added energy efficiency.

14.2.A (2) The basement furnace vent pipe was touching the insulation. Recommend a minimum of 1" clearance between the insulation and vent pipe.

14.2.A (3) Loose batt insulation was noted on the front family room vertical wall. Re-secure.

14.4.A (1) No insulation was noted on the attic entry door. Recommend installation for added energy efficiency.

14.4.A (2) One spring arm was loose. Repair.

14.4.A (3) Missing flooring was noted next to the access door. Recommend installation for added convenience.

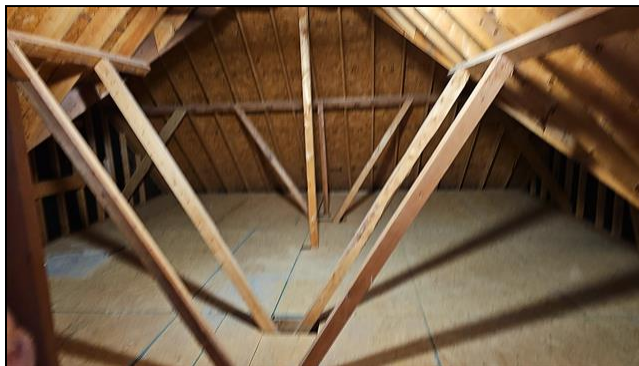
lower attic

14.2.B Loose batt insulation was noted on the left vertical wall. Re-secure.

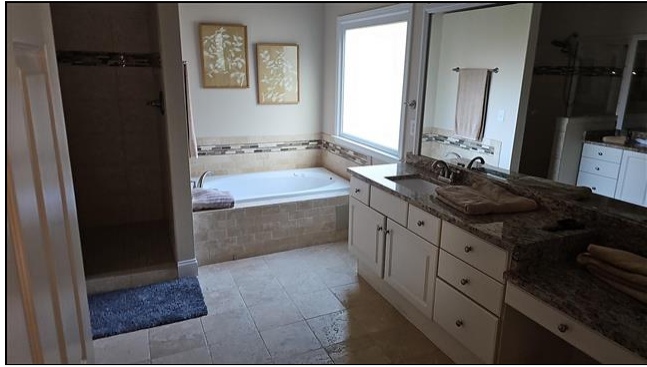
master bathroom

15.2.A One floor tile was cracked next to the bathroom door. Repair.

15.5.A Recommend sealing open gap noted between backsplash and countertop at the right sink.

15.6.A (1) The sink drain plugs were broken. Repair.

15.6.A (2) Accordion drain pipe was noted on the right sink drain. This type of piping is not permitted on drain pipes. Recommend replacing with a smooth wall drain pipe.

15.7.A The tub faucet was loose. Repair.

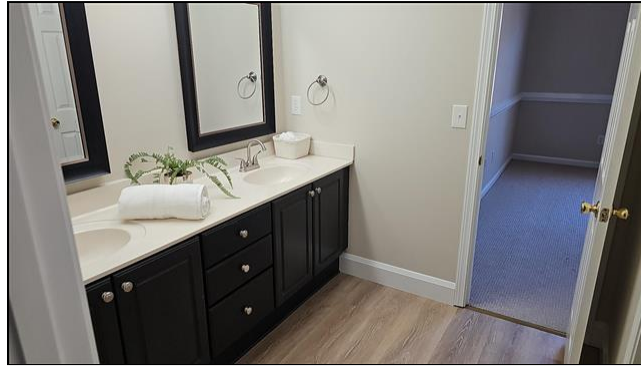
right bathroom

15.5.B One sink drained slowly when tested. Recommend cleaning drain as necessary.

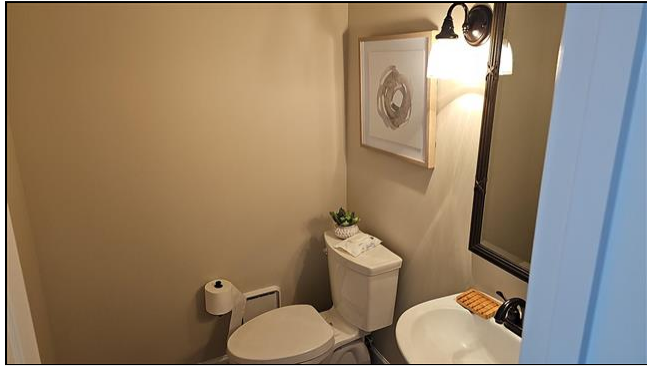
half bathroom

15.1.C The subfloor was squeaky when tested. Repair.

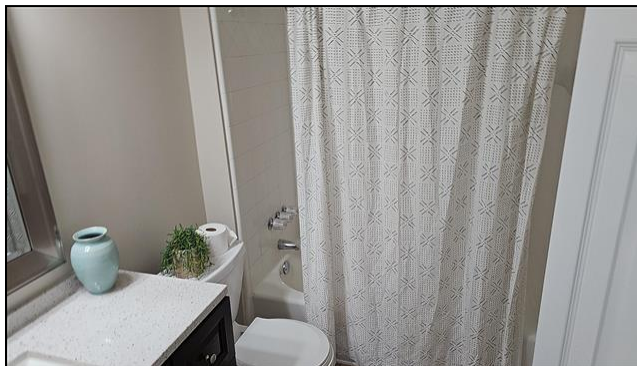
left bathroom

15.1.D The subfloor was squeaky when tested. Repair.

15.8.D The toilet was located too close to the sink cabinet. Recommend a minimum of 15" from the center of the toilet to a wall or cabinet.

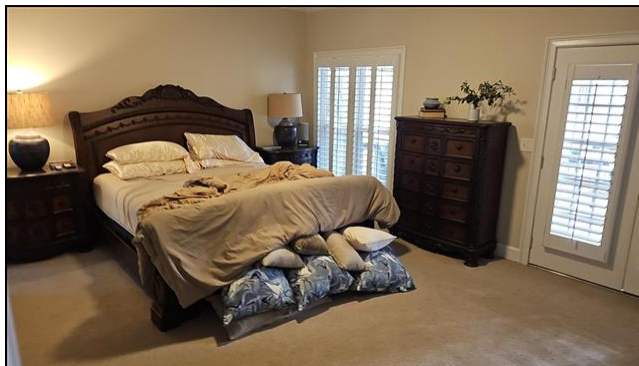
master bedroom

16.3.A The subfloor was squeaky when tested. Repair.

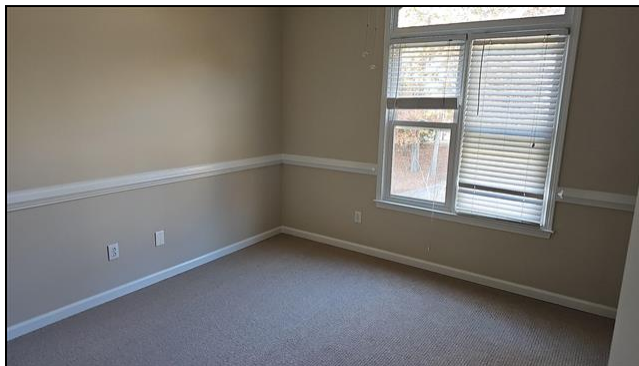
front right bedroom

16.3.B (1) The carpet was dirty. Recommend cleaning.

16.3.B (2) The subfloor was squeaky when tested. Repair.

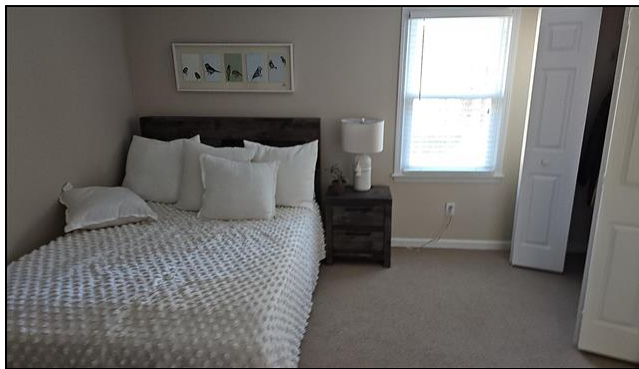
left bedroom

16.4.C The bedroom door self opens when tested. Re-adjust the door hardware.

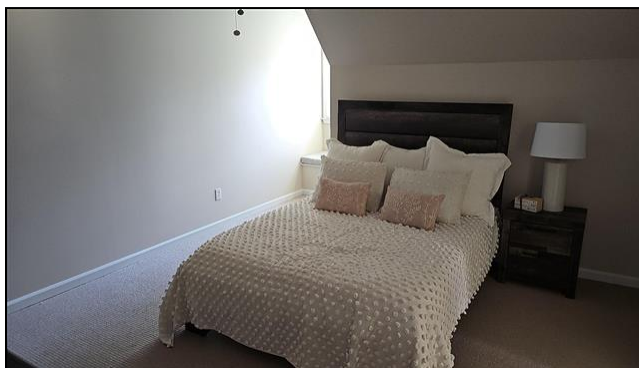
rear right bedroom

16.3.D The subfloor was un-level near the window. Recommend further evaluation from a licensed contractor.
