## Inspection Report

**Property Address:**  
100 Main Street  
Anytown GA 30000

**Champ Home Inspections, Inc.**

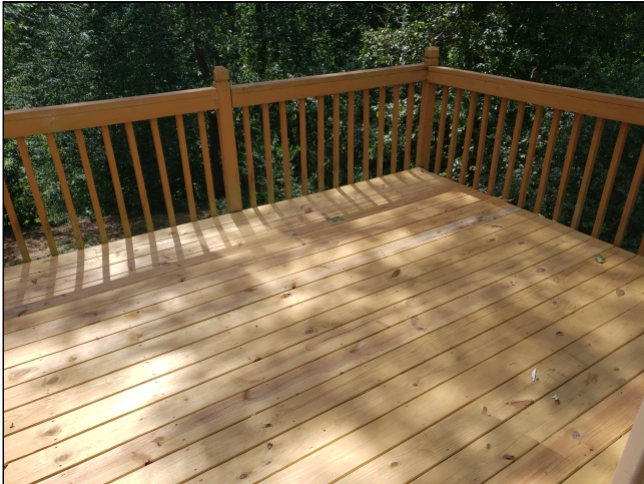
rear deck

1.3 (1) The rear right post was damaged at the deck connection. Repair.

1.3 (2) Rot was noted on the left outer joist near the deck stairs. Repair.

1.3 (3) Several deck joists were separating from the ledger connection causing inadequate bearing on wood. The ledger was also bowed outward at the connection to the house. Recommend further evaluation from a licensed contractor.

**1.3 (4)** The guard railings were too low. Recommend a minimum guard railing height of 36".

**1.3 (5)** The guard railing picket spacings were too far apart. Recommend a maximum picket spacing of 4".

**1.3 (6)** No flashing was noted between the deck and the house. Recommend installation.

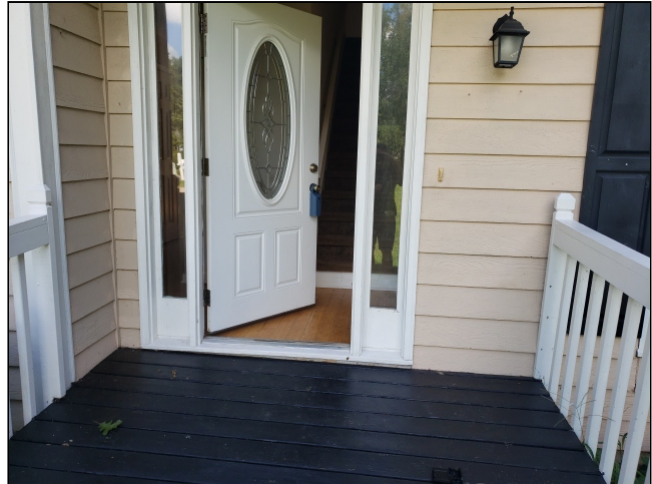
1.2 The front porch was leaning. Recommend further evaluation from a licensed contractor.

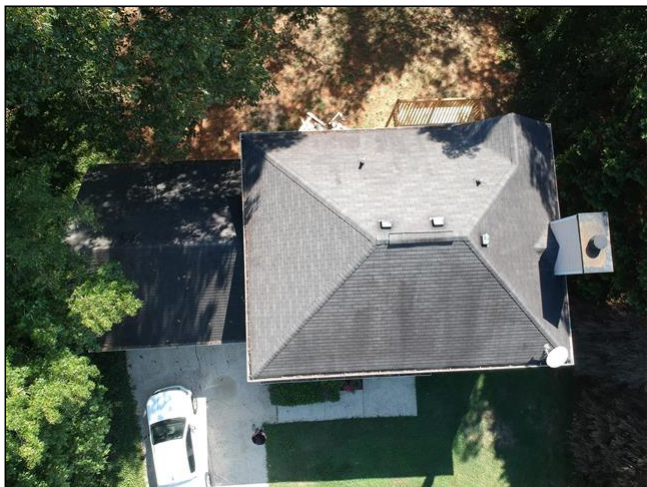
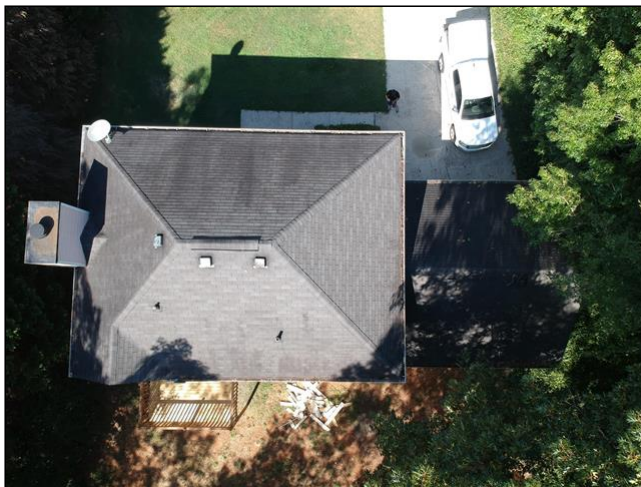
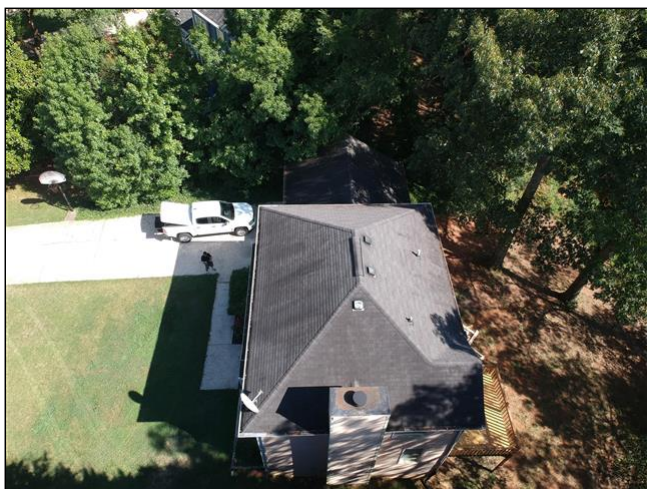
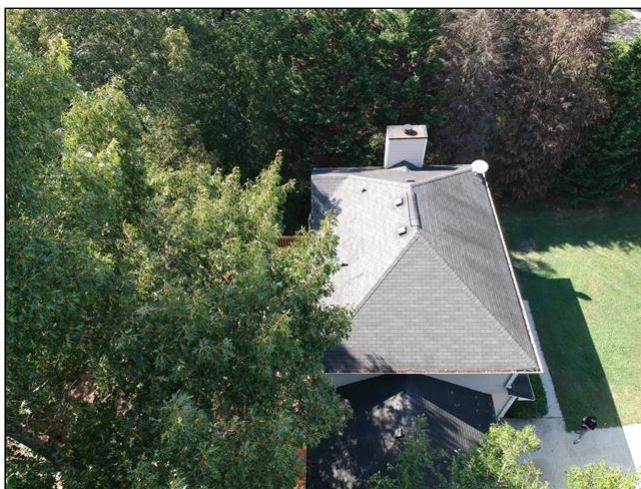
**2.0** Moss was noted on the front left side of the roof. The roof also appears to be near its designed age life. Recommend further evaluation from a licensed roofer and budget for replacement.

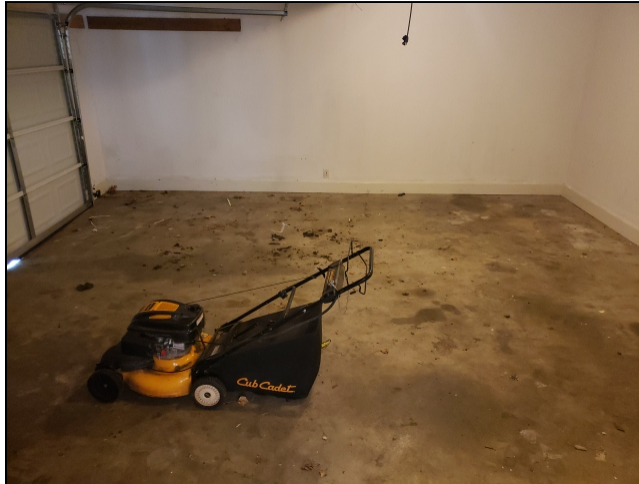
4.3 (1) Torn weather stripping was noted on the bottom of the garage door. Repair.

4.3 (2) The right mounting board was pulling away from the wall. Repair.

4.4 The safety sensors were installed together next to the ceiling. Recommend installing sensors between 5" - 6" above the floor.

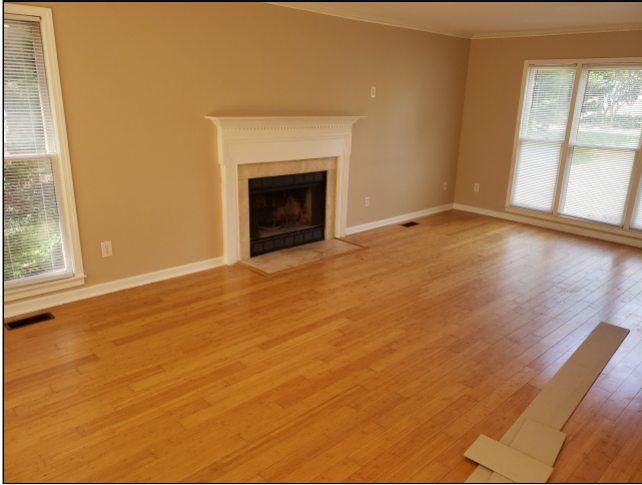
7.0 (1) Patch work was noted on the family room ceiling. Monitor for issues.

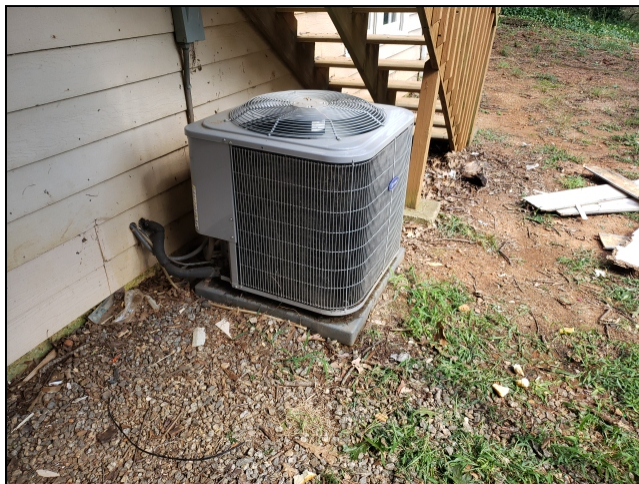
**12.0** The ac unit was located below the rear deck stairs. Recommend further evaluation from a licensed HVAC contractor to ensure proper clearance.

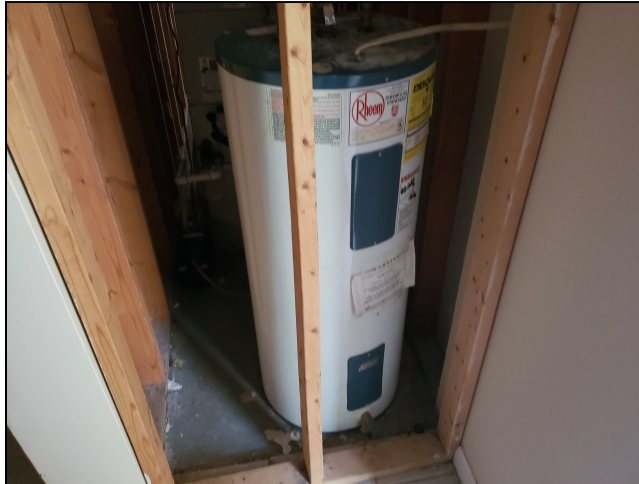
**13.0 (2)** The water heater was beyond its designed age life. *The unit was producing sufficient hot water during the inspection.* Budget for replacement.
